RE: Allen Pit, Permit No. M-2002-094, Technical Revision (TR-01) Adequacy Review (01)

MINERALS PROGRAM INSPECTION REPORT
PHONE: (303) 866-3567

MINE NAME: Allen Pit	MINE/PROSPECTING ID#: M-2002-094	MINERAL: Gravel	COUNTY: Montrose
INSPECTION TYPE: Monitoring	INSPECTOR(S): Dustin Czapla	INSP. DATE: June 23, 2022	INSP. TIME: 11:40
OPERATOR: Hank Williams, Inc. dba Williams Construction Contractors	OPERATOR REPRESENTATIVE: None	TYPE OF OPERATION: 112c - Construction Regular Operation

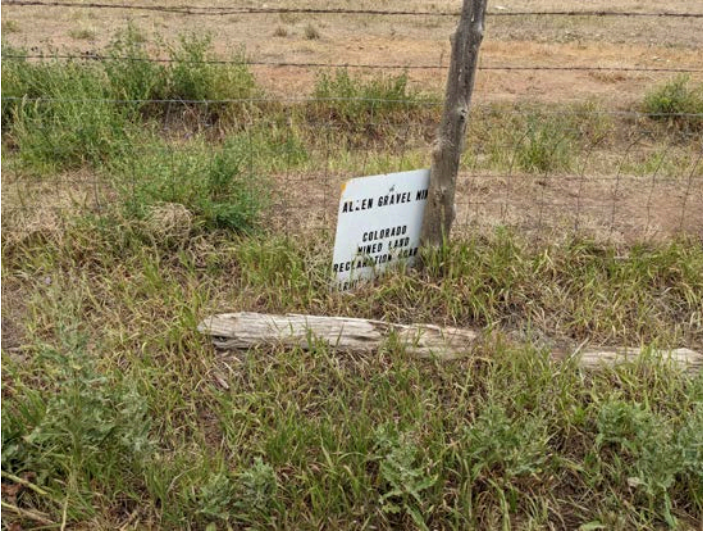
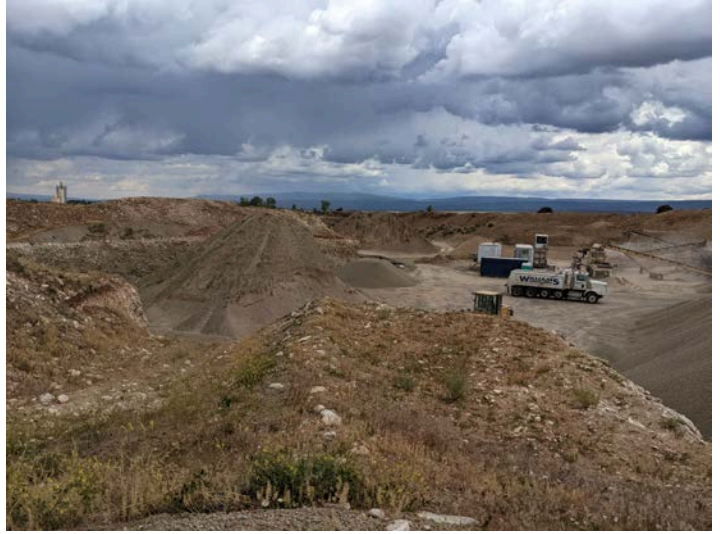
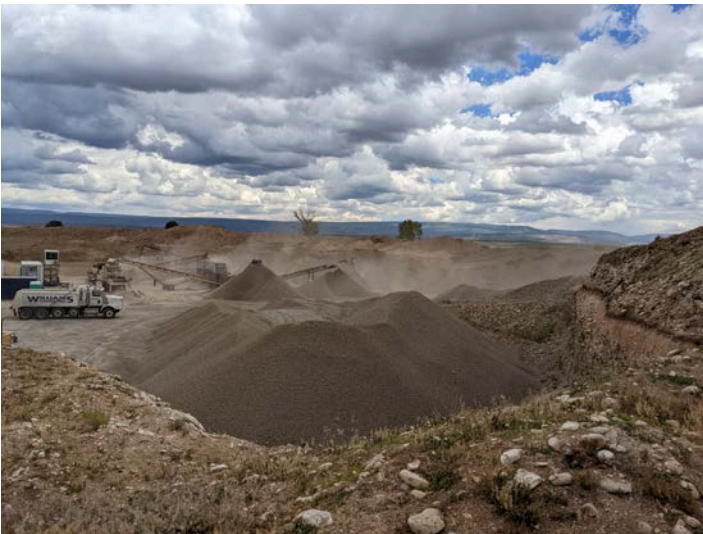
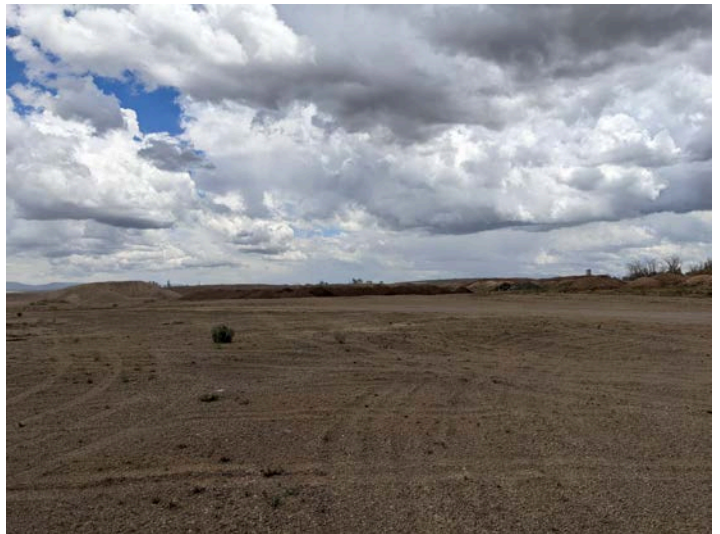
PROBLEM/POSSIBLE VIOLATION: Problem: Mining is not occurring in accordance with the approved Mine Plan. The operation has mined through the north permit boundary daylighting the pit to the adjacent Angie Pit (M-2000-049).

The permit was transferred to Hank Williams, Inc. in January 2015. During the Division's May 2019 inspection the operator stated that they were pursuing an agreement with the adjacent landowner that would allow the highwall separating the north end of the Allen Pit and the south end of the adjacent Angie Pit (M-2000-049) to be mined out in order to combine the two pits, both of which are operated by the same Operator. The currently approved Reclamation Plan requires that the highwall be backfilled to 2.5H:1V. **The Operator will need to submit a Technical Revision for the permit in order to address this change to the Mine Plan and associated change to the Reclamation Plan. This has been noted as a problem.**

CORRECTIVE ACTIONS: Submit a Technical Revision to the permit to address the change to the Mine Plan and to update the final Reclamation Plan for the site.
