April 7, 2023
Project#01349-0001

Subject: Summary of Instrumentation Monitoring
1st Quarter 2023
Bowie Coal Waste Disposal Area No. 3
Paonia, Colorado

**SUBJECT: Summary Report, 1st Quarter 2023, Vibrating Wire Piezometers
January through March 2023, Bowie Mine #2
Coal Waste Disposal Area (CWDA) #3**

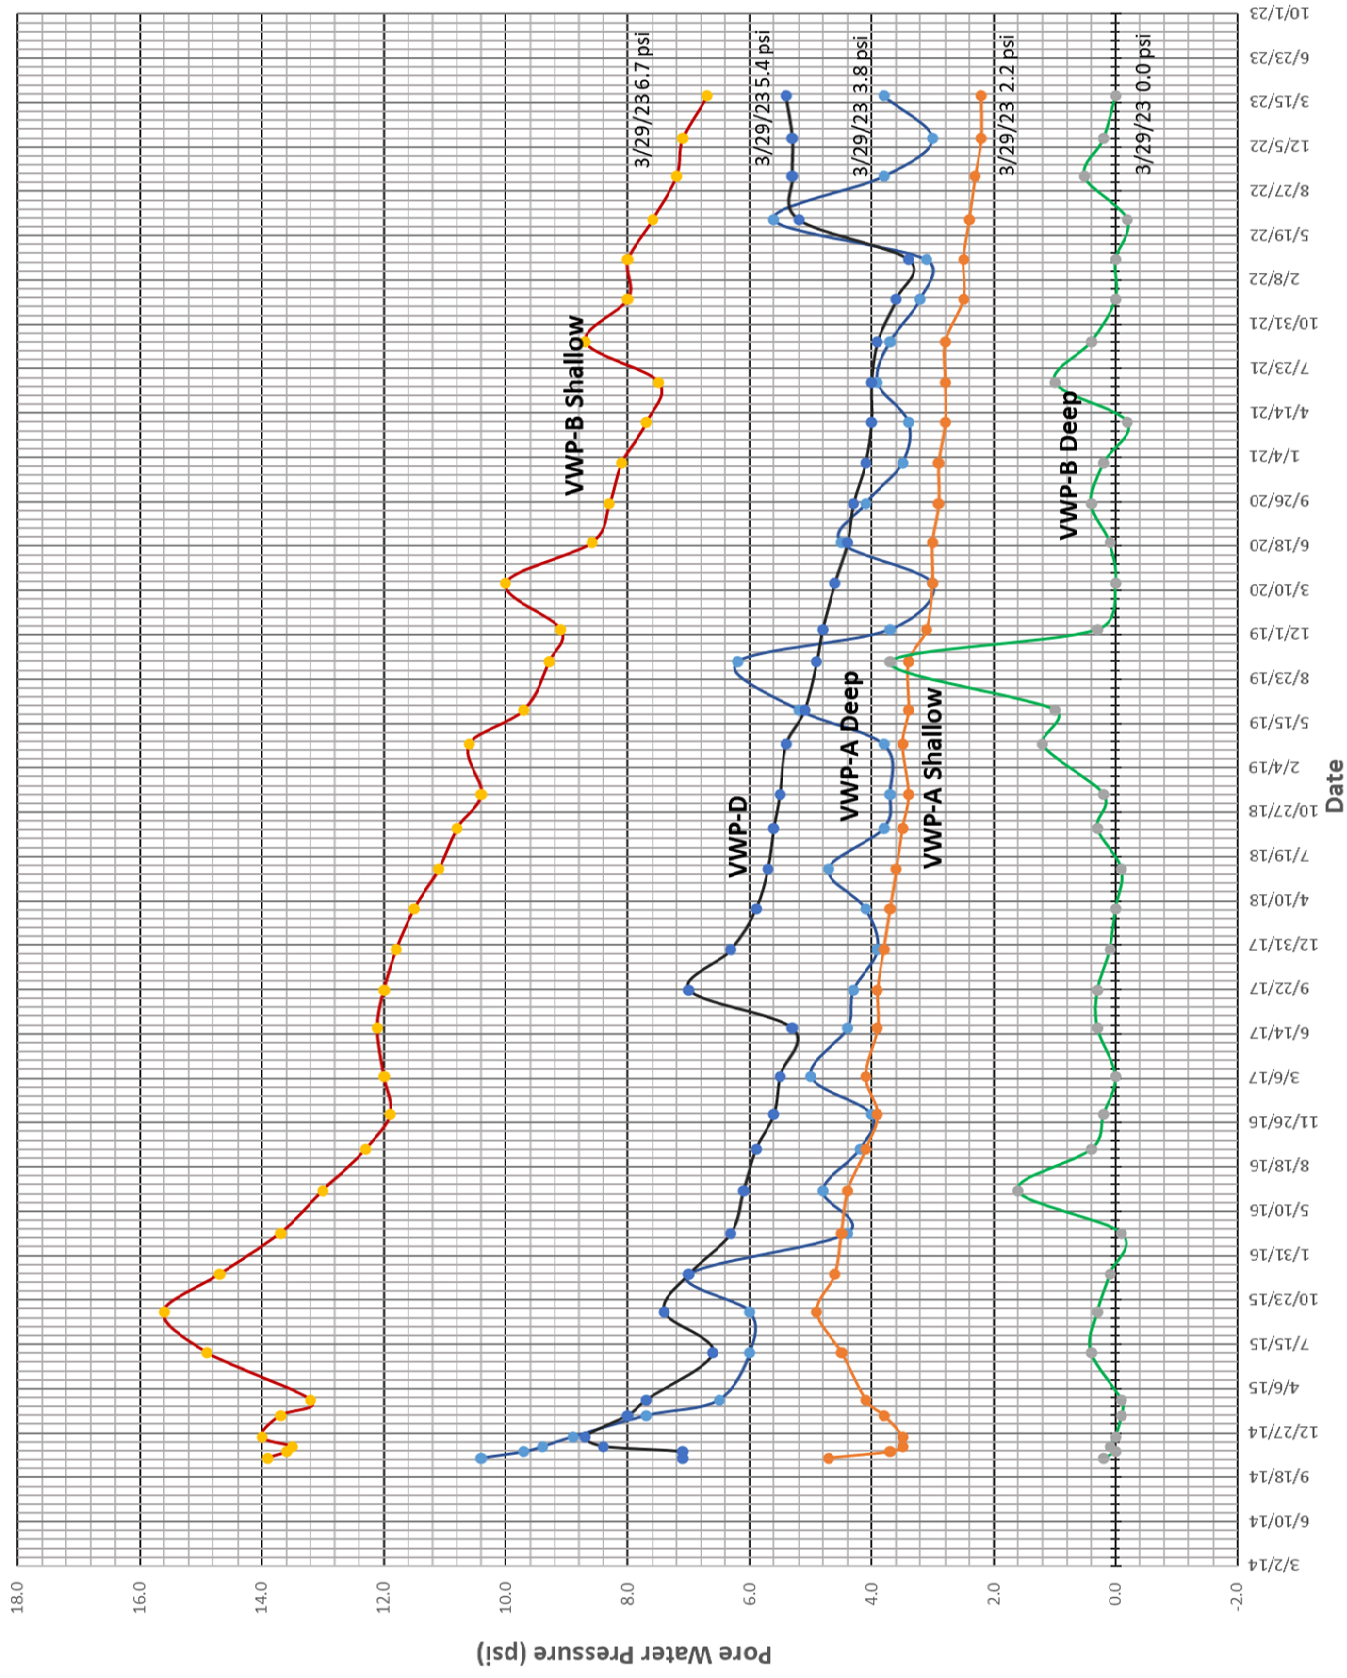
Figure 1 - Bowie Mine #2 - CWDA #3
Vibrating Wire Piezometer Data

As seen on Figure 1 and Table 1, since last quarter, two of the five VWP's decreased in pore pressure by 0.2-0.4 psi, two VWP's increased in pore pressure by 0.1-0.8 psi, and one VWP (VWP-D) did not change in pore pressure. Since installation in 2014, all five VWP's have decreased in pore pressure (-0.2 to -7.2 psi). Although there is a general trend of decreasing pore pressure over time, three of the piezometers (VWP-A Deep, VWP-B-Deep, and VWP-D) have more recent erratic behavior since early 2019.

Based upon the results of the most recent VWP monitoring data, HBET does not believe that there is any reduction in the stability of CWDA No. 3.

We present a graph of measured pore pressures on the attached Figure 1 and numerically in Table 1 below. Table 1 is a summary of the initial, last year, last quarter and current readings. In addition, we present the difference between the current pore pressures and those at the time of installation, the previous quarter, and previous year.
