MINERALS PROGRAM INSPECTION REPORT
PHONE: (303) 866-3567

MINE NAME: Gravel Pit M-093	MINE/PROSPECTING ID#: M-1995-026	MINERAL: Gravel	COUNTY: Custer
INSPECTION TYPE: Monitoring	WEATHER: Windy	INSP. DATE: May 10, 2023	INSP. TIME: 12:15
OPERATOR: Custer County	OPERATOR REPRESENTATIVE: Vince Koch	TYPE OF OPERATION: 112c - Construction Regular Operation

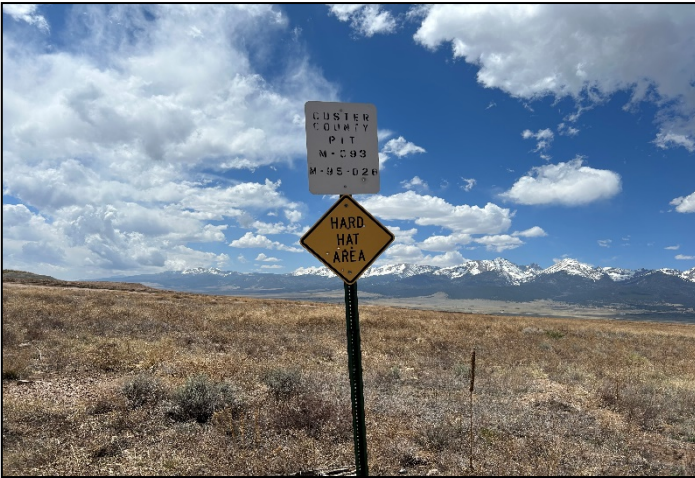
This was a routine monitoring inspection of the Gravel Pit M-093 permit, a 40.3 acre 112c permit held by Custer County. The inspection was conducted by DRMS representative Eric Scott, who met with Custer County Road and Bridge Supervisor Vince Koch on-site at approximately 12:15. This site is located approximately 4.5 miles south of Westcliffe, and 1.9 miles east of Highway 69 on Rosita Road/CR 328 and immediately west of the County Landfill. The site identification sign was present at the entrance to the site on the south side of CR 328 (photo 1).

Photo 1 – Site identification sign at site entrance on south side of CR 328.

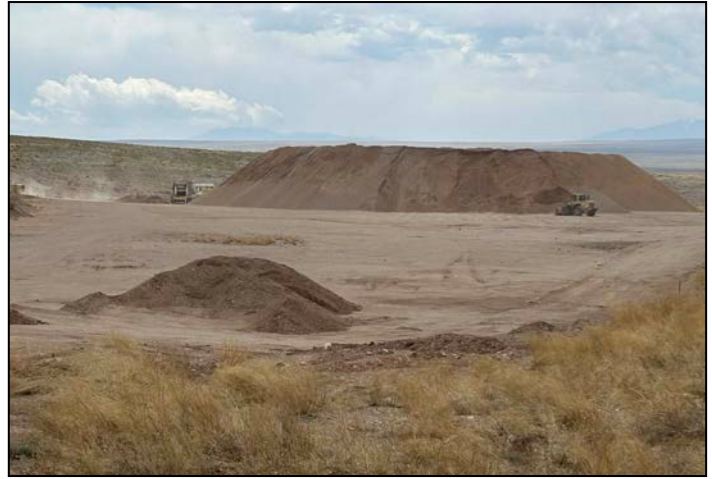
The site was operation at the time of the inspection with excavation taking place in the south-center of the permit area, processing and stockpiling in the SW corner of the permit, and trucks being loaded from the product stockpile (photo 2). The operation appeared to be in compliance with the approved mining plan at the time of this inspection. As specified previously in this report, only two issues were noted that will require follow up corrective actions by the County.

Photo 2 – Mining and stockpile activity in SW and South Center of permit area during inspection.
