MINERALS PROGRAM INSPECTION REPORT

MINE NAME: Heintzelman Project (Pit 116)	MINE/PROSPECTING ID#: M-2009-018	MINERAL: Sand and gravel	COUNTY: Weld
INSPECTION TYPE: Monitoring	WEATHER: Clear	INSP. DATE: May 16, 2023	INSP. TIME: 08:30
OPERATOR: Varra Companies, Inc.	OPERATOR REPRESENTATIVE: Garrett Varra, Brad Janes	TYPE OF OPERATION: 112c - Construction Regular Operation	
REASON FOR INSPECTION: Normal I&E Program	BOND CALCULATION TYPE: None	BOND AMOUNT: \$425,000.00	
DATE OF COMPLAINT: NA	POST INSP. CONTACTS: None	JOINT INSP. AGENCY: None	
INSPECTOR(S): Robert Zuber, P.E. Michael Cunningham	INSPECTOR'S SIGNATURE:

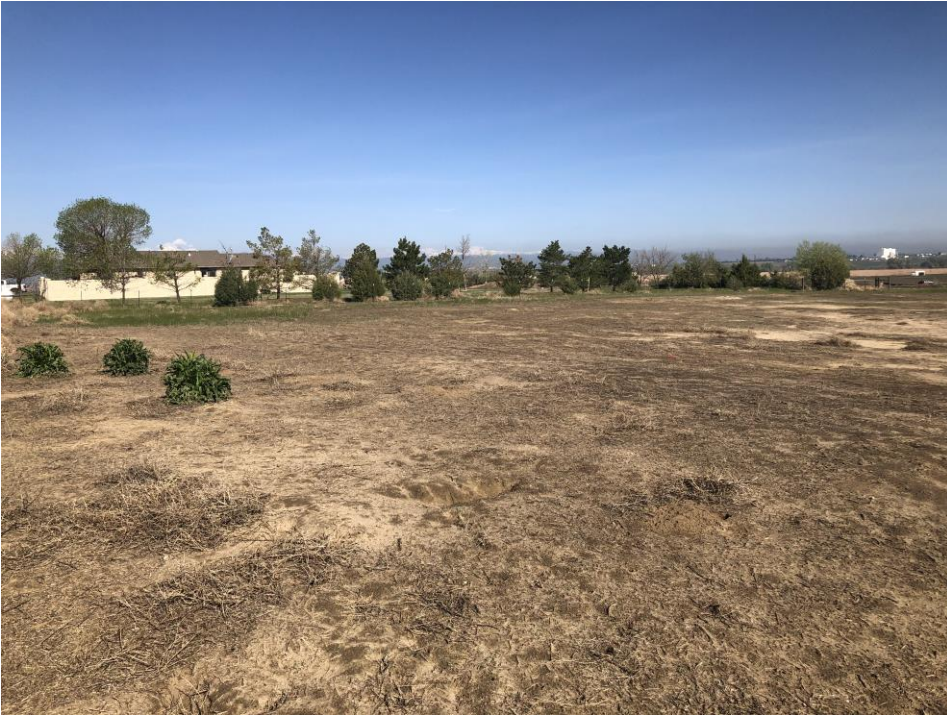
The primary reason for this inspection was AR-01. This application for a reduction in acreage from the permit was received by the Division on March 13 and found complete by the Division on March 22, 2023. This application seeks to remove 1.95 acres from the permit. The application indicated that the area in question has not been disturbed by mining activity. However, during the inspection, it was determined that Varra Companies did grade this area. Therefore, another application (a technical revision) will be needed to update the mining and reclamation plans before AR-01 can be approved.

Main portion of AR-01 area

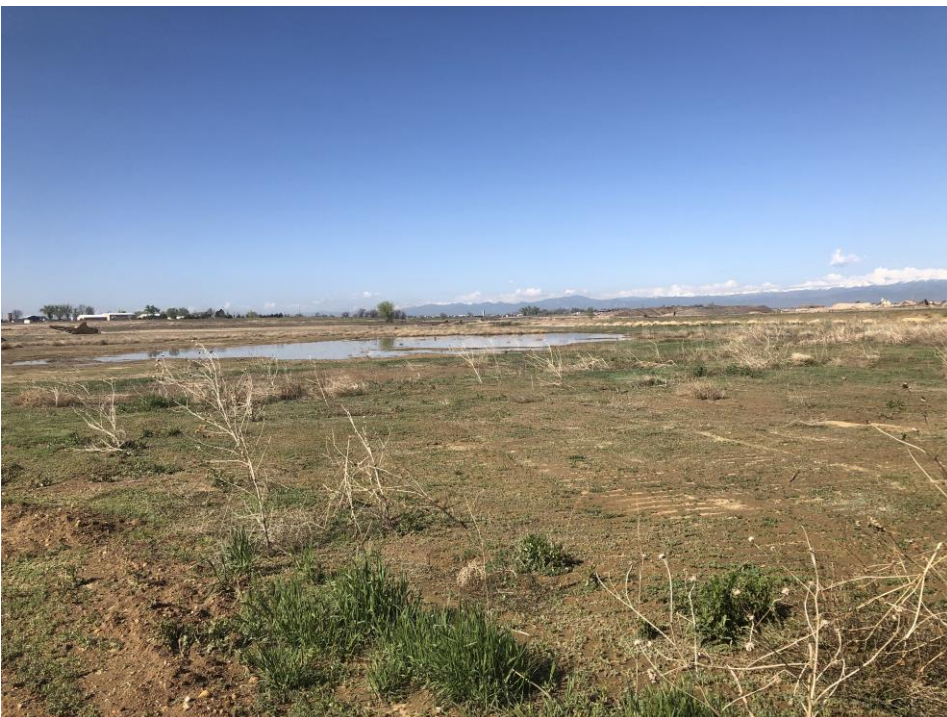
Tract B: The mining excavation in the tract is complete, and the pit has been filled with sand from Tract C to eliminate long-term groundwater exposure. The area that was once a settling pond (northeast portion of Tract B) has been filled with sediment; only a small area of detained water remains from recent rain. The Division requires that the Operator revise the approved Mining and Reclamation Plans to reflect that the tract has been backfilled and no lined reservoir will be constructed in the tract. This should be done with a technical revision.

Former settling pond

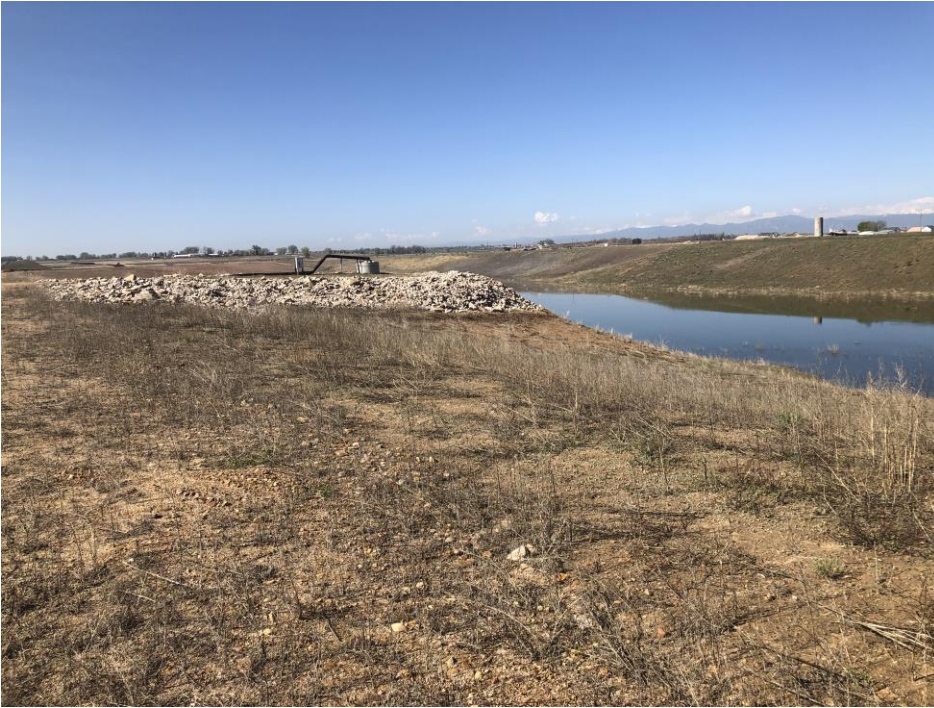
Tract A: Mining excavation in the tract has been completed, and pit slopes have been backfilled and sealed with a clay liner. The Operator should submit to the Division any documentation related to leak testing of the liner (from the State Engineer's Office) that has not already been submitted. The regraded slopes were stable and no erosion features were observed during the inspection, however the vegetation cover is poor. Because Kerr-McGee and Anadarko gas well and lines located in this tract were removed and relocated, and a peninsula in the tract was mined through, the Division requires that the Operator revise the approved Mining and Reclamation Plans to accurately show these features on maps. This should be done with a technical revision.

Reservoir in Tract A

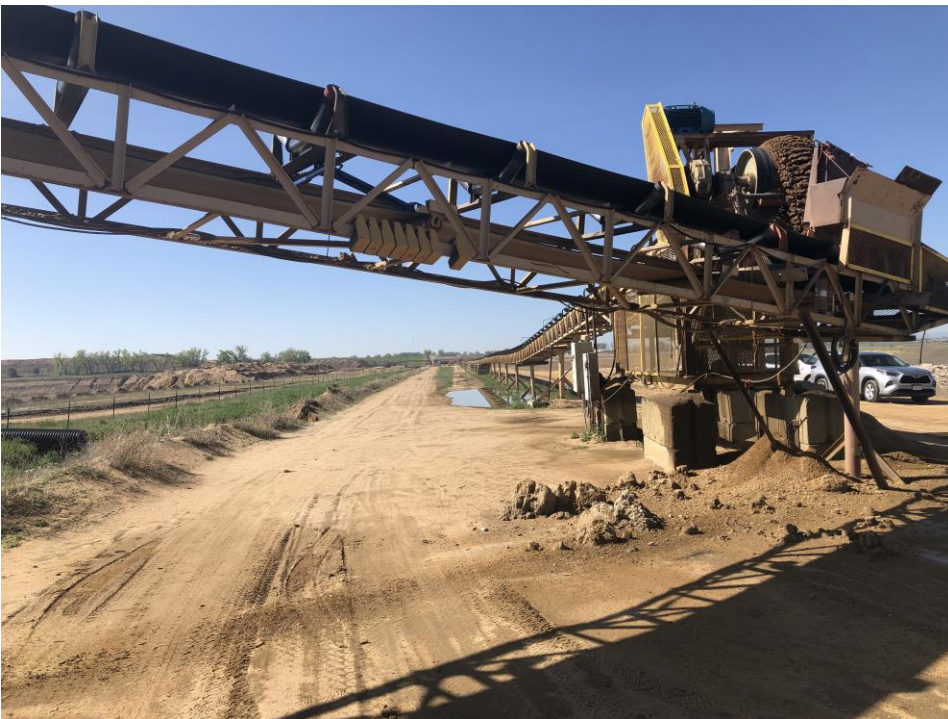
West side of permit boundary, looking south along conveyor
