Bowie #1 inspection report

Permit Number: C-1981-038 Mine Name: Bowie No. 1 Mine Operator: Bowie Resources, LLC Operator Address: Mr. Basil R Bear P.O. Box 1488 Paonia, CO 81428 County: Delta Operation Type: Underground Permit Status: Active Ownership: Private

| Inspection Start Date: June 8, 2023 Inspection Start Time: 11:45 Inspection End Date: June 8, 2023 Inspection End Time: 14:00 | | | Inspection Type: Coal Complete Inspection Inspection Reason: Normal I&E Program Weather: Clear | |

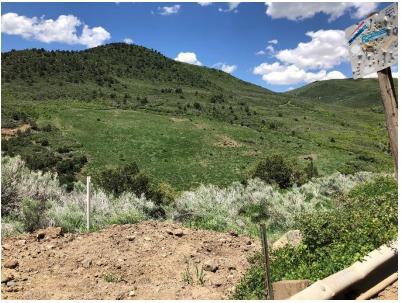
Cattle were grazing on the West Mine during the inspection.

West Mine, from Johnson Road

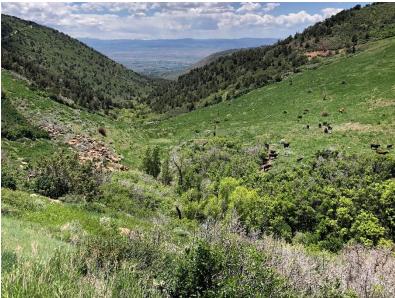
The ponds at the loadout, the Coal Storage Area (near Black Bridge Road), and the West Mine were mostly dry, and no problems were identified with these ponds.

West Mine ponds

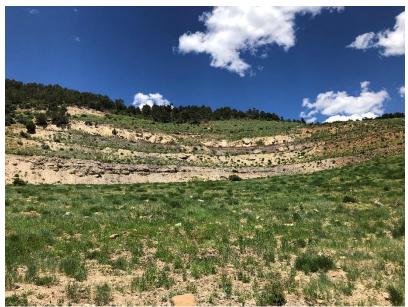
East Mine, steep slope above reclaimed portal bench

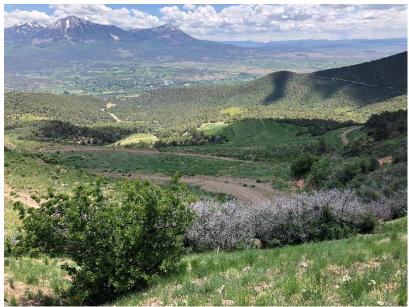
East Mine, lower portion

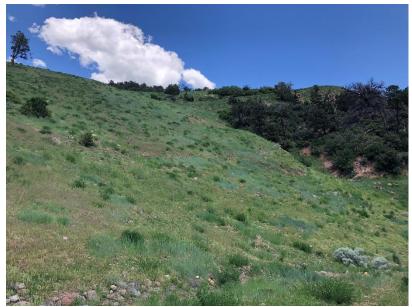
The recent slide at the East Mine was observed and it has not gotten worse in recent weeks. The rills seen at the West Mine during recent inspections are not a problem; they appear to have healed.

East mine, recent slide area

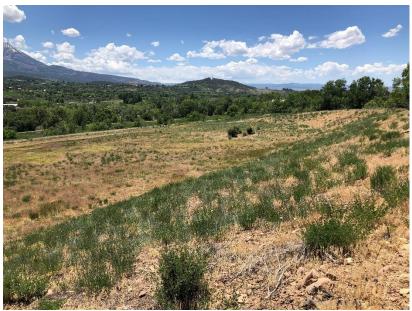
Basil Bear indicated that he has been spraying weeds, in particular he has sprayed white top at the Coal Storage Area by the highway. No white flowers were seen at this portion of the site.

No erosion or other problems were seen with the Coal Storage Area by Black Bridge Road.

Former Coal Storage Area by Highway 133 and Black Bridge Road
