July 11, 2023
Project#01349-0001

Subject: Summary of Instrumentation Monitoring
2nd Quarter 2023
Bowie Coal Waste Disposal Area No. 3
Paonia, Colorado

**SUBJECT: Summary Report, 2nd Quarter 2023, Vibrating Wire Piezometers
April – June 2023, Bowie Mine #2
Coal Waste Disposal Area (CWDA) #3**

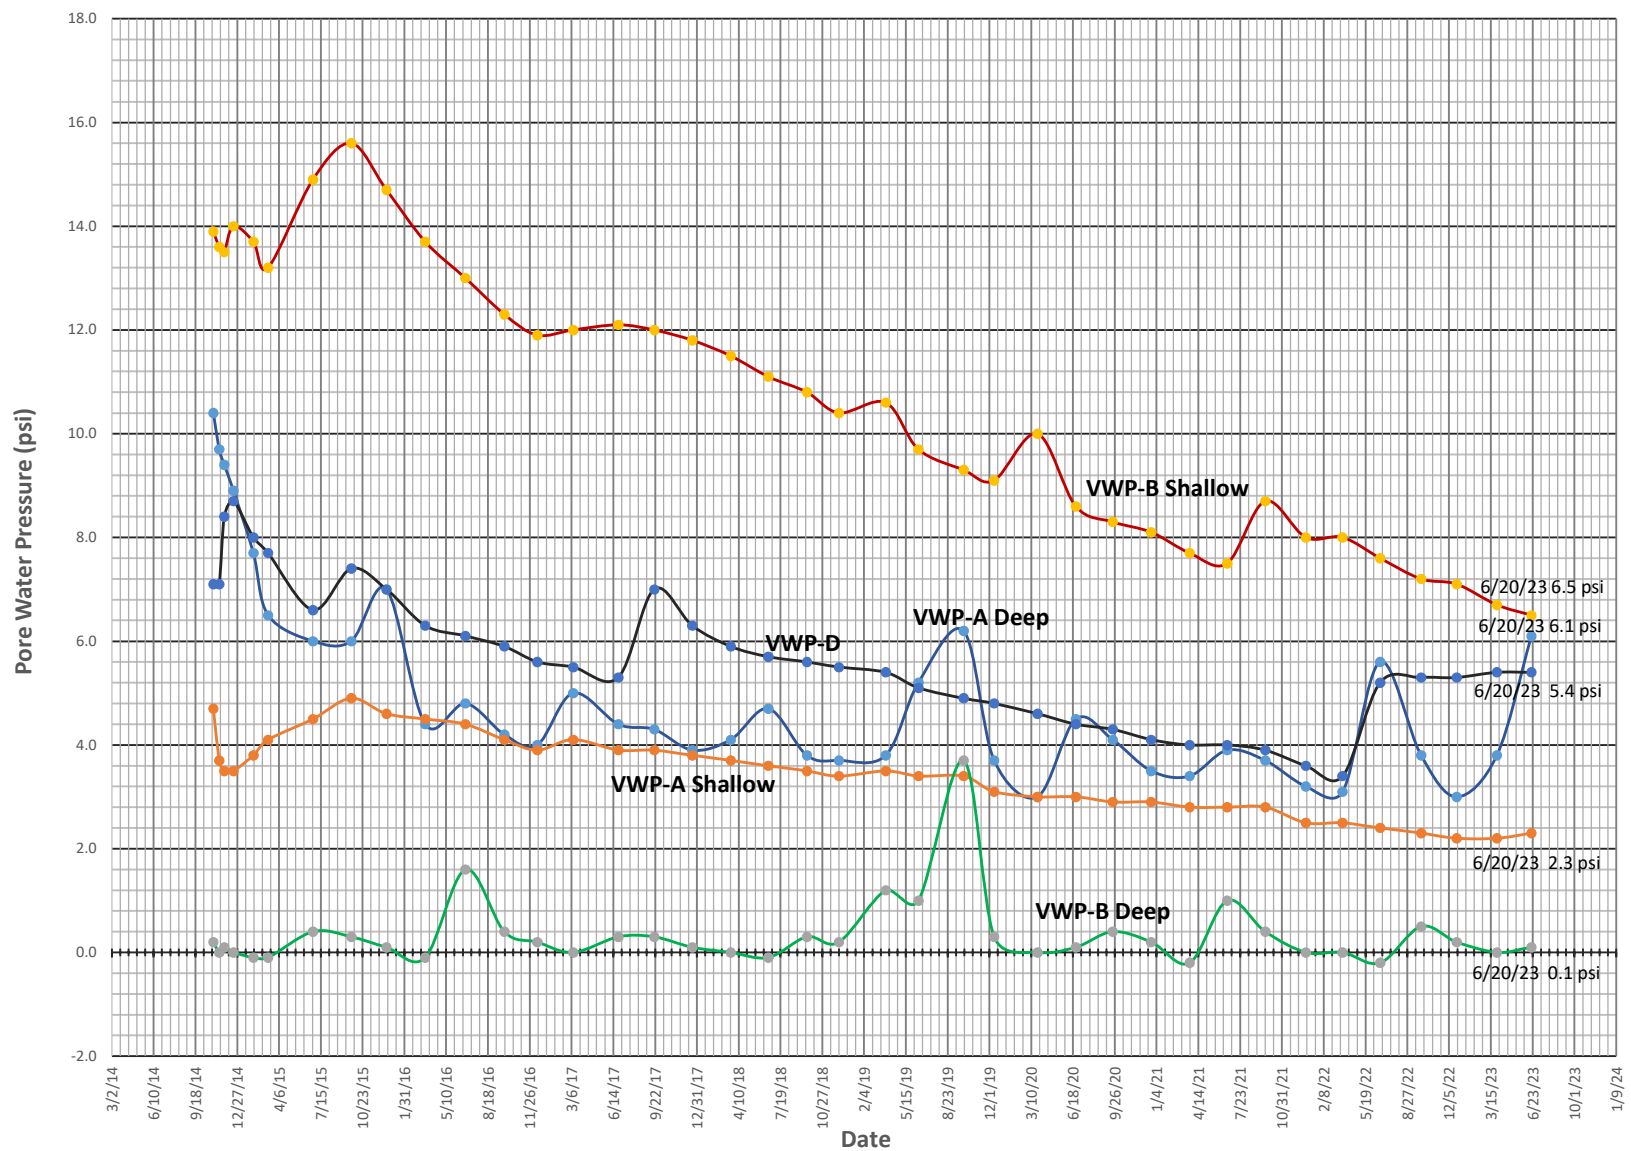
Figure 1 - Bowie Mine #2 - CWDA #3
Vibrating Wire Piezometer Data

We present a graph of measured pore pressures on the attached Figure 1 and numerically in Table 1 below. Table 1 is a summary of the initial, last year, last quarter and current readings. In addition, we present the difference between the current pore pressures and those at the time of installation, the previous quarter, and previous year.

As seen on Figure 1 and Table 1, one of the five VWP's increased dramatically in pore pressure (VWP-A Deep) and the other four had minor changes in pore pressure when compared with the previous quarter. All VWP's have decreased in pore pressure since installation in 2014. Although there is a general trend of decreasing pore pressure over time, three of the piezometers (VWP-A Deep, VWP-B-Deep and VWP-D) have more recent erratic behavior since early 2022.
