MINERALS PROGRAM INSPECTION REPORT
PHONE: (303) 866-3567

MINE NAME: Longmont Distel Operations	MINE/PROSPECTING ID#: M-1989-029	MINERAL: Sand and gravel	COUNTY: Weld
INSPECTION TYPE: Surety-Related Inspection	WEATHER: Clear	INSP. DATE: September 26, 2023	INSP. TIME: 09:00
OPERATOR: Holcim - WCR, Inc.	OPERATOR REPRESENTATIVE: Wyatt Webster	TYPE OF OPERATION: 112c - Construction Regular Operation	
REASON FOR INSPECTION: Acreage/Surety Release Requested	BOND CALCULATION TYPE: None	BOND AMOUNT: \$1,216,716.00	
DATE OF COMPLAINT: NA	POST INSP. CONTACTS: None	JOINT INSP. AGENCY: None	
INSPECTOR(S): Hunter Ridley	INSPECTOR'S SIGNATURE:

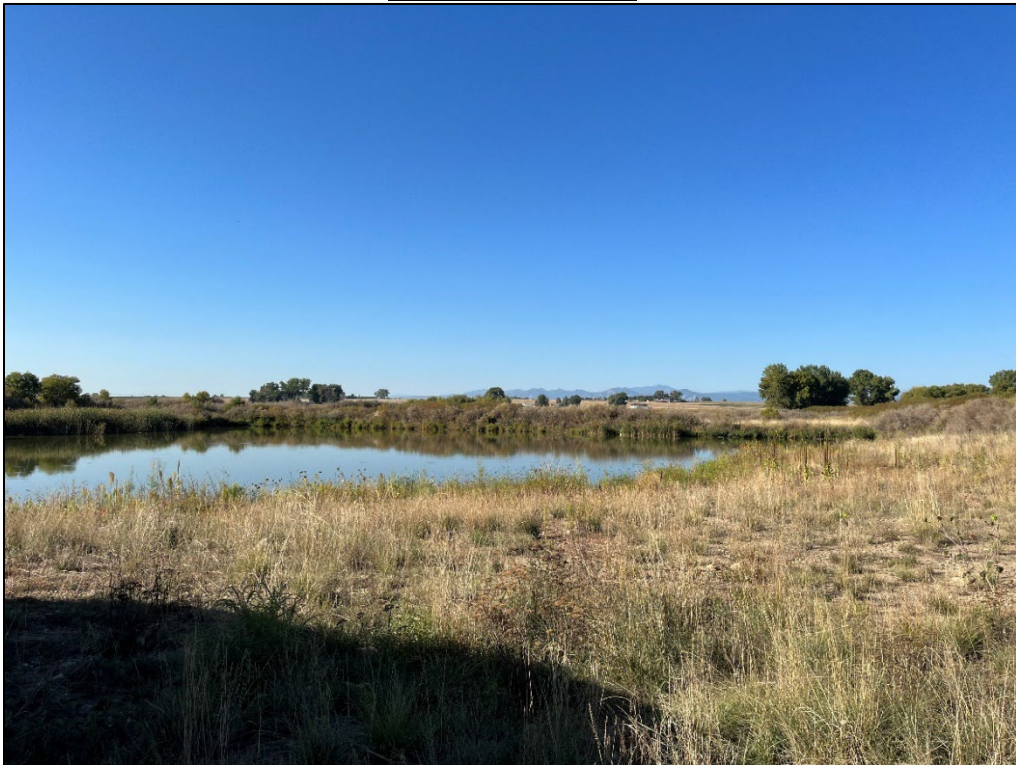
populated by a fair amount of native willow and grass species (Photos 1, 4, and 5). However, large swathes of weedy species like kochia still dominate this area. Russian Olive were noted in this parcel as well.

Photo 1: View south of a pre-existing pond feature in the westernmost City of Longmont Parcel 3.

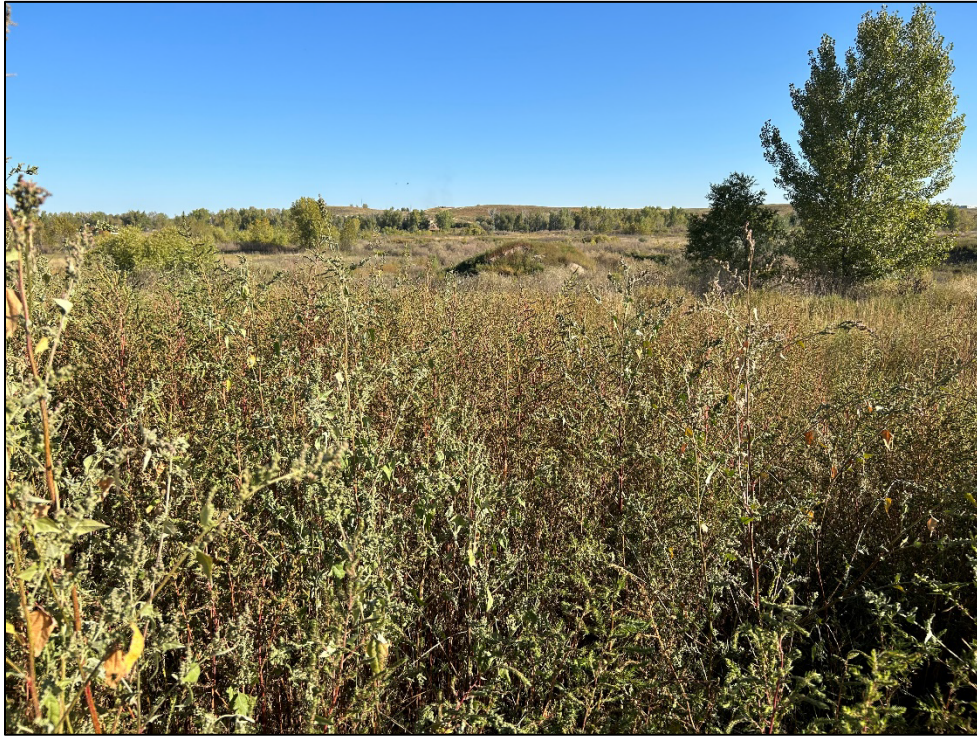
This parcel is located in the northernmost portion of the AR-2 release request area. This parcel was heavily impacted by the 2013 flooding of the St. Vrain River. The Longmont Distel Operations pit in this area captured the St. Vrain as a result. To date, no reclamation work has been done in this parcel, as the river corridor has been allowed to remain in its new configuration. The parcel is now made up of various populations of grasses and riparian vegetation, though much of this vegetation consists of weedy species such as kochia. Two Colorado List B Noxious Weed species, Russian Olive and Saltcedar, were also noted in this parcel. The Division is citing this as a problem for failure to implement the currently approved Noxious Weed Control Plan. Please provide proof to the Division that noxious weeds have been treated in line with the currently approved plan by the corrective action due date. Currently, one stockpile of topsoil/overburden leftover from the pre-existing pit is located in this parcel (Photo 2).

AM4, approved in 2016, updated the site's reclamation plan following the City of Longmont and Colorado Parks and Wildlife's decision to allow the St. Vrain channel to remain in place after the LDO pit captured the river during the 2013 flood. However, additional, reclamation tasks for this area remain. During the inspection, Holcim stated that they will be entering this parcel to conduct noxious weed eradication. Additionally, the Division noted the presence of a topsoil stockpile. Holcim will be required to remove the small topsoil/overburden stockpile located just north of the pre-existing pond feature which was discussed during the inspection.

Photo 2: View north of topsoil pile which remains within the permit boundary in the City of Longmont Parcel 1. This area was heavily impacted by the 2013 flooding of the St. Vrain River.

The Division informed Holcim and City of Longmont representatives that the acreage release request could not be approved in its current state. Noxious weed treatment and reclamation of the topsoil pile in the City of Longmont Parcel 1 area will need to occur in order for the Division to consider approval of a release request of this area in the future. Following this discussion, Holcim submitted a request to withdrawal the AR-2 request. This request was approved by the Division on September 26, 2023.

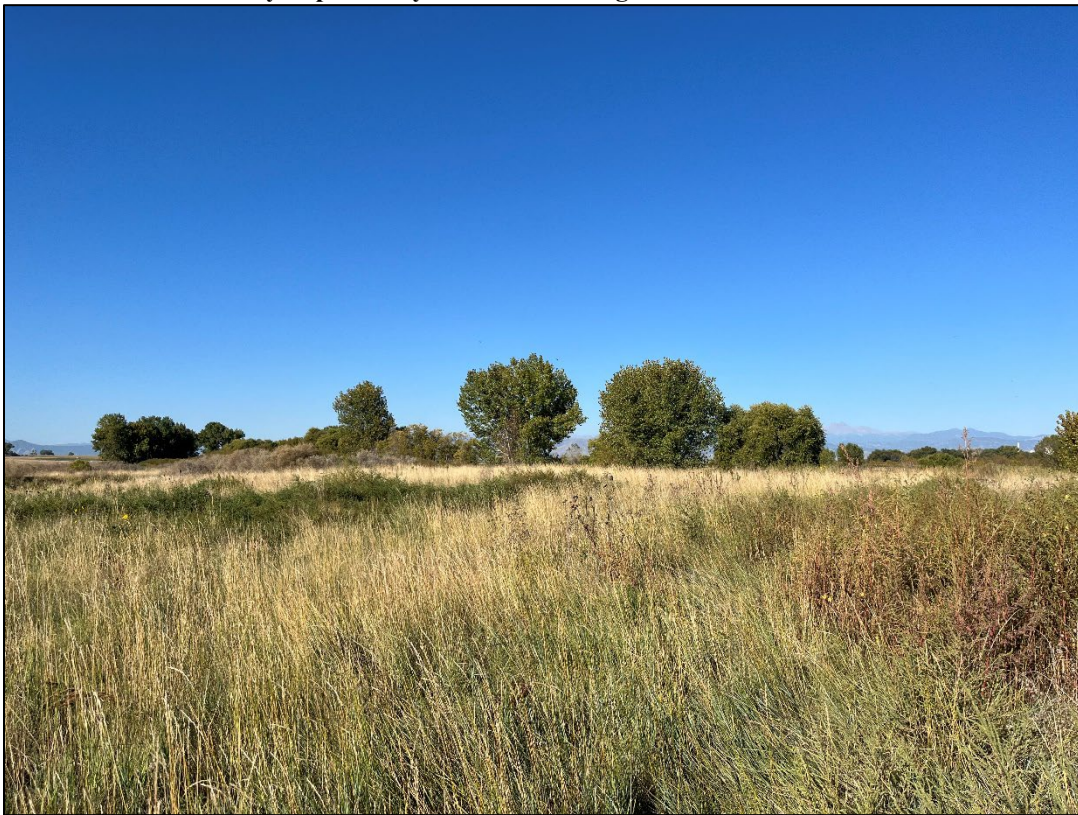
This parcel is located in the southwestern most corner of the AR-2 release request area and includes a pre-existing pond. Some grading and seeding work has occurred in this area (Photo 3) and the pre-existing pond is

Photo 3: View southwest of a portion of the City of Longmont Parcel 3.

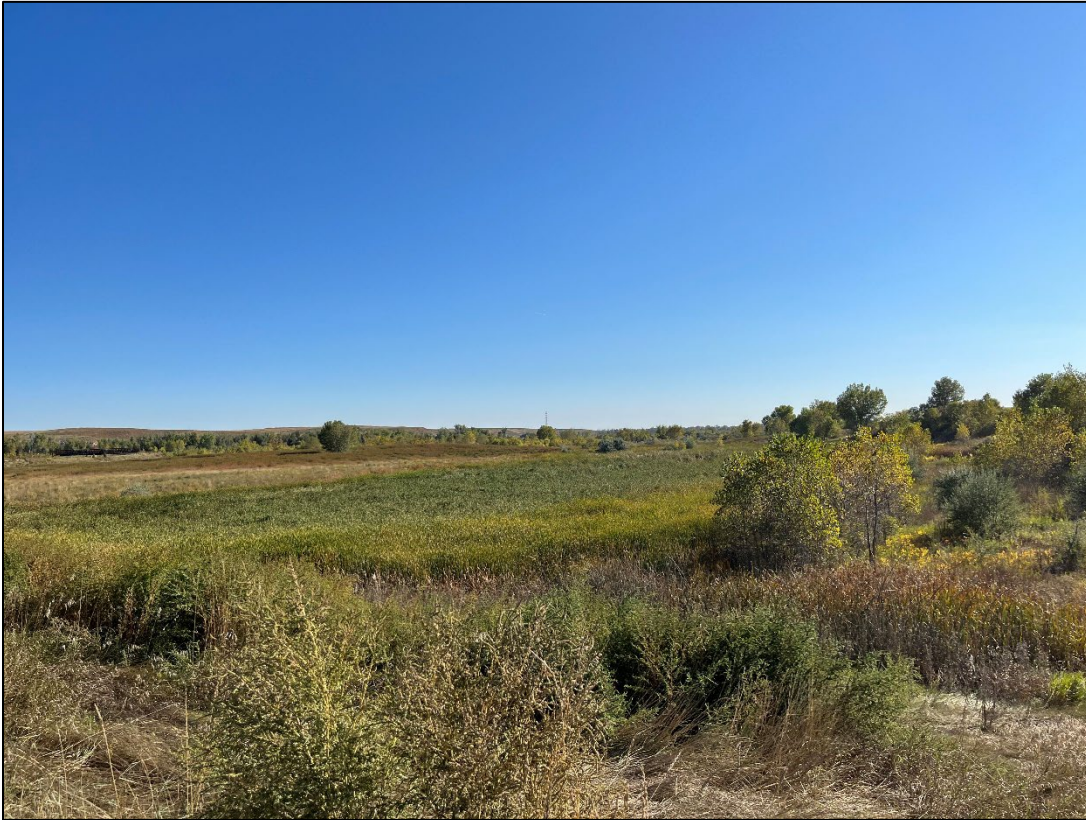
Photo 4: View northeast from atop the easternmost boundary of the AR2 release area into the City of Longmont Parcel 3.

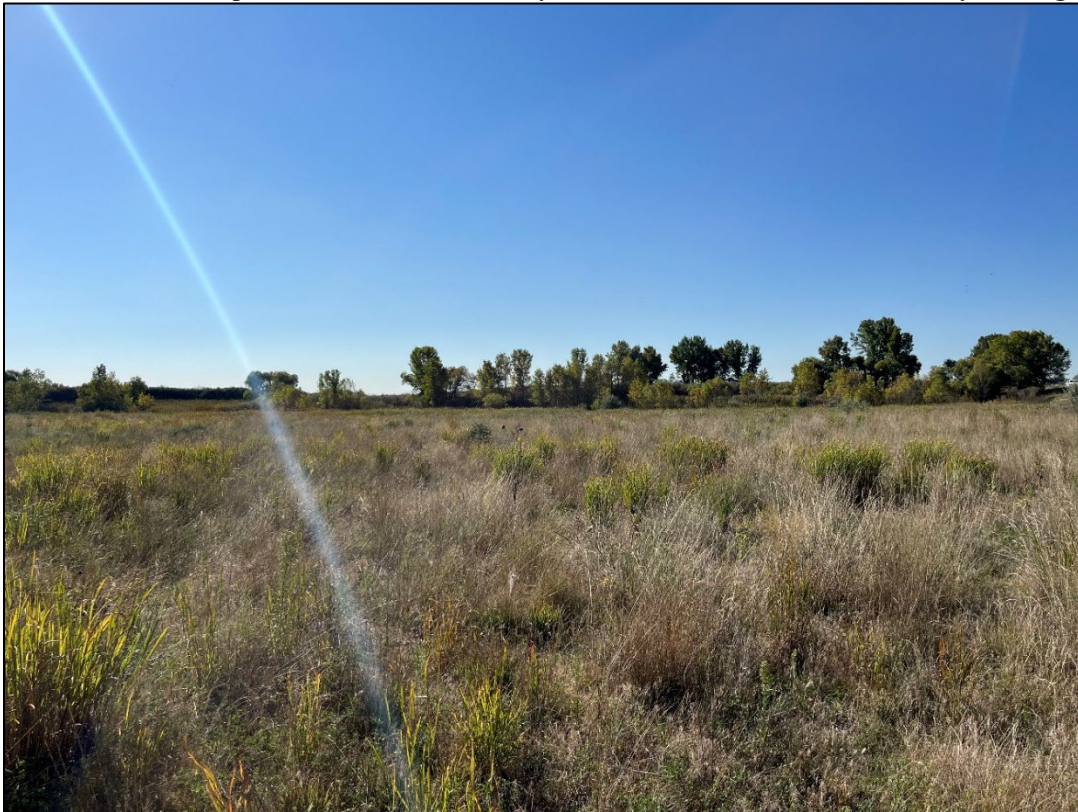
Photo 5: View east into City of Longmont Parcel 3, a fair amount of native grasses have been reestablished here.
