**Huddleston-Berry**  
Engineering & Testing, LLC

Subject: Summary of Instrumentation Monitoring  
3<sup>rd</sup> Quarter 2023  
Bowie Coal Waste Disposal Area No. 3  
Paonia, Colorado

**SUBJECT: Summary Report, 3<sup>rd</sup> Quarter 2023, Vibrating Wire Piezometers  
 July – September 2023, Bowie Mine #2  
 Coal Waste Disposal Area (CWDA) #3**

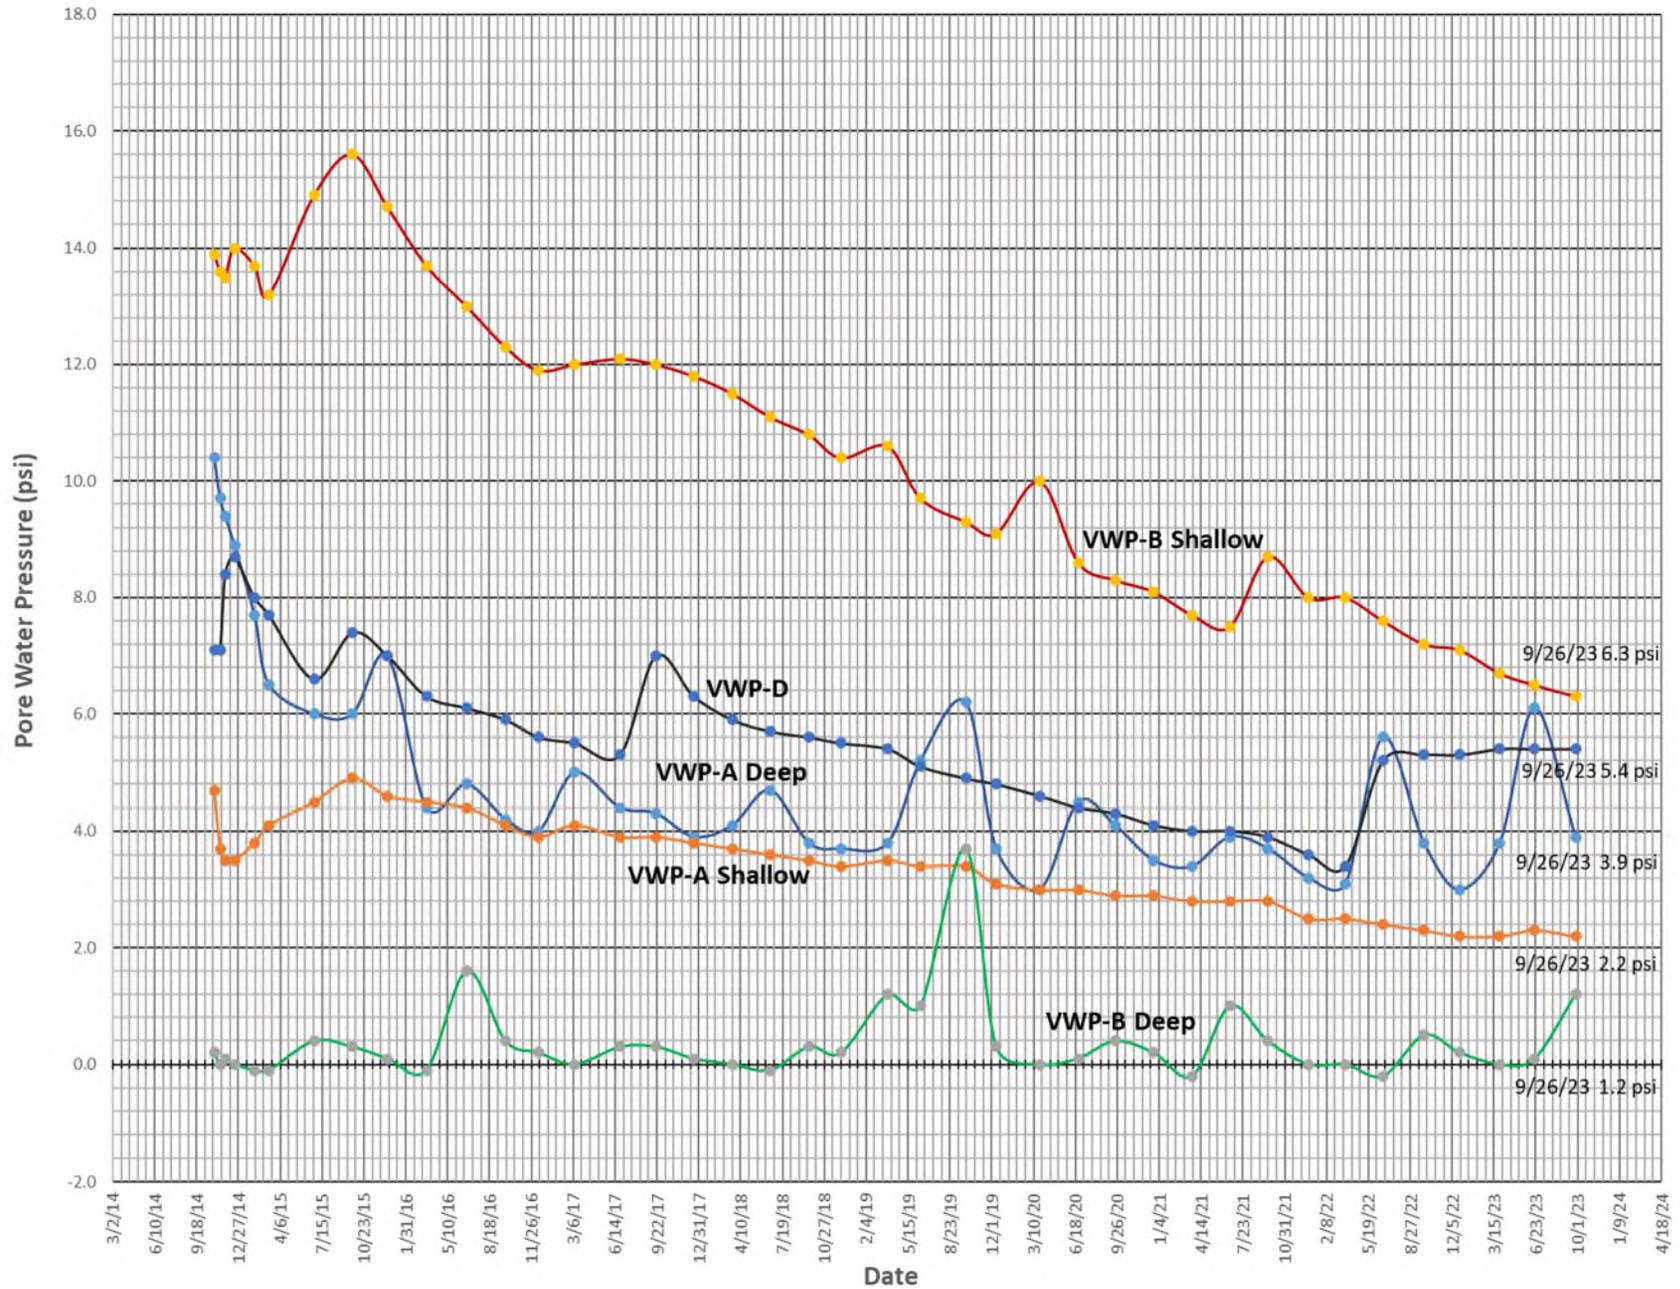
**Figure 1 - Bowie Mine #2 - CWDA #3  
Vibrating Wire Piezometer Data**

We present a graph of measured pore pressures on the attached Figure 1 and numerically in Table 1 below. Table 1 is a summary of the initial, last year, last quarter and current readings. In addition, we present the difference between the current pore pressures and those at the time of installation, the previous quarter, and previous year.

As seen on Figure 1 and Table 1, one of the five VWP's increased dramatically in pore pressure (VWP-B Deep), one decreased sharply in pore pressure (VWP-A Deep), and the other three had minor changes or no change in pore pressure when compared with the previous quarter. All VWP's have decreased in pore pressure since installation in 2014 except for VWP-B Deep, which fluctuates above and below the original pore pressure throughout its history. Although there is a general trend of decreasing pore pressure over time, three of the piezometers (VWP-A Deep, VWP-B-Deep and VWP-D) have more recent erratic behavior since early 2022.
