Keenesburg inspection report

PERMIT INFORMATION

Permit Number: C-1981-028 Mine Name: Keenesburg Strip Mine Operator: Coors Energy Company Operator Address: Mr. Ben Moline P.O. Box 4030 Golden, CO 80402	County: Weld Operation Type: Surface Permit Status: Permanent Cessation Ownership: Private
	Operator Representative Present: None
Operator Representative Signature: (Field Issuance Only)

Inspection Start Date: November 8, 2023 Inspection Start Time: 10:40 Inspection End Date: November 8, 2023 Inspection End Time: 12:10		Inspection Type: Coal Complete Inspection Inspection Reason: Normal I&E Program Weather: Cloudy	
Joint Inspection Agency: None		Joint Inspection Contacts: 	
Post Inspection Agency: None		Post Inspection Contacts: 	
Inspector(s): Robert Zuber, P.E.	Inspector's Signature:

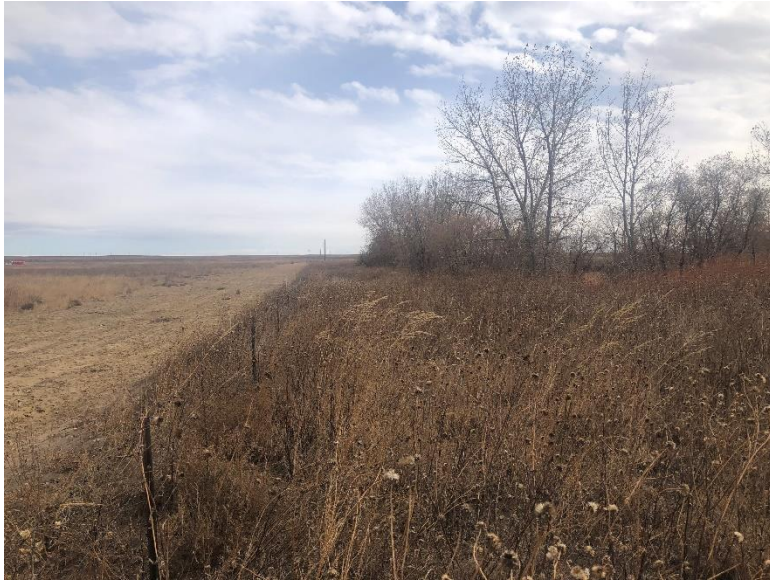
Sediment Pond 2 and the Dugout Pond contained little to no water (thick vegetation obscures the bottoms). They were not discharging during the inspection. There were no signs that either pond had discharged recently. No problems were observed.

Area downstream of Sediment Pond #2

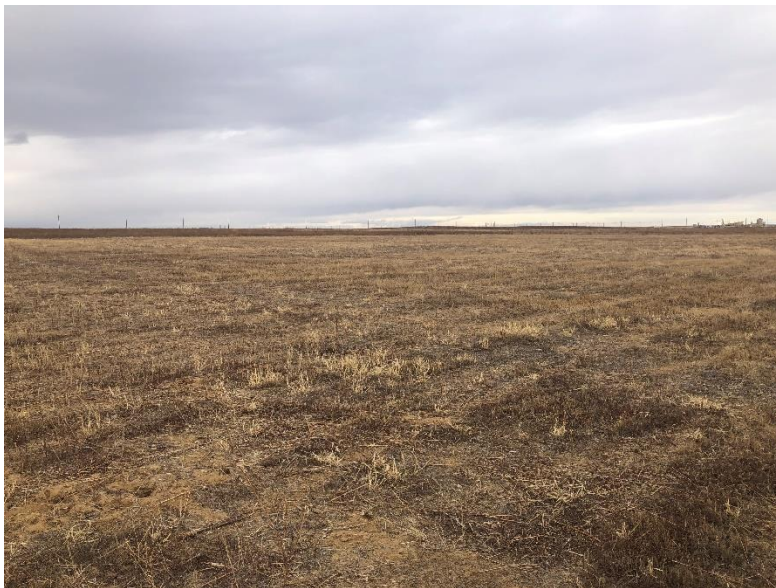
The site is in Permanent Cessation. Reclamation activities were completed in the fall of 2020. However, due to poor success in some areas, Coors Energy reclaimed these areas a second time in spring 2022, and additional reclamation activities were being performed in Area 36 by Habitat Management (CEC contractor) during the inspection. A small harrow was being used in preparation for seeding.

Areas where recent harrowing has been done include Areas 25, 36, and 42.

Area 36, which has been harrowed before seeding

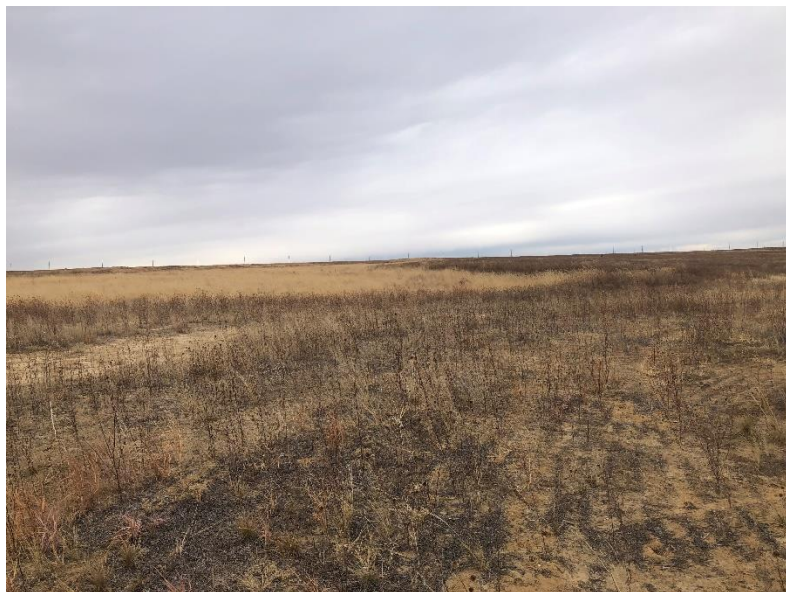
Areas 33 and 36, looking west at east end

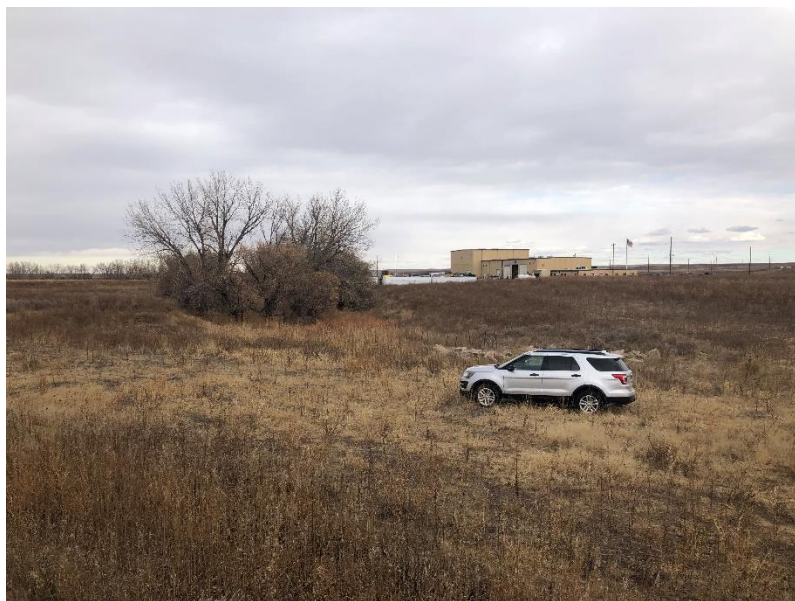
No erosion problems were seen onsite. Bare spots were seen in some areas. The steep area east of the Dugout Pond was stable.

Dugout Pond and reclaimed topsand storage, south of the facility area
