## Loloff Mine inspection report

**MINERALS PROGRAM INSPECTION REPORT**  
**PHONE: (303) 866-3567**

<b>MINE NAME:</b> Loloff Mine	<b>MINE/PROSPECTING ID#:</b> M-1985-112	<b>MINERAL:</b> Sand and gravel	<b>COUNTY:</b> Weld
<b>INSPECTION TYPE:</b> Surety Release Inspection	<b>WEATHER:</b> Clear	<b>INSP. DATE:</b> November 9, 2023	<b>INSP. TIME:</b> 13:45
<b>OPERATOR:</b> Loloff Construction, Inc.	<b>OPERATOR REPRESENTATIVE:</b> Kelly Hodge, J.C. York	<b>TYPE OF OPERATION:</b> 112c - Construction Regular Operation	
<b>REASON FOR INSPECTION:</b> Surety Release Requested	<b>BOND CALCULATION TYPE:</b> None	<b>BOND AMOUNT:</b> \$244,389.00	
<b>DATE OF COMPLAINT:</b> NA	<b>POST INSP. CONTACTS:</b> None	<b>JOINT INSP. AGENCY:</b> None	
<b>INSPECTOR(S):</b> Robert Zuber, P.E.	<b>INSPECTOR'S SIGNATURE:</b>

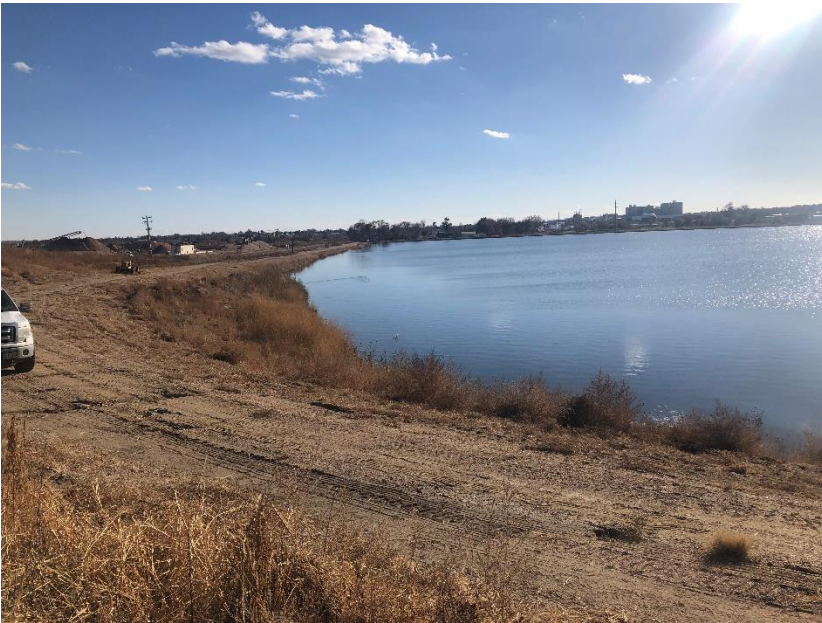
**East side of site, looking south**

The reservoir was nearly full of water. The water level was approximately three feet in elevation below the top. No significant erosion was seen on the part of the banks above the waterline.

The vegetation around the reservoir is of poor quality, consisting mostly of kochia, an undesirable species. However, no listed weeds were identified around the site. Some desirable grasses were also seen. No signs of erosion, sediment loading, or other off-site impacts were identified.
