MINERALS PROGRAM INSPECTION REPORT
PHONE: (303) 866-3567

MINE NAME: Centennial Uranium Project	MINE/PROSPECTING ID#: P-2008-043	MINERAL: Uranium	COUNTY: Weld
INSPECTION TYPE: Monitoring	WEATHER: Clear	INSP. DATE: November 2, 2023	INSP. TIME: 10:00
OPERATOR: Powertech (USA) Inc.	OPERATOR REPRESENTATIVE: Lisa Scheinost	TYPE OF OPERATION: MP - Mineral Prospecting	
REASON FOR INSPECTION: Normal I&E Program	BOND CALCULATION TYPE: Complete Bond	BOND AMOUNT: \$71,400.00	
DATE OF COMPLAINT: NA	POST INSP. CONTACTS: None	JOINT INSP. AGENCY: None	
INSPECTOR(S): Hunter Ridley	INSPECTOR'S SIGNATURE:

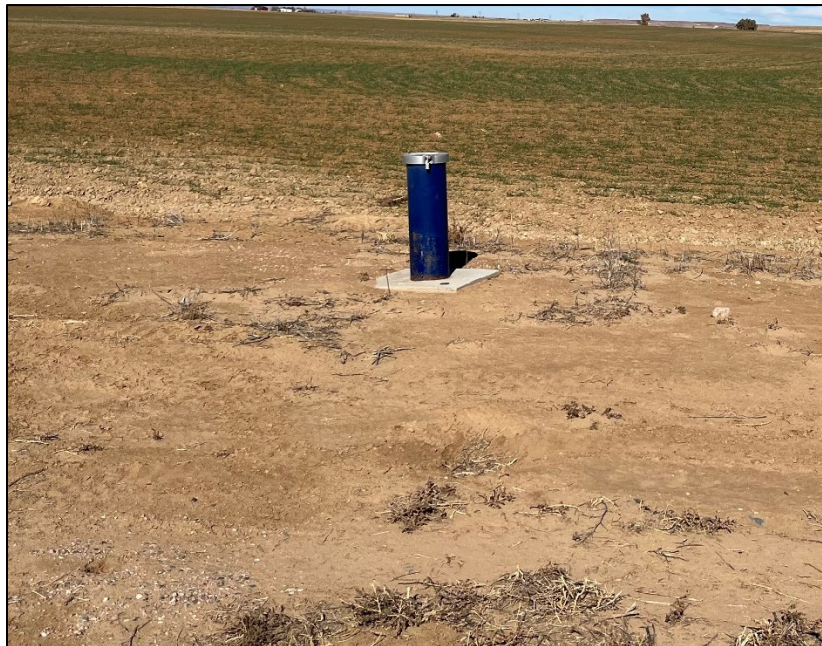
When necessary, well locations have been protected by corral fencing or are within private property protected by barbed wire. All wells are sealed with a lockable metal cap. No erosion or sedimentation issues were noted. Wells sites are clear of drilling debris or trash. The surrounding vegetated areas were stable and had good cover. No new activity has occurred since the last inspection on October 25, 2019. The Operator intends to maintain the NOI as active for future hydrologic studies and monitoring, however the Operator representative stated that monitoring samples have not been collected recently.

Photo 1: Typical pump test well and surrounding vegetation.
