Larsen Pit Pre-Operation Inspection Report

MINERALS PROGRAM INSPECTION REPORT
PHONE: (303) 866-3567

MINE NAME: Larsen Pit	MINE/PROSPECTING ID#: M-2023-036	MINERAL: Sand and gravel	COUNTY: Cheyenne
INSPECTION TYPE: Pre-operation Inspection	WEATHER: Clear	INSP. DATE: December 5, 2023	INSP. TIME: 10:00
OPERATOR: Cheyenne County	OPERATOR REPRESENTATIVE: Jim Brown	TYPE OF OPERATION: 112c - Construction Regular Operation	
REASON FOR INSPECTION: Pre-operation Inspection	BOND CALCULATION TYPE: None	BOND AMOUNT: N/A	
DATE OF COMPLAINT: NA	POST INSP. CONTACTS: None	JOINT INSP. AGENCY: None	
INSPECTOR(S): Nikie Gagnon	INSPECTOR'S SIGNATURE:

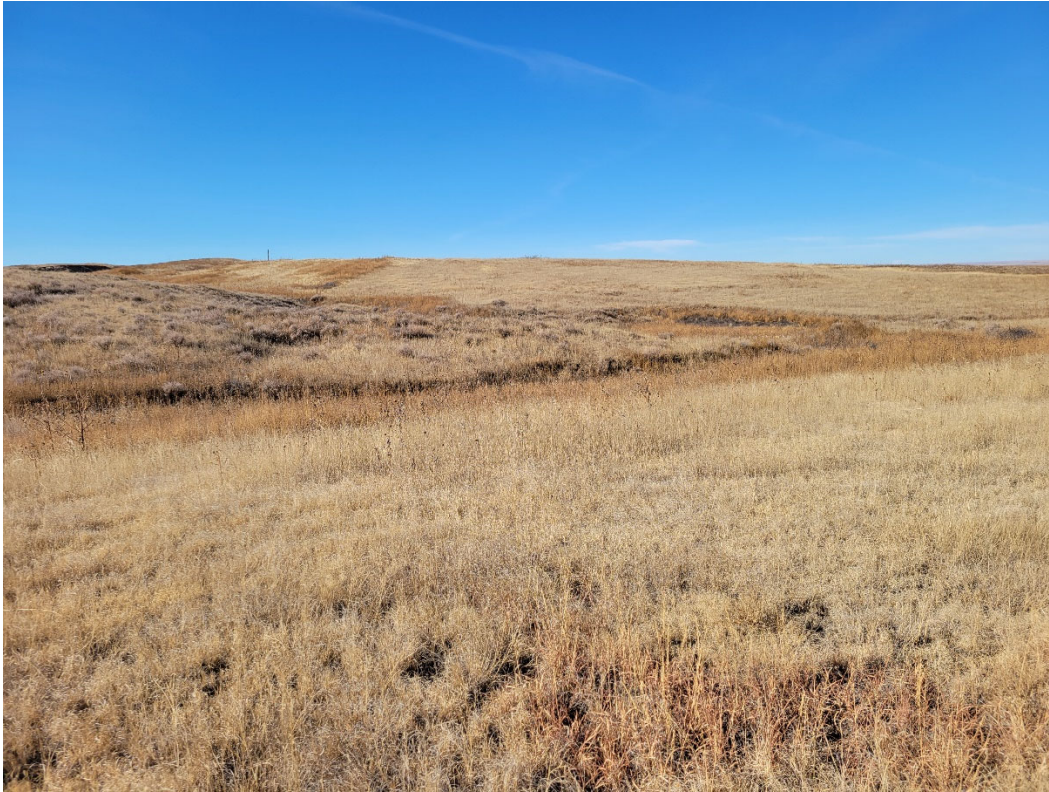
Photo 1: View looking west across the permit area from the eastern side.

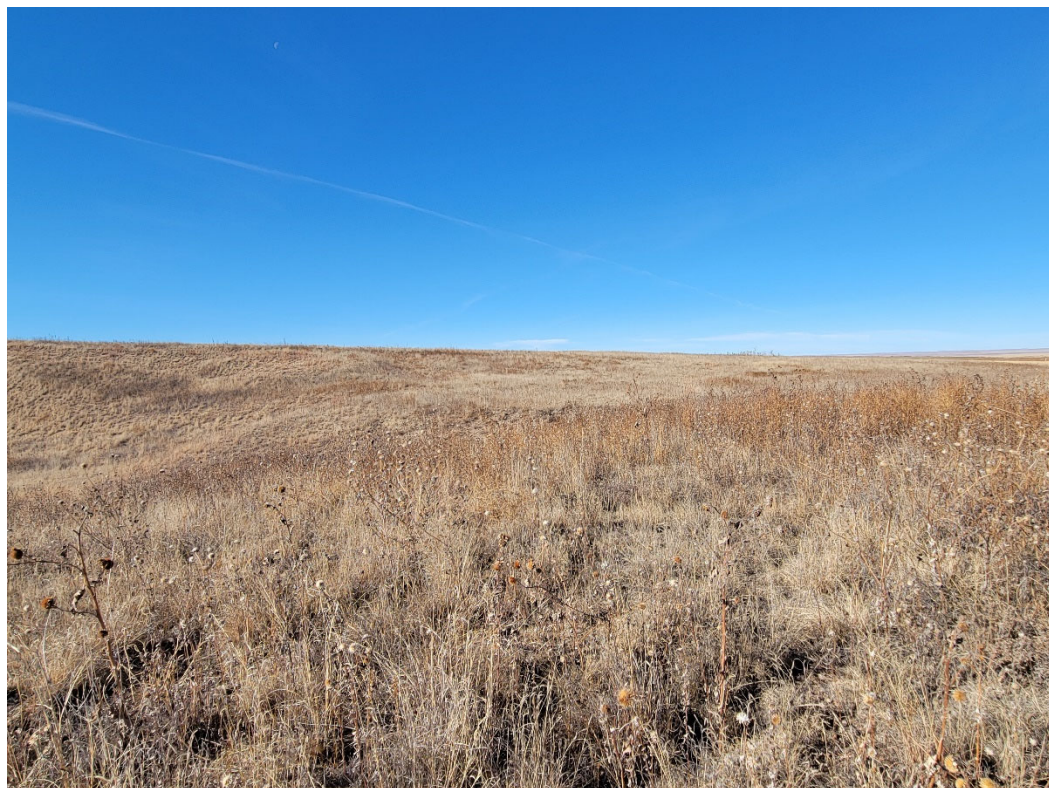
Photo 2: View looking west across the permit area from the center of the proposed permit area.

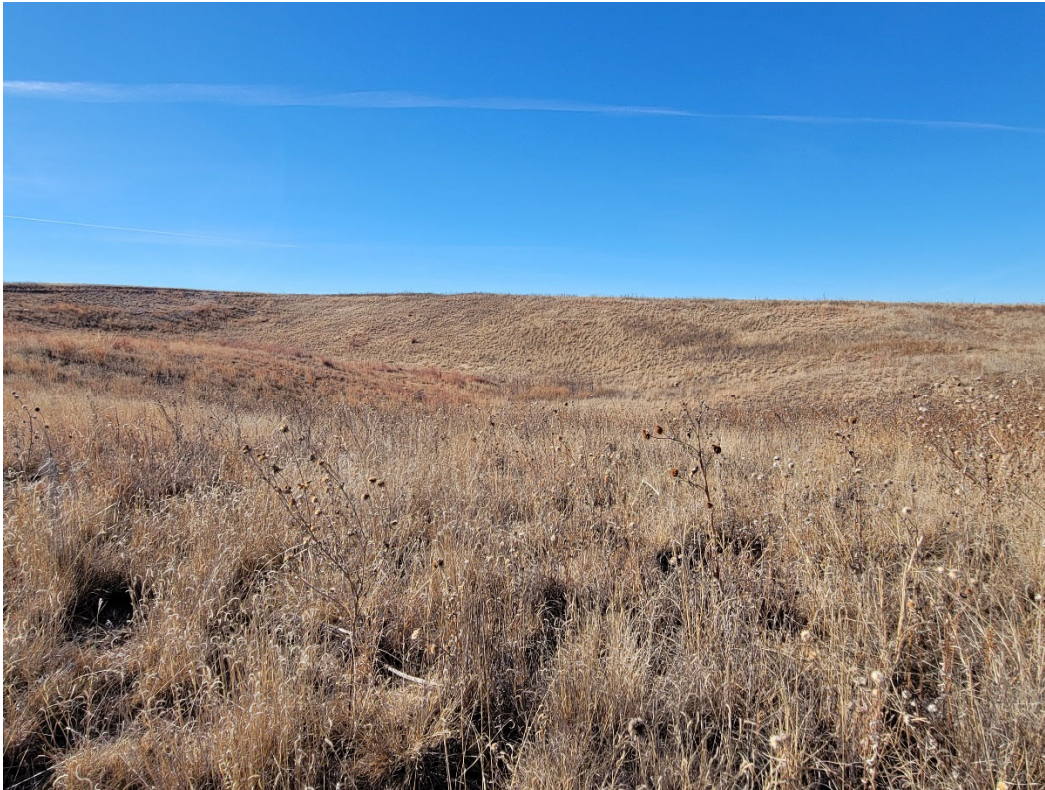
According to the application and confirmed by Division records, the Larsen Pit is a re-entry into an older gravel pit of the same name (permit no. M-1978-140). The older pit was a 16.5 acre 112c permit, of which approximately 6.5 acres were disturbed by mining prior to reclamation and release in 2018. During this inspection, the Division observed a revegetated shallow crescent excavation that daylights to the northeast in the center of the proposed permit area.

Photo 3: View of the former Larsen Pit mining area in the center of the proposed permit area.

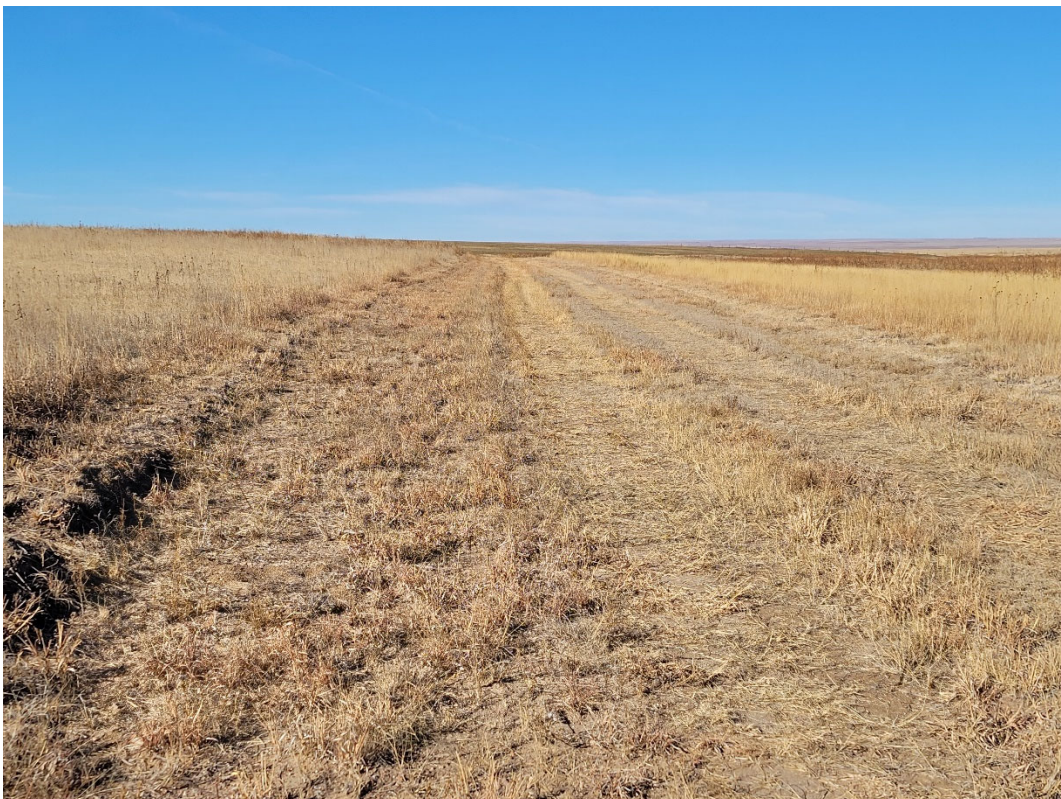
The current land use is rangeland. Observations during this inspection are consistent with the application. The site is dominated by short grass prairie species. Conservation Reserve Program (CRP) grass is planted on the north side of the parcel, outside the proposed permit area, north of the access road. The Operator indicated they will not disturb the CRP area when they widen the access road.

Photo 4: View looking northwest down the access road. Proposed permit area is on the left side of the photo. CRP planted field on the right side.

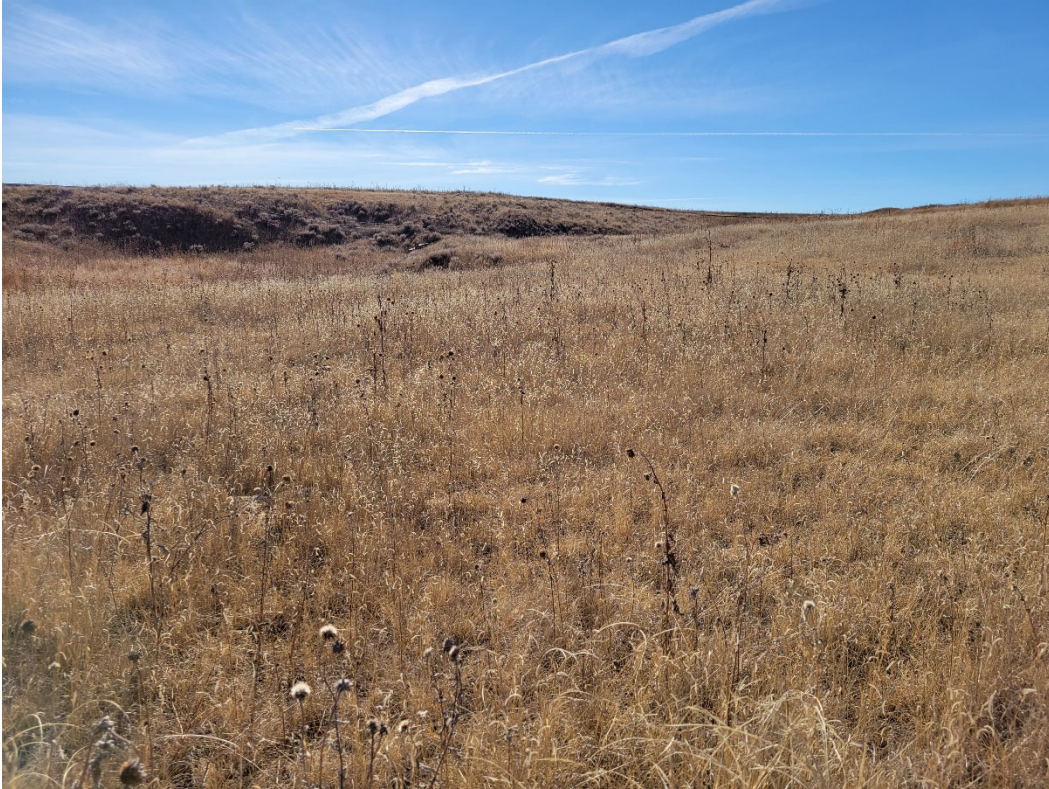
wire fence runs along the southern boundary of the parcel. The Division also observed a soil berm in the southeastern corner of the permit area, separating the proposed mining area from the railroad right-of-way which will not be mined. During this inspection, the Operator stated there will be a topsoil berm inside the parcel boundary running along the southern end of the permit area and no mining will occur within 200 feet of the railroad right-of-way. The application includes correspondence with Union Pacific Railroad. Union Pacific states they do not sign agreements of this nature and indicated the County should move forward with an engineering evaluation pursuant to Rule 6.4.19, which states, "where such an agreement cannot be reached, the applicant shall provide an appropriate engineering evaluation that demonstrates that such structure shall not be damaged by activities occurring at the mining operation".

Photo 5: View looking south at berm that separates the permit area from the Union Pacific Railroad right-of-way in the southeast corner of the proposed permit area.

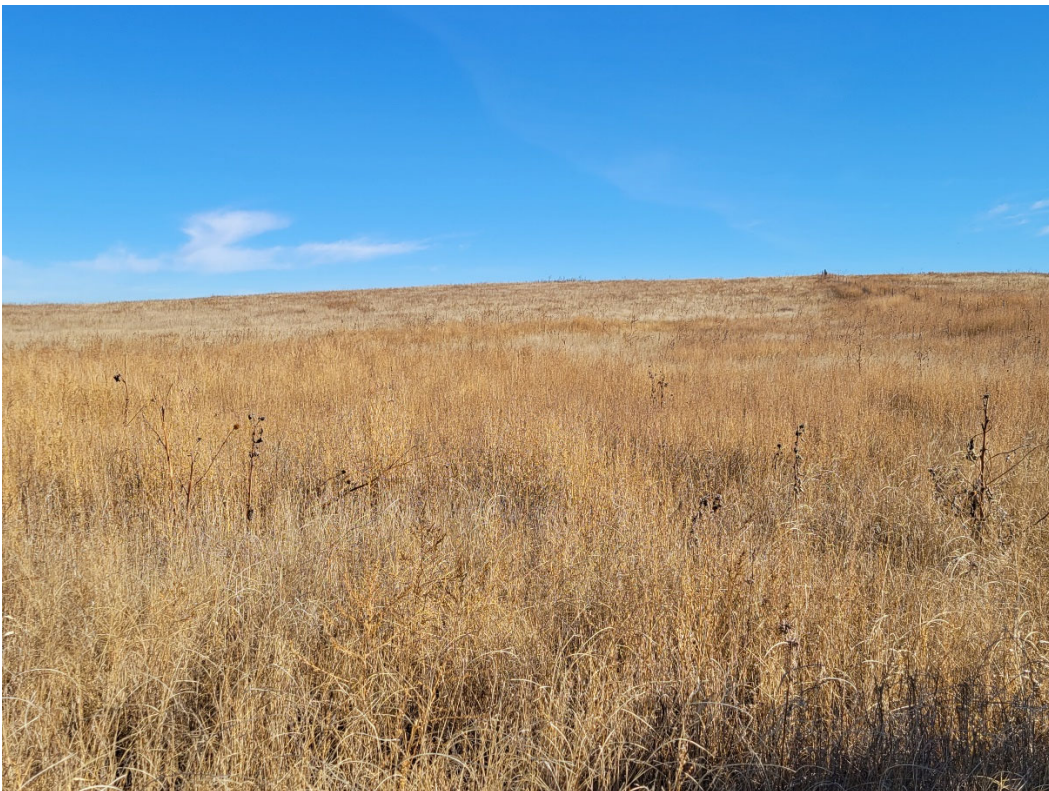
Photo 6: View from the southwest corner looking east along the southern permit boundary.

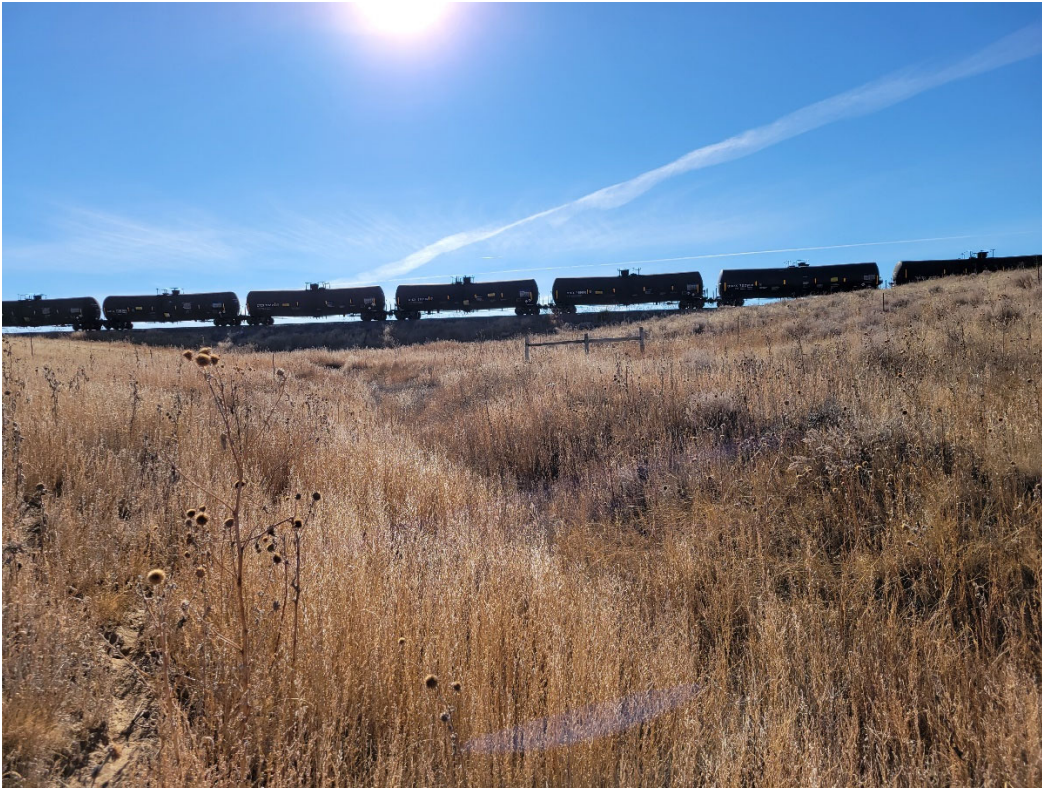
The Division observed the Union Pacific Railroad which runs parallel to the proposed southern boundary of the permit area. The Operator measured the distance to the right-of-way and shared a photo with the Division. The photo shows the distance from the permit boundary to the railroad right-of-way is 193 feet. A barbed

Photo 7: View looking south at the adjacent Union Pacific Railroad right-of-way from the southeast corner of the proposed permit area.

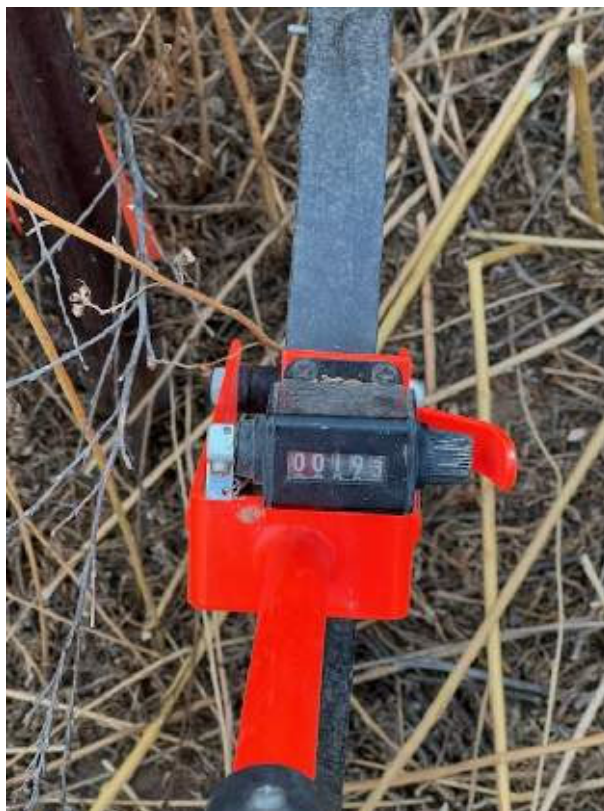
Photo 8: Measuring tape showing distance from southern permit boundary to Union Pacific Railroad right-of-way. Photo shared by Operator.

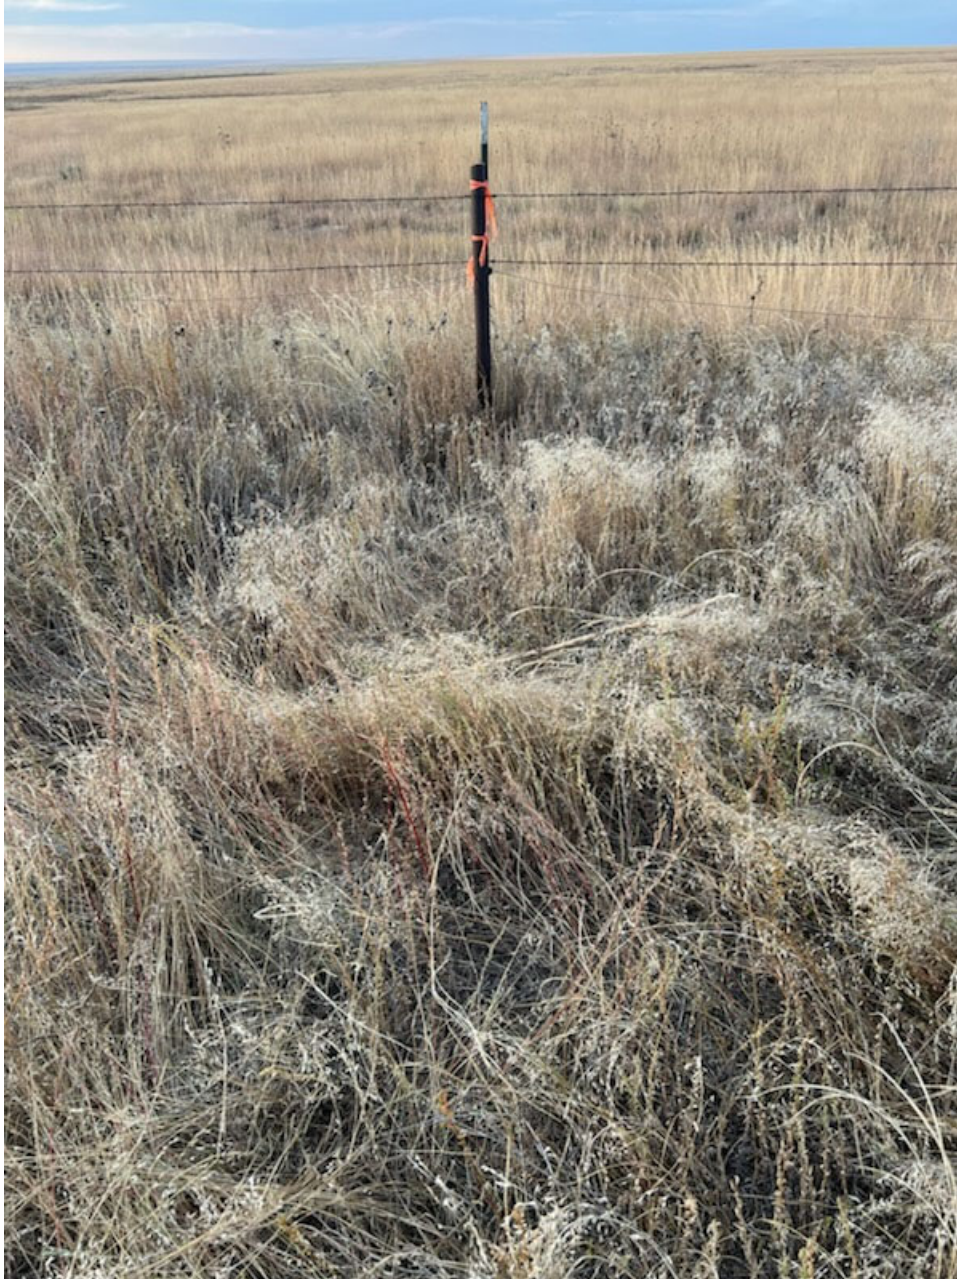
The proposed permit area is bordered by a wire fence on the south and west sides. This fence is owned by Cheyenne County, the permittee and parcel owner. There is a small corral 30 feet north of the haul road entrance on a parcel owned by the Colorado State Land Board. A letter of agreement for this structure was included in the application.

Photo 9: Looking south at barbed wire fence and boundary marker on the southern permit boundary.

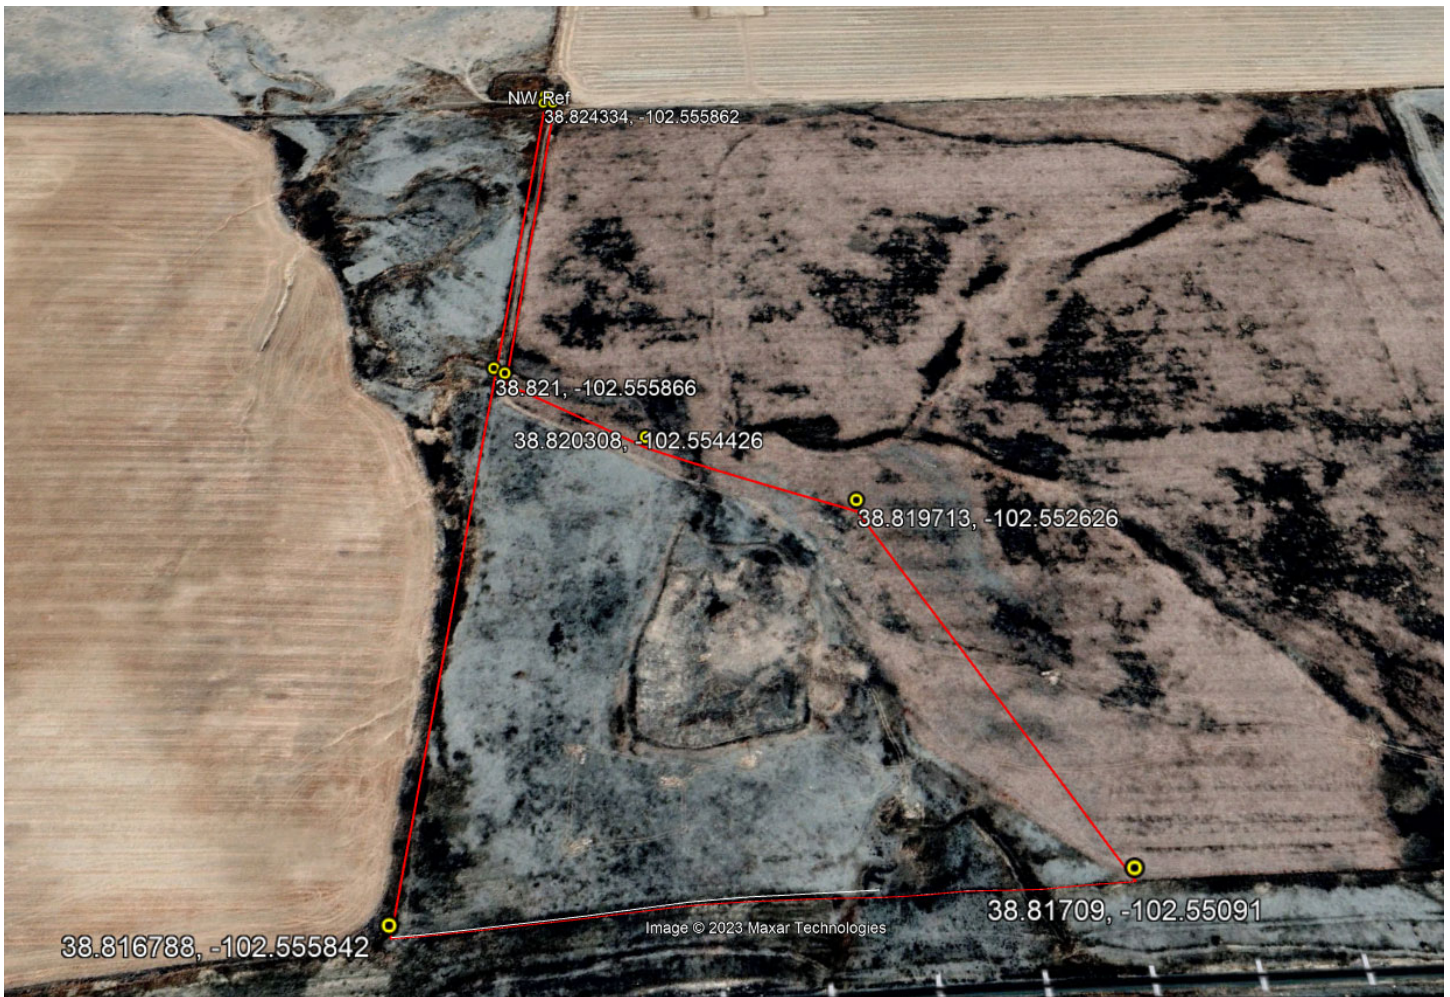
Figure 1: Google imagery from March 2020. Red boundary indicates proposed permit boundary. GPS points provided by Operator.
