**MINERALS PROGRAM INSPECTION REPORT**  
**PHONE: (303) 866-3567**

<b>MINE NAME:</b> Moore's Agg Fields	<b>MINE/PROSPECTING ID#:</b> M-2023-044	<b>MINERAL:</b> Unknown commodity	<b>COUNTY:</b> Mesa
<b>INSPECTION TYPE:</b> Illegal(Unpermitted Operation)	<b>WEATHER:</b> Clear	<b>INSP. DATE:</b> December 19, 2023	<b>INSP. TIME:</b> 11:05
<b>OPERATOR:</b> Moore's Ranching	<b>OPERATOR REPRESENTATIVE:</b> Leon Moore's	<b>TYPE OF OPERATION:</b> IM - Is it Mining	
<b>REASON FOR INSPECTION:</b> Citizen Complaint	<b>BOND CALCULATION TYPE:</b> None	<b>BOND AMOUNT:</b> None	
<b>DATE OF COMPLAINT:</b> NA	<b>POST INSP. CONTACTS:</b> DRMS	<b>JOINT INSP. AGENCY:</b> None	
<b>INSPECTOR(S):</b> Amy Yeldell Travis Marshall	<b>INSPECTOR'S SIGNATURE:</b>

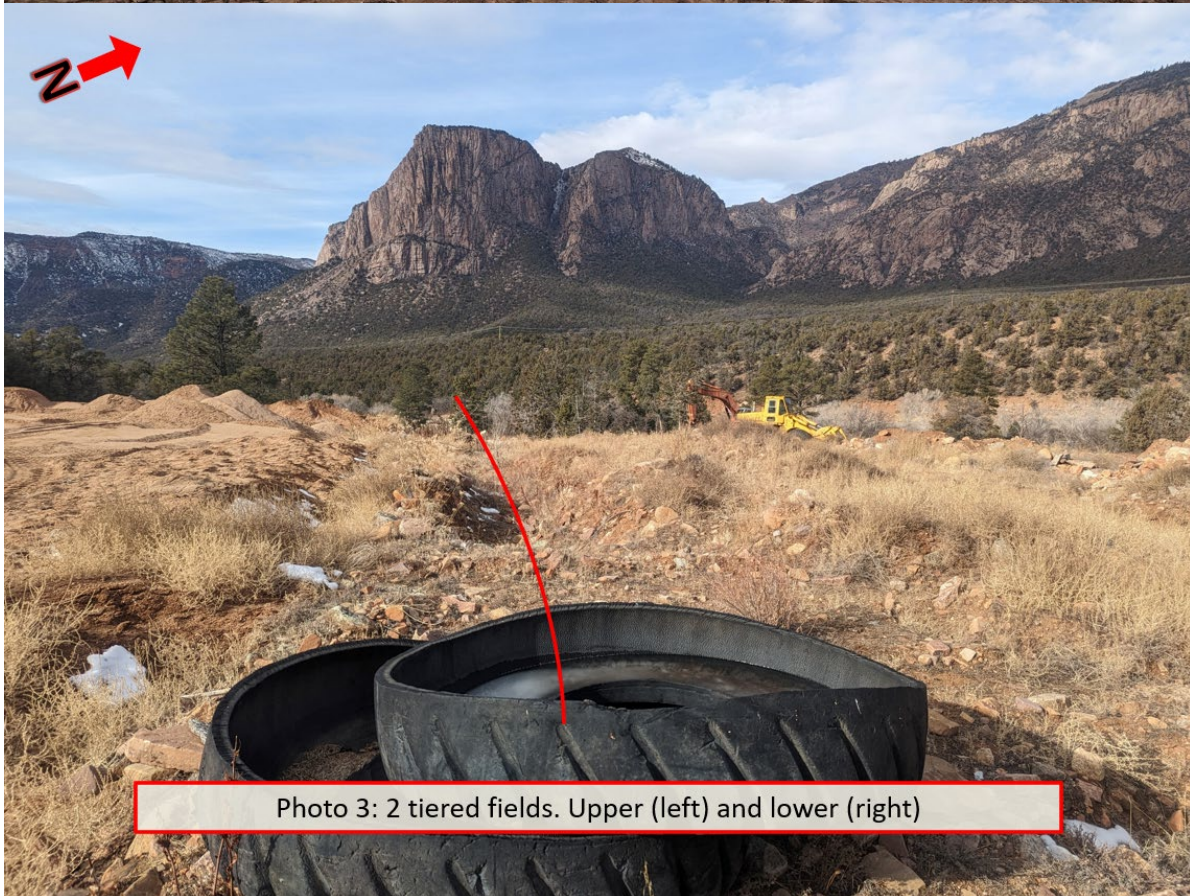
To the west of their existing fields are the new fields that are the subject of the complaint. The fields will be 2 tiered (Photo Three) with a lower collection ditch to the far north to intercept waste irrigation water. The Division estimates that approximately 3 acres is associated with the western fields. The southern most tier/field is nearly complete and will result in a half-acre field. Irrigation piping is in place and only final grading and planting remains (Photos Four – Six). The northernmost field is currently being constructed; no irrigation is in place to date (Photo Seven).

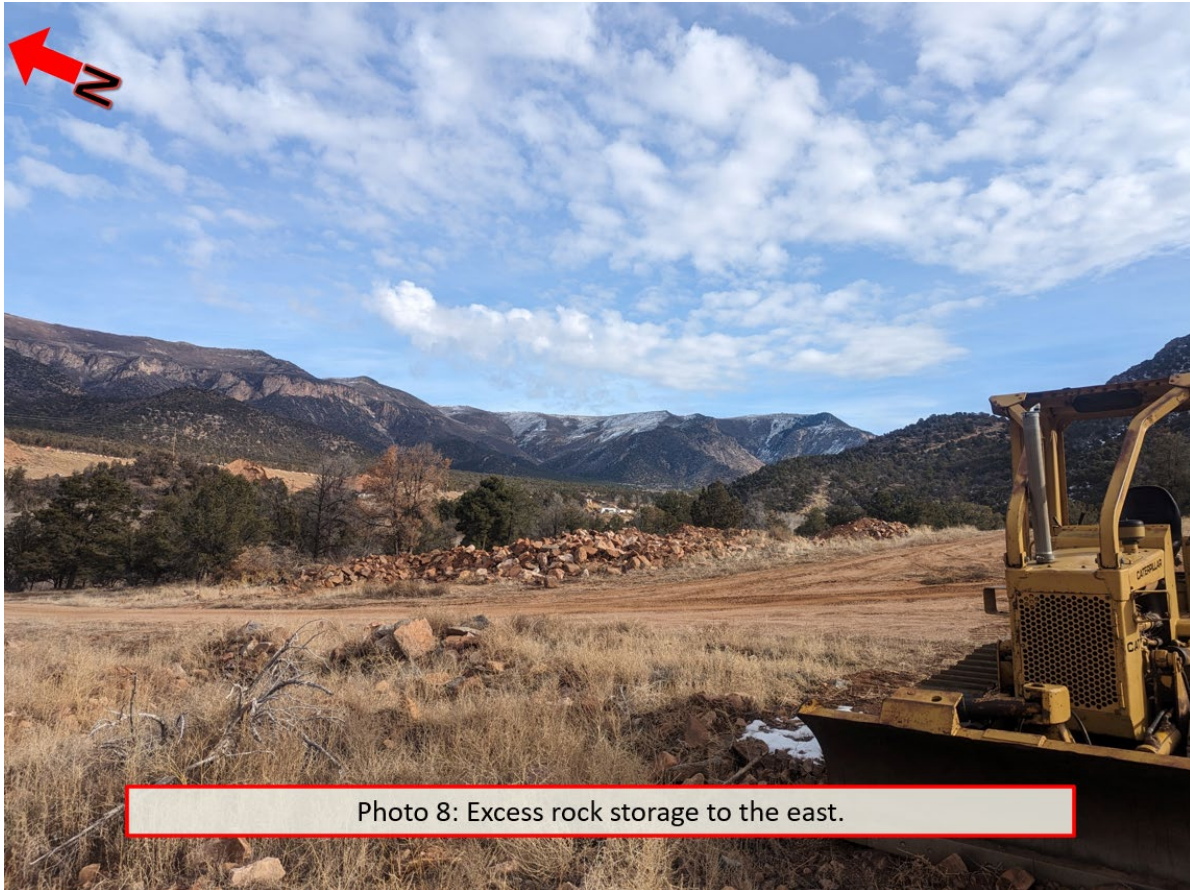
Excess rocks from clearing and building of the fields are stored in several piles throughout the ranch. One main rock pile is to the east of new field and will need to be removed if the field expands to the east (Photo Eight). It was indicated that excess rocks may be imported to the pit across the highway (M-1980-178) as a means of getting rid of them. Any encountered topsoil is also salvaged and replaced after final grading. Located on site are several pieces of heavy equipment such as loaders and excavators. Work on this project is conducted as the landowner has time and is generally after hours and weekends. The Division does not regulate hours of operation. Additional discussions with the complainant were in regard to noise, which is also non-jurisdictional for the Division.
