January 8, 2024
Project#01349-0001

Subject: Summary of Instrumentation Monitoring
4th Quarter 2023
Bowie Coal Waste Disposal Area No. 3
Paonia, Colorado

**SUBJECT: Summary Report, 4th Quarter 2023, Vibrating Wire Piezometers
October – December 2023, Bowie Mine #2
Coal Waste Disposal Area (CWDA) #3**

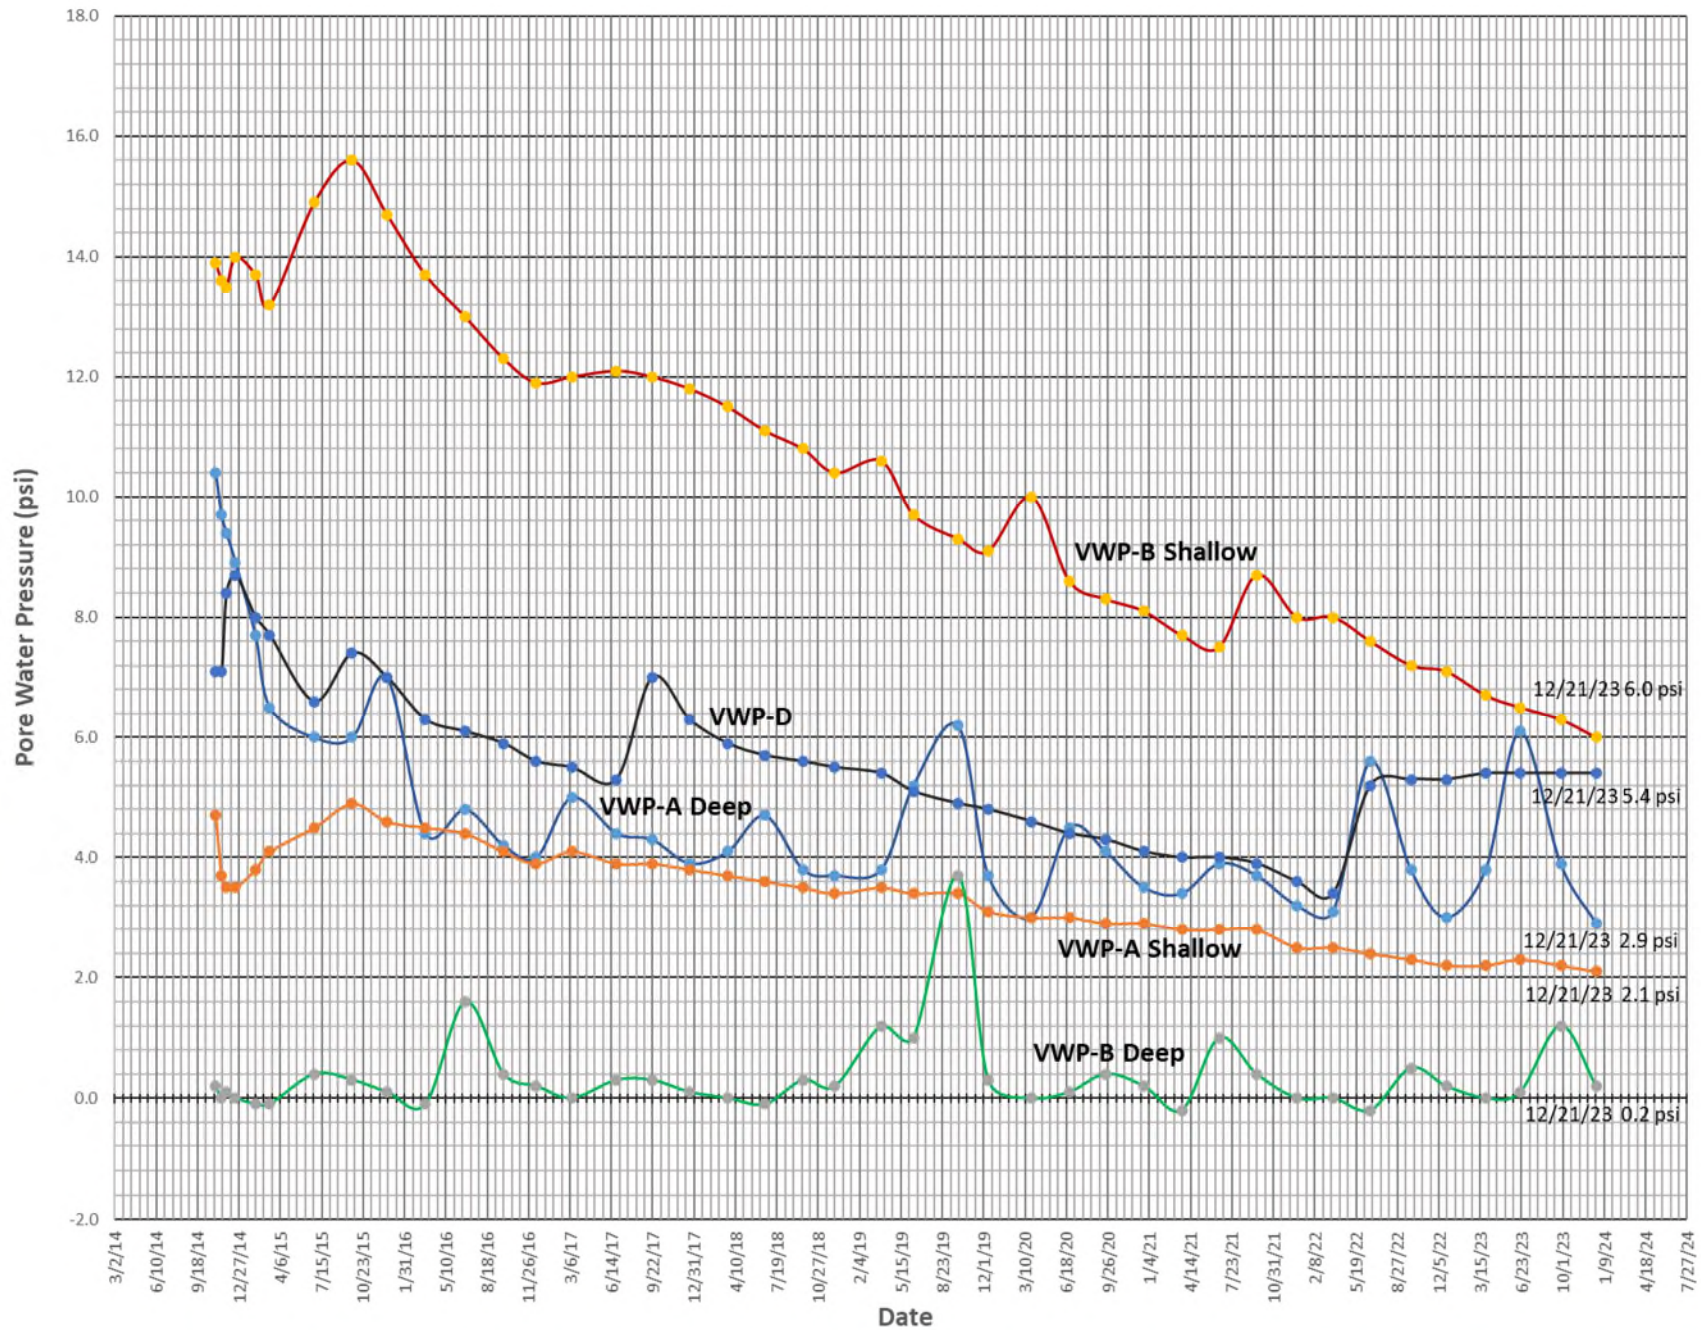
Figure 1 - Bowie Mine #2 - CWDA #3
Vibrating Wire Piezometer Data

We present a graph of measured pore pressures on the attached Figure 1 and numerically in Table 1 below. Table 1 is a summary of the initial, last year, last quarter, and current readings. In addition, we present the difference between the current pore pressures and those at the time of installation, the previous year, and the previous quarter.

As seen on Figure 1 and Table 1, when compared with the previous quarter, four VWP's decreased 0.1 to 1.0 psi and one (VWP-D) had no change in pore pressure. When compared with the 4th quarter of last year, three VWP's decreased 0.1 to 1.1 psi, one (VWP-D) increased 0.1 psi, and one (VWP-B Deep) had no change in pore pressure. Since installation in 2014, all VWP's have generally decreased in pore pressure except for VWP-B Deep, which fluctuates above and below the original pore pressure throughout its history. Although there is a general trend of decreasing pore pressure over time, two of the piezometers (VWP-A Deep and VWP-B-Deep) exhibit seasonal fluctuations in pore pressure since 2019 that mirror each other. VWP-D had a general decline in pore pressures through much of its history until the second quarter of 2022 when pore pressures rose and then have stayed roughly the same elevated level since then.

VWP-A Deep was installed on October 6, 2014 near the northern edge of CWDA No. 3. VWP-A Deep was installed in the foundation soil approximately eight feet below the bottom of the gob. The pore pressures recorded at VWP-A Deep generally decreased since installation until September 2015. After that, the pore pressures have generally fluctuated in a narrow range; however, a significant increase in pore pressures has been observed in September of 2019, and June of 2022 and 2023. These 'spikes' may reflect climatic conditions during the summer months. However, HBET does not believe that the pore pressure changes in VWP-A Deep are an indication of instability in CWDA No. 3.

VWP-A Shallow was installed on October 6, 2014 near the northern edge of CWDA No. 3. VWP-A Shallow was installed approximately ten feet above the base of the gob. After installation, the pore pressures dropped until November 2014. Between November 2014 and September 2015, increases in the pore pressures were recorded at VWP-A Shallow. However, between September 2015 and December 2016, the pore pressures decreased. Since then, the data have fluctuated within a narrow range; with a general downward trend. In general, HBET does not believe that the pore pressure changes in VWP-A Shallow are an indication of instability in CWDA No. 3.

VWP-B Deep was installed on October 6, 2014 in the west-central portion of CWDA No. 3. VWP-B Deep was installed in the foundation soil approximately ten feet below the bottom of the gob. Since installation, the pore pressures recorded at VWP-B Deep have fluctuated within a narrow range. In general, HBET does not believe that the pore pressure changes in VWP-B Deep are an indication of instability in CWDA No. 3.

VWP-B Shallow was installed on October 6, 2014 in the west-central portion of CWDA No. 3. VWP-B Shallow was installed approximately ten feet above the base of the gob. Since installation, the pore pressures recorded at VWP-B Shallow have fluctuated with periods of slight increase and slight decrease; likely associated with activity on the gob pile. However, the pore pressures have shown a decreasing trend over the last several years. In general, HBET does not believe that the pore pressure changes in VWP-B Shallow are an indication of instability in CWDA No. 3.

VWP-D was installed on October 7, 2014 in the east-central portion of CWDA No. 3. VWP-D was installed approximately ten feet above the base of the gob. Since installation, the pore pressures recorded at VWP-D have fluctuated. However, the pore pressures increased significantly in June 2022 before leveling out. Since then, the fluctuations have been within a narrow range and HBET does not believe that the pore pressure changes in VWP-D are an indication of instability in CWDA No. 3.

Based upon the results of the most recent VWP monitoring data, HBET does not believe that there is any reduction in the stability of CWDA No. 3.

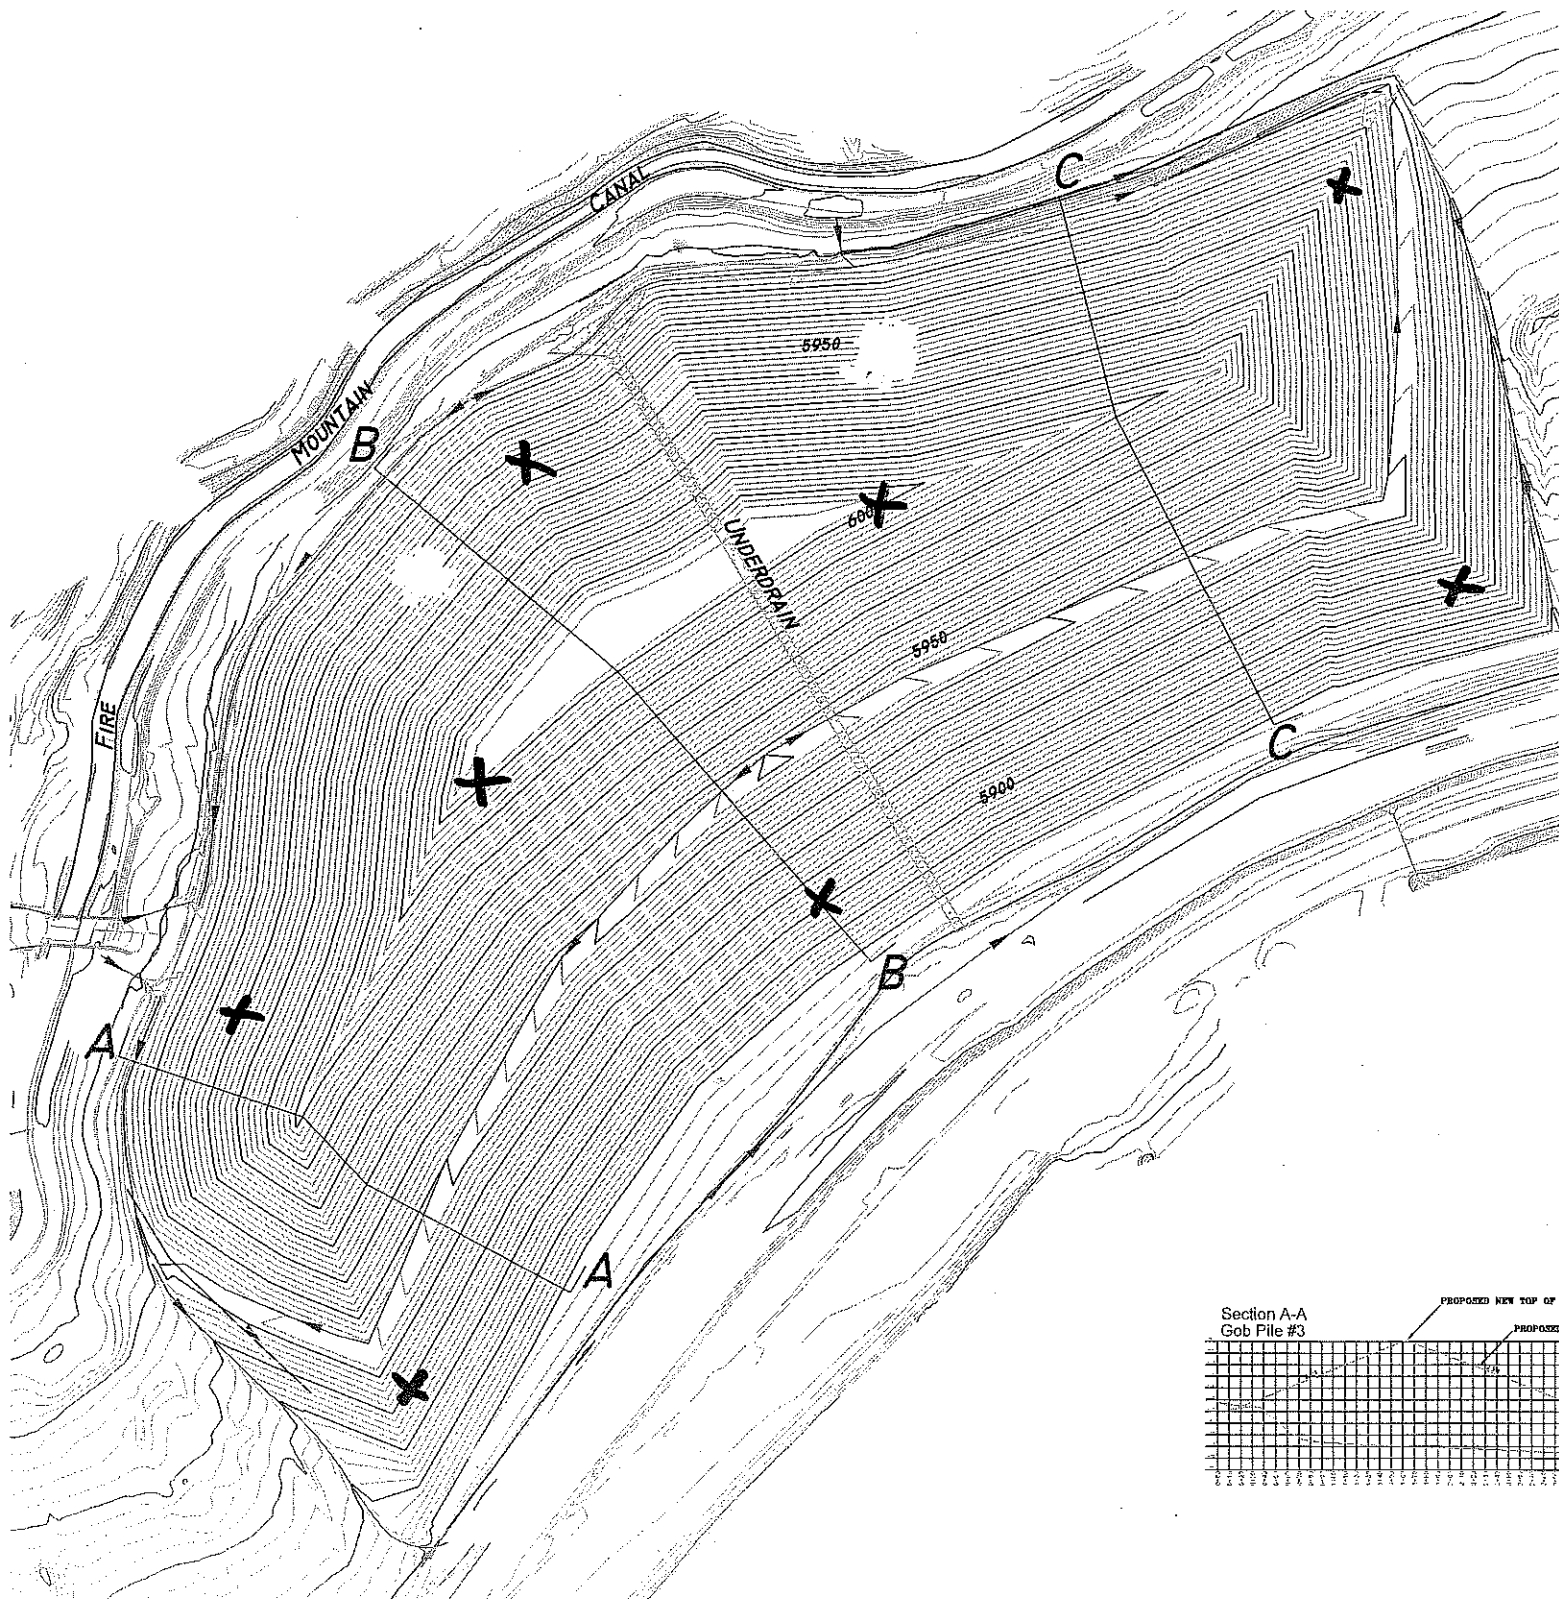
Section A-A
Gob Pile #3

Five vibrating wire piezometers were installed in CWDA No. 3 in October 2014. The piezometers were installed at three locations within the footprint of the gob pile as shown on the attached figure. Monitoring of the functioning piezometers was completed by Buckhorn Engineering (Buckhorn) on December 21st, 2023. The attached monitoring report prepared by Buckhorn includes the piezometer monitoring data and the data is summarized in the following table.
