MINERALS PROGRAM INSPECTION REPORT

MINE NAME: Byzantine Quarry	MINE/PROSPECTING ID#: M-2007-014	MINERAL: Limestone (general), granite, granite gneiss and sandstone (silica, stone, quartzite)	COUNTY: Fremont
INSPECTION TYPE: Surety-Related Inspection	WEATHER: Clear	INSP. DATE: September 14, 2023	INSP. TIME: 11:40
OPERATOR: Holcim - WCR, Inc.	OPERATOR REPRESENTATIVE: Lu Toxvard & Kurt Thurmman	TYPE OF OPERATION: 112c - Construction Regular Operation

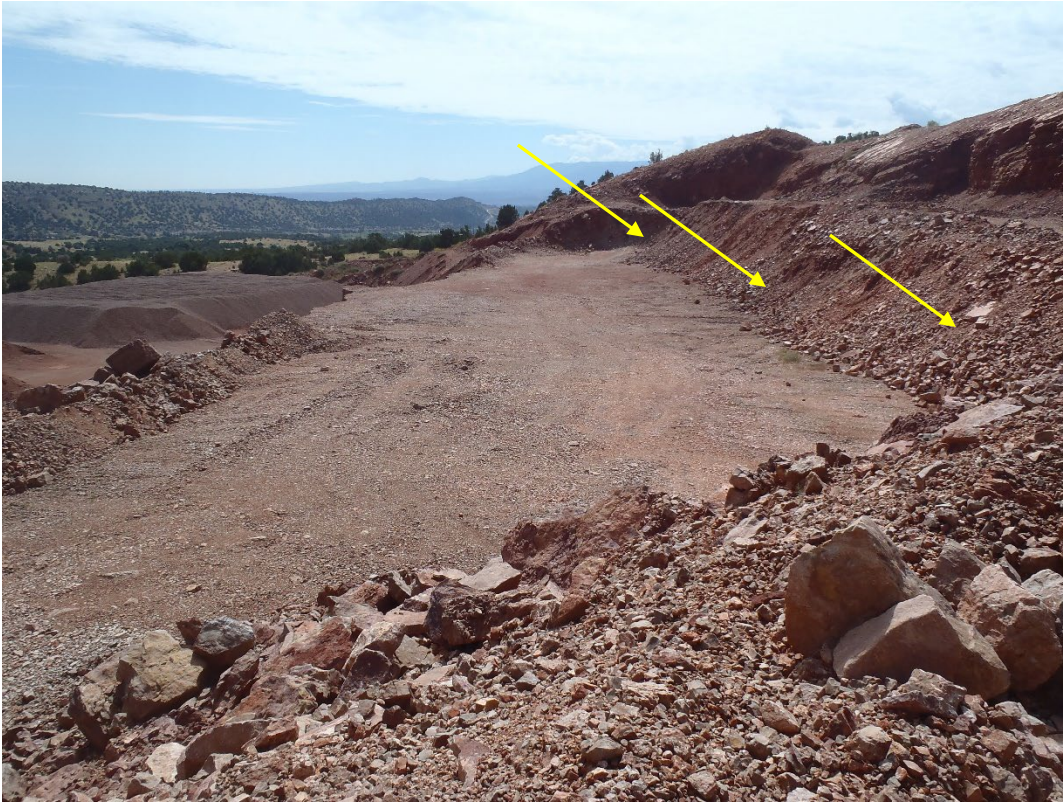
Photo 1. Highwall face at 0.5H:1V or flatter above the lowest bench (looking south).

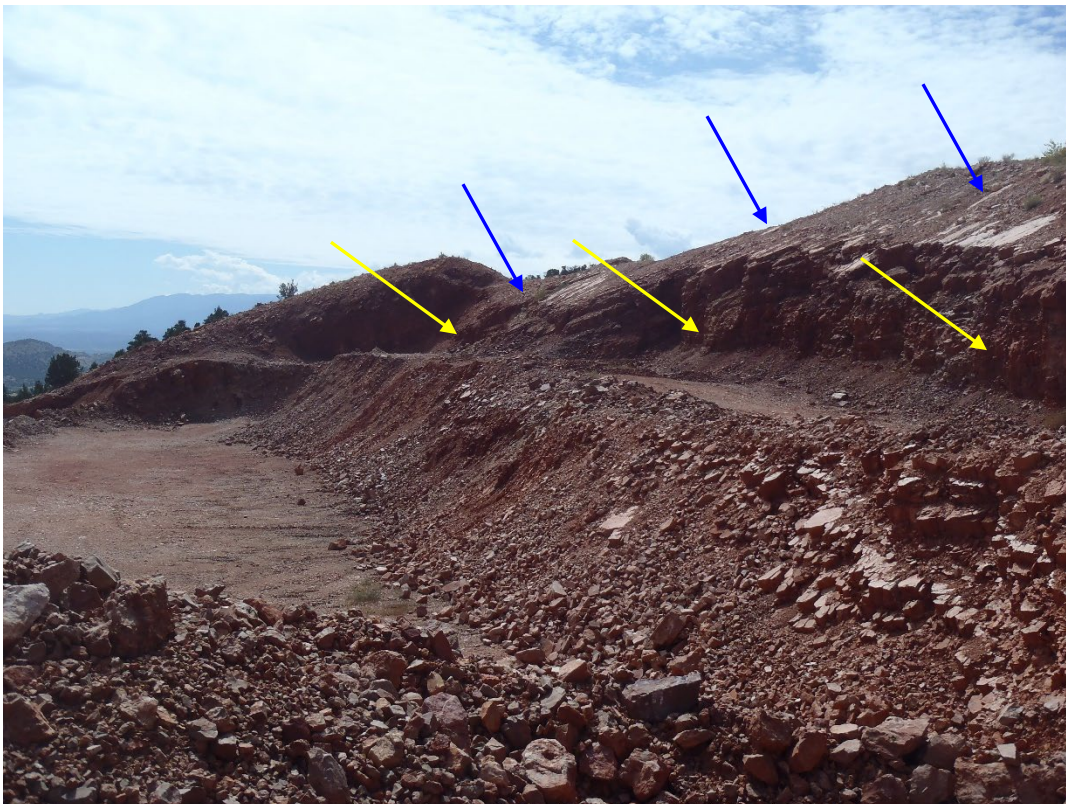
Photo 2. Highwall face with breakpoint above the upper bench (looking SSW).

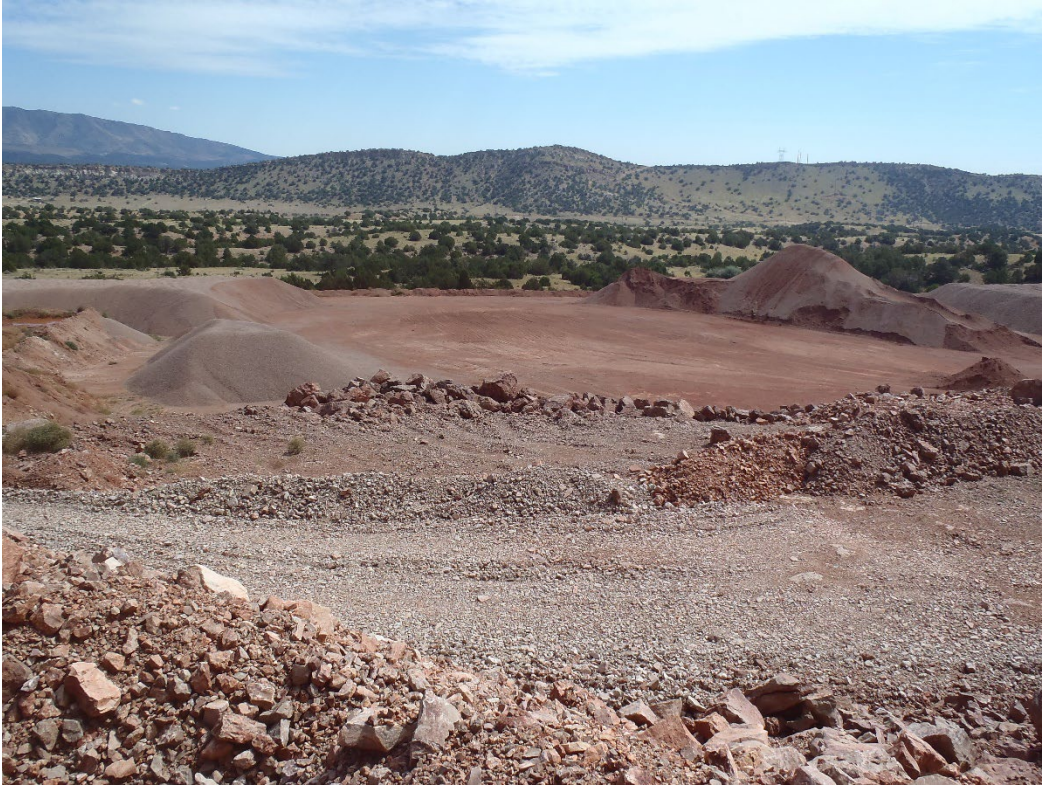
Processing Waste: All observed stockpiles (including crusher fines) were characterized by site representatives as product (see **Photo 3**). No processing waste was observed.

Photo 3. Product stockpiles on pit floor (looking east from upper bench area).

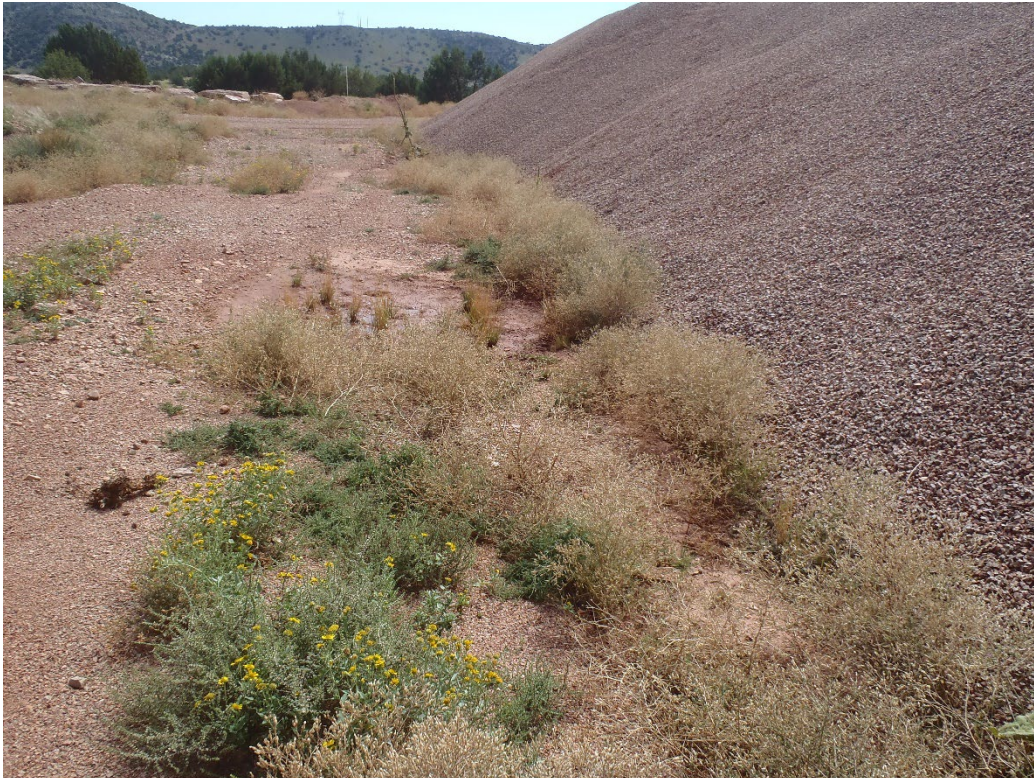
PROBLEM/POSSIBLE VIOLATION: Problem: There are state-listed noxious weeds (Diffuse knapweed) present on site. This is a problem for failure to employ weed control methods for state listed noxious weed species within the permitted area, and to reduce the spread of weeds to nearby areas as required by Section 3.1.10 (6) of the rule.

Revegetation: A significant amount of Diffuse knapweed was observed (see **Photo 4**). **The presence of this List B noxious weed is cited as a problem on p. 1 of this report.**

Photo 4. Diffuse knapweed on north side of product stockpiles (looking east).

CORRECTIVE ACTIONS: Implement approved weed control plan and provide proof to the Division that this has been done.

- Problem cited – presence of diffuse knapweed. We discussed needing a technical revision (TR) for a noxious weed control plan. A subsequent file review found the approved reclamation plan (Exhibit E) contains the following verbiage: *"Larsen Colorado LLC [original Permittee] will control all prohibited noxious weeds and other weed species which seriously threaten revegetation success in accordance with and in concert with the Fremont County Weed Control Department"* (reference paragraph 3.1.10(6)). As such a TR is not necessary, but the program needs to be initiated and documentation provided to the DRMS to verify its implementation.

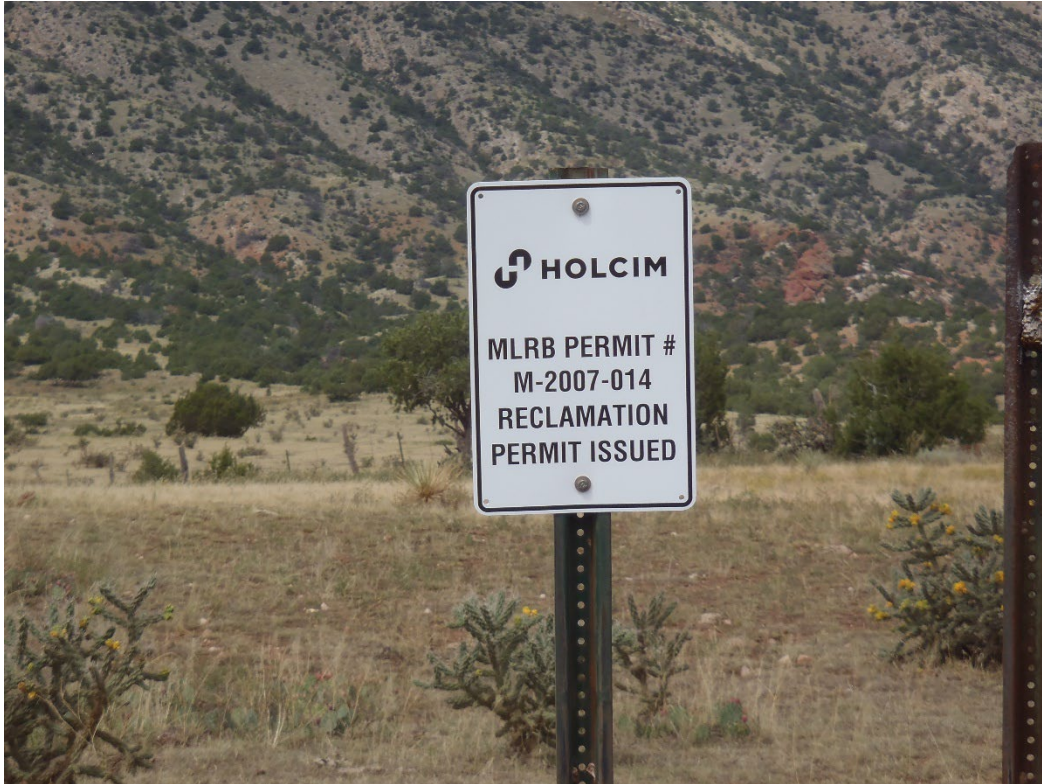
Signs and Markers: The permit sign was properly posted (see **Photo 5**) near the cattle guard on the access road just west of FCR 69 and boundary markers were observed to delineate the permit boundary.

Photo 5. New permit sign (near cattle guar just west of FCR 69).
