Miller Gravel Pit (M-1982-112)	
UPDATED: March 2024	2024 Annual Report Map Due: March 11, 2024
SCALE 1"=500'	
SHEET 1 of 2	Revegetation Status

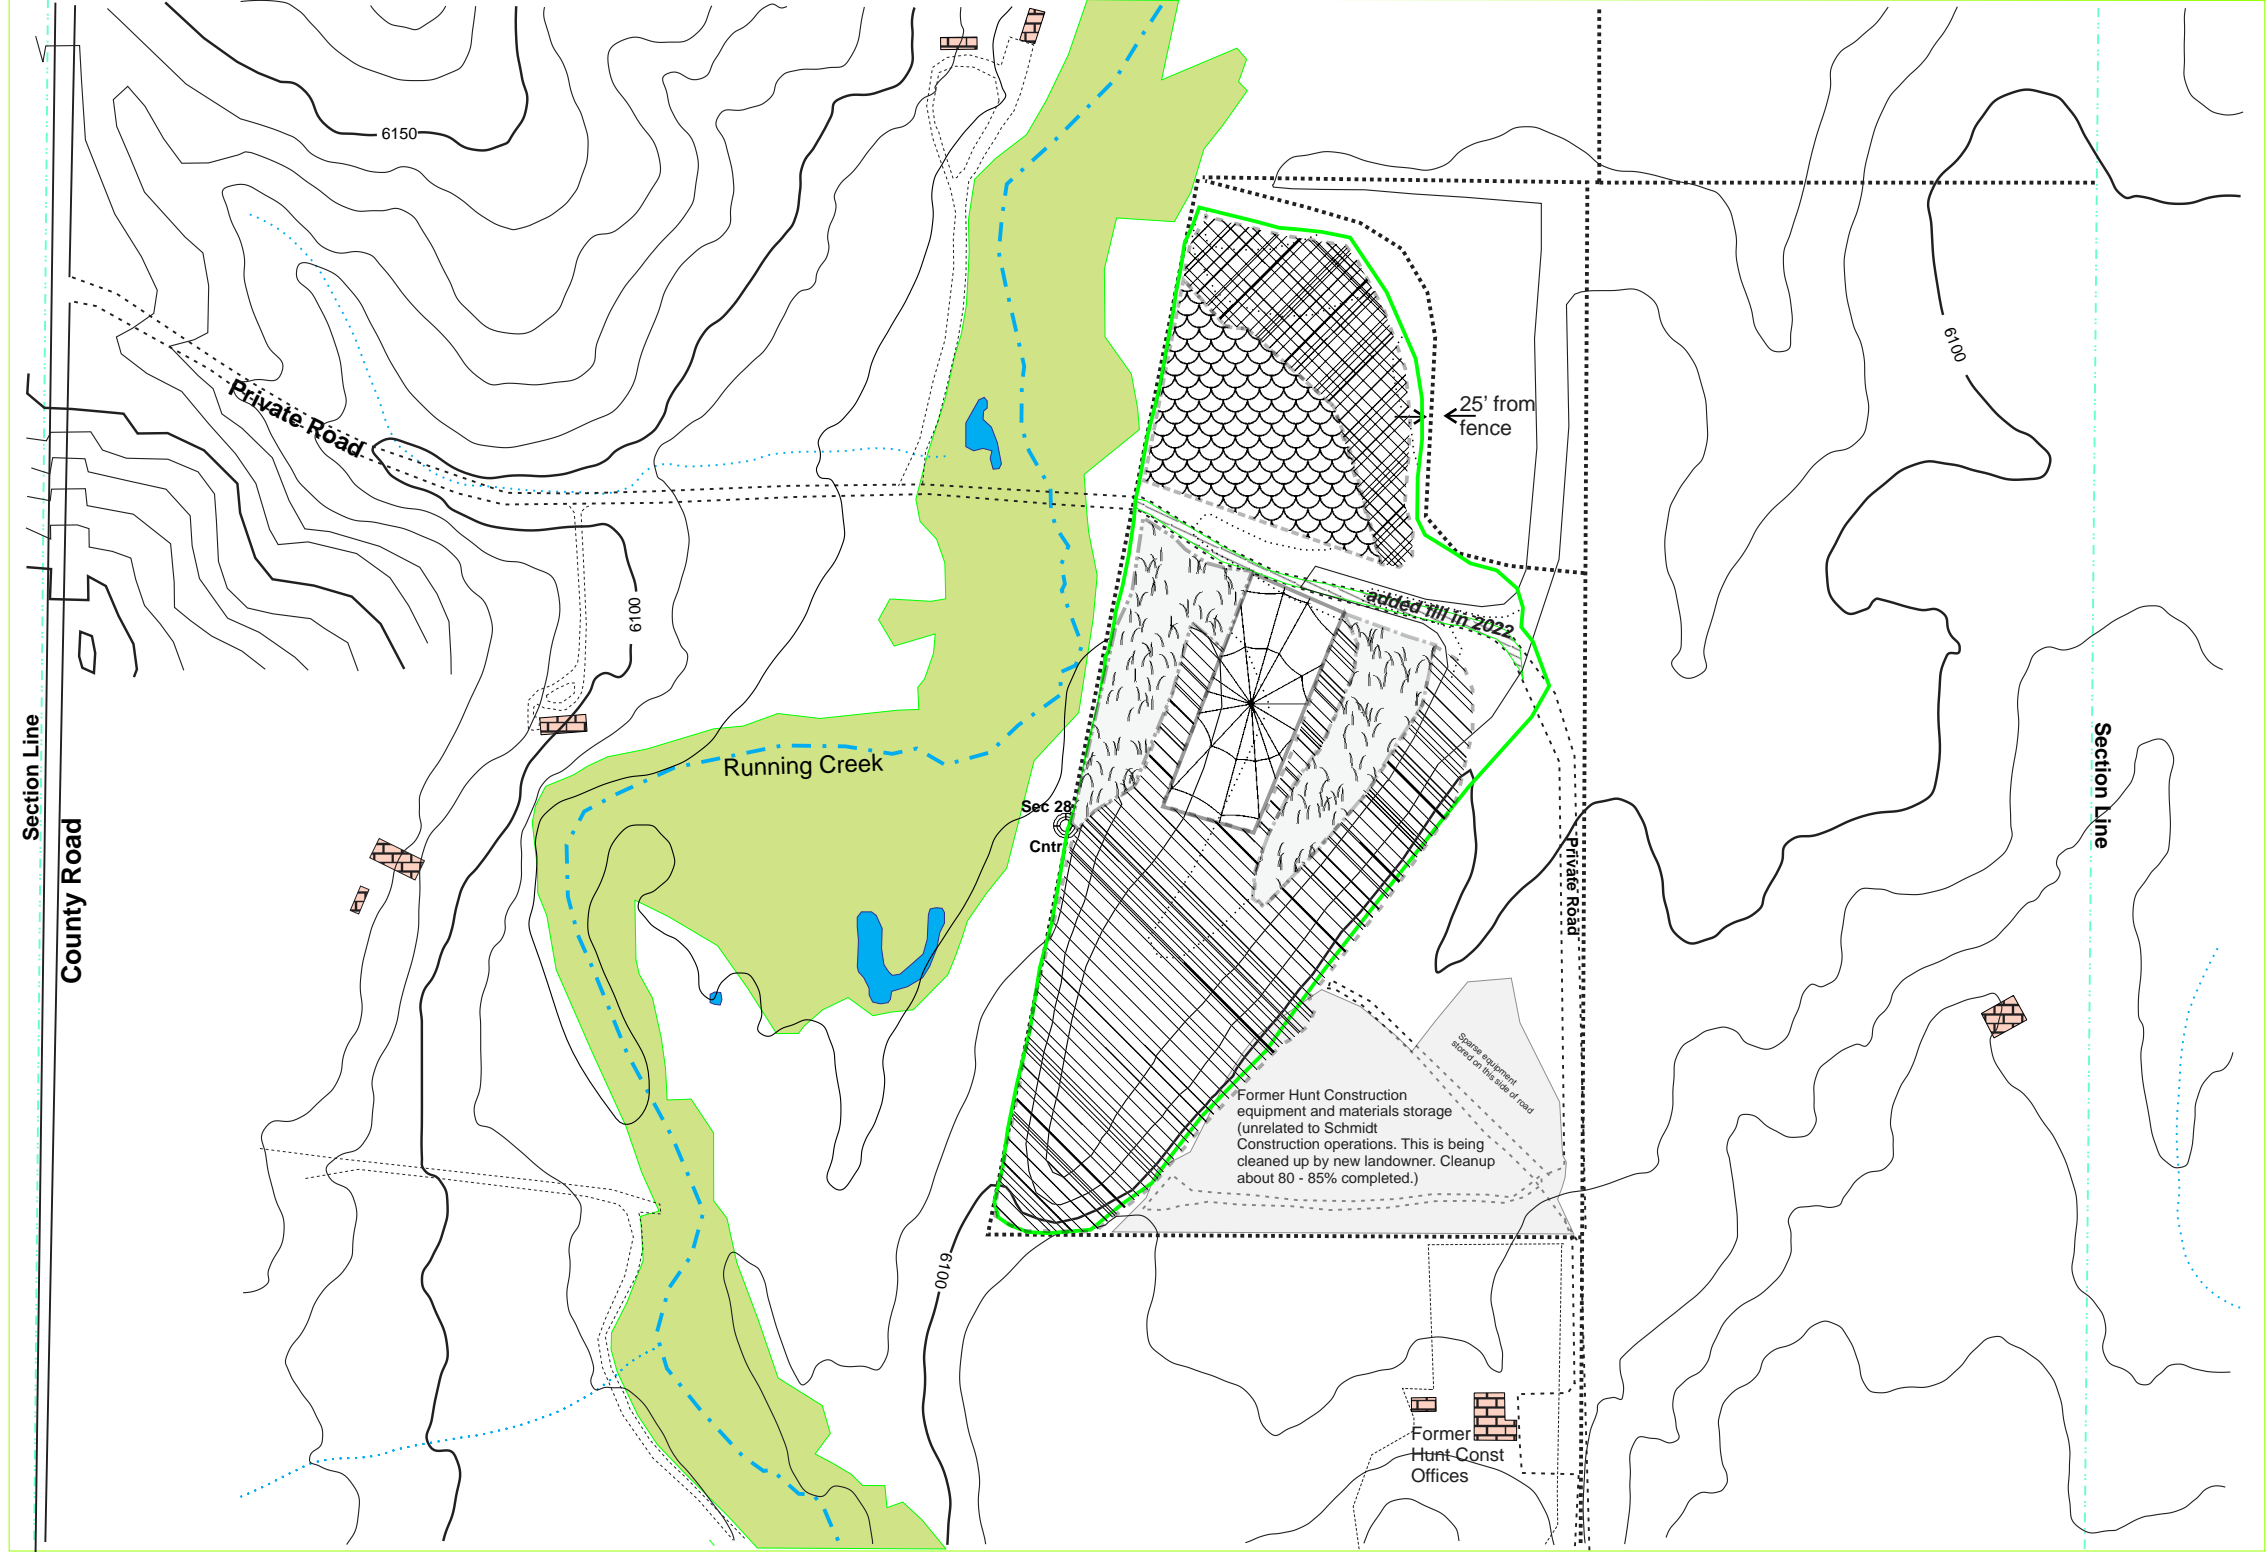
- Primarily weeds with some grasses and forbs underneath, but with young cottonwood plants here and there south of the road. (24.2 acres)
- Vegetation severely affected by flooding; mainly weeds but also with desirable plants planted or brought in by flooding. (5.3 acres)
- Location of deep fill of foreign materials. No vegetation so fill likely done well after the growing season. (3.7 acres; about 42,000 cu yds assuming ave. depth = 7 feet)
- Low weed density and high grass success plus spotty facultative and obligate wetland species as well as sparse young willows and cottonwood. (6.1 acres)

Total affected land reclaimed = 43.3 acres
