Newmont CC&V

VLF #2 Phase #3 Liner Remediation

Project Weekly Report

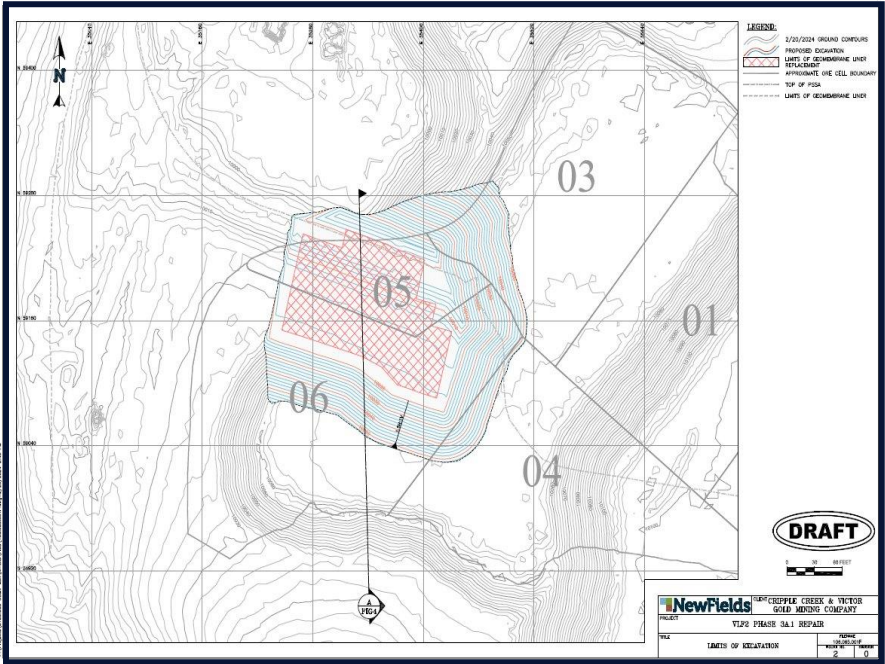
2. **LIMITS OF EXCAVATION:** Excavation limits for the current overburden removal.

Report Period:  Thursday-Friday	Ambient Temperature		Weather Conditions
	High	Low	Precipitation
Date: 2/28/2024 - 2/29/2024	61	17	None
Observations & Comments	Overburden excavation started on Wednesday, 2/28/24 and the work continued through Thursday 2/29/24. 5’ minimum of ROM and DCF material was left covering liner, to be removed by contractor. A total of <b>323,249ft<sup>3</sup></b> of overburden material has been removed from the project area.

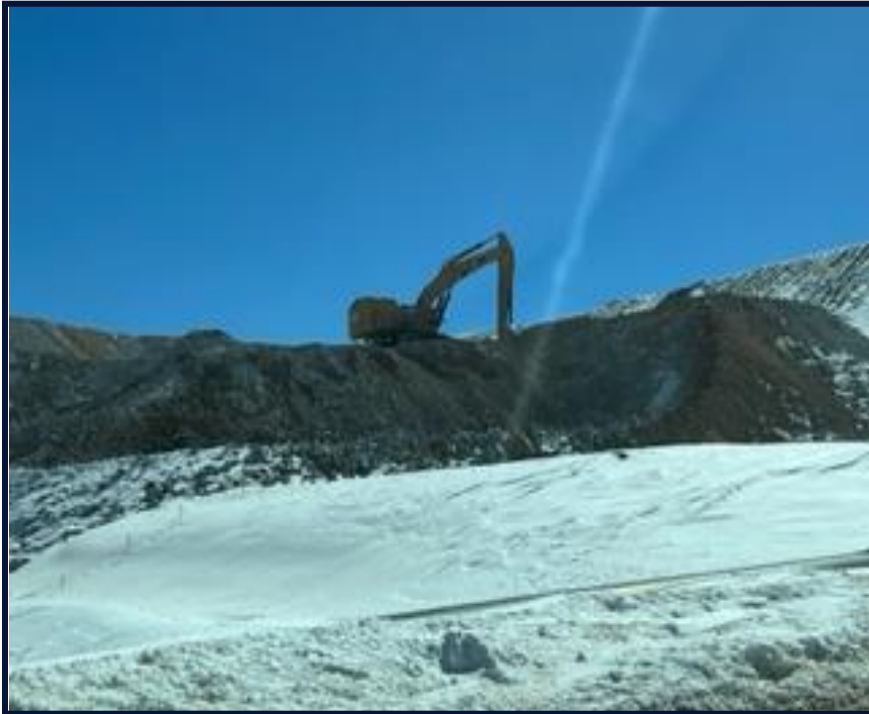
**ACTIVE OVERBURDEN EXCAVATION AREA PHOTOGRAPH:** Insert 1 photo of overburden excavation activity – if possible, include equipment or vehicles for scale to accurately convey excavated area size.

### 3. MATERIAL COVERING LINER DEPTH – NOT TO BE BELOW 5FT FROM TOP OF LINER:

Excavation height  $\geq 5'$
