Bowie #1 inspection report

Permit Number: C-1981-038 Mine Name: Bowie No. 1 Mine Operator: Bowie Resources, LLC Operator Address: Mr. Basil R Bear P.O. Box 1488 Paonia, CO 81428	County: Delta Operation Type: Underground Permit Status: Active Ownership: Private
	Operator Representative Present: Basil Bear
Operator Representative Signature: (Field Issuance Only)

Inspection Start Date: March 20, 2024 Inspection Start Time: 10:00 Inspection End Date: March 20, 2024 Inspection End Time: 12:00	Inspection Type: Coal Complete Inspection Inspection Reason: Normal I&E Program Weather: Clear
Joint Inspection Agency: None	Joint Inspection Contacts:
Post Inspection Agency: None	Post Inspection Contacts:
Inspector(s): Robert Zuber, P.E.	Inspector's Signature:

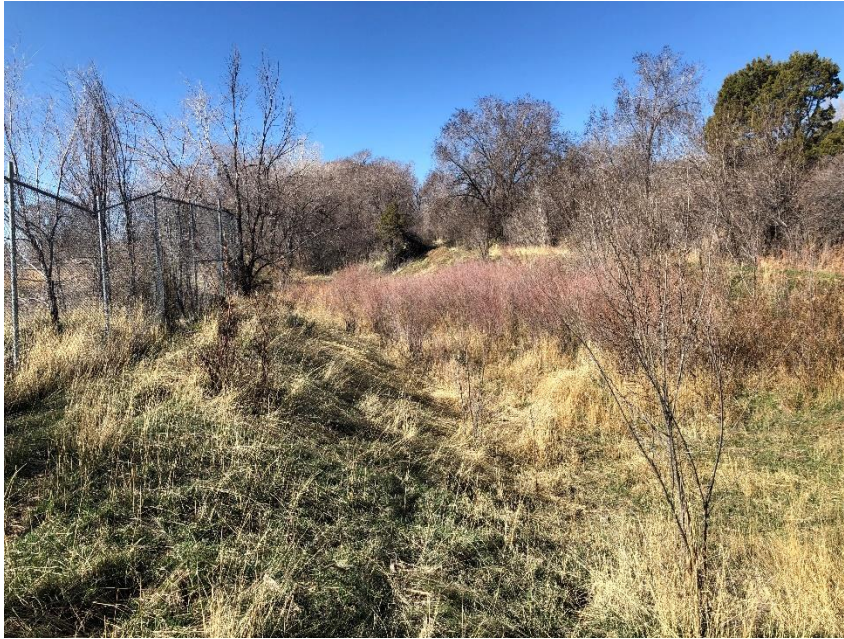
The ponds at the loadout, the Coal Storage Area (near Black Bridge Road), and the West Mine were empty of water, and no problems were identified with these ponds.

Loadout pond, looking west

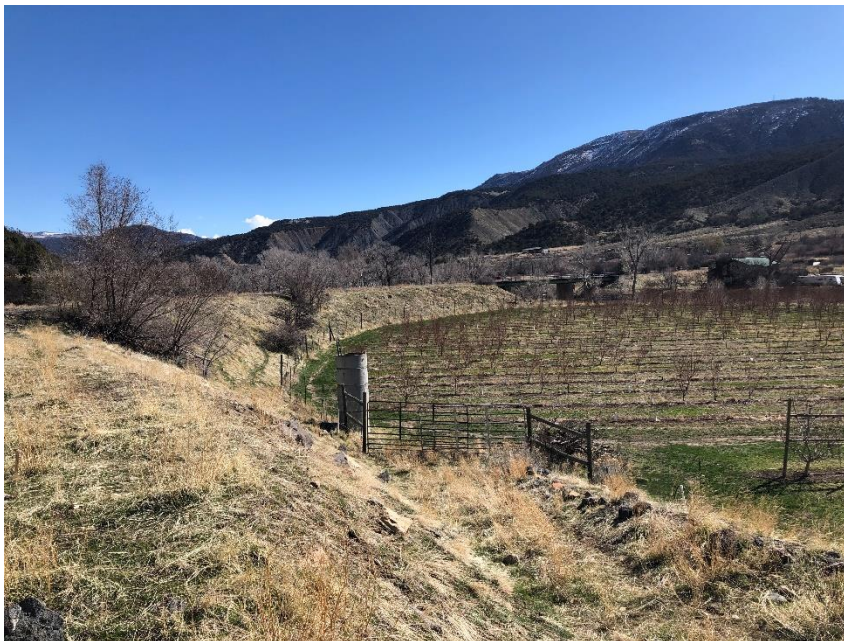
No erosion was seen at the loadout, including the steep slope between the loadout and the orchard below. The trestle across the river appears stable.

Slope below loadout, looking toward trestle

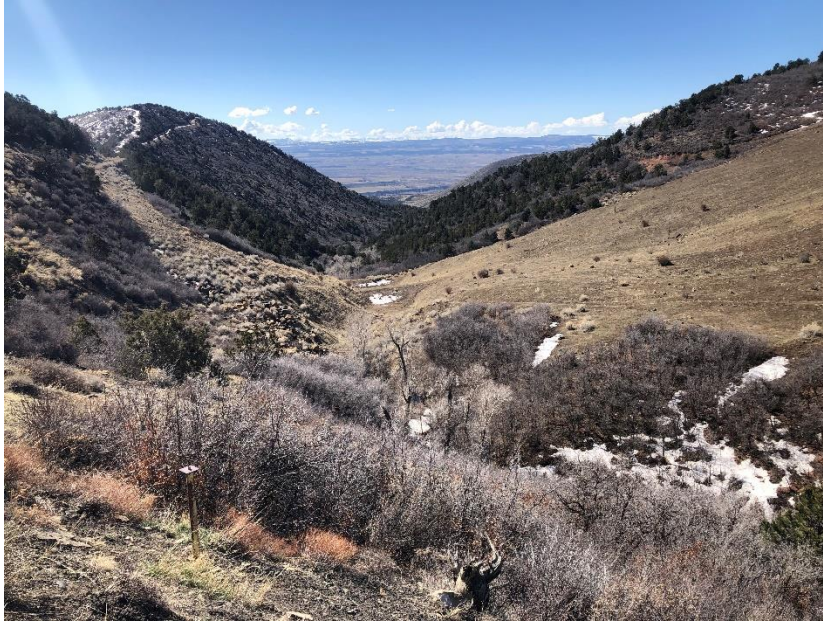
Ponds at West Mine

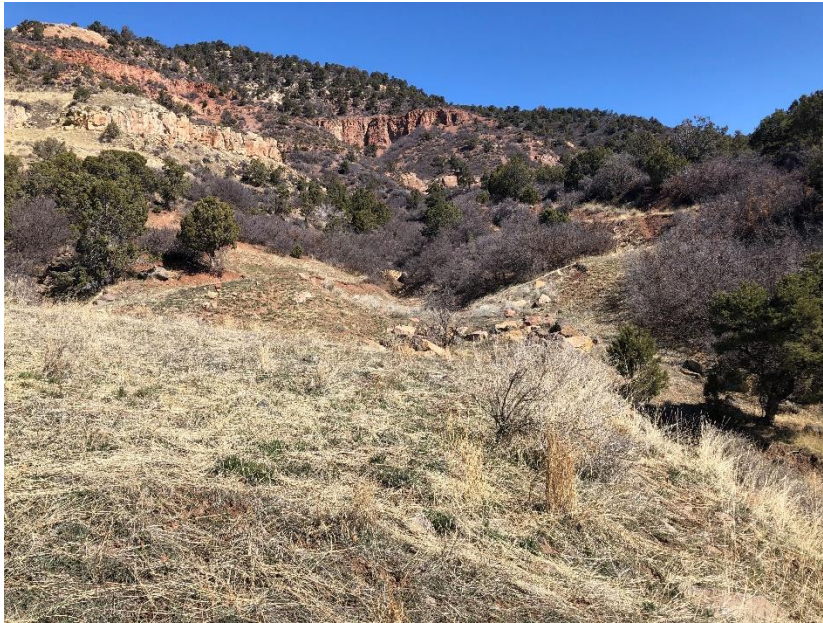
No erosion was seen at the reclaimed ponds at the East Mine (Ponds 1 – 4) or the reclaimed road at the West Mine.

Reclaimed ponds at East Mine
