MINERALS PROGRAM INSPECTION REPORT
PHONE: (303) 866-3567

MINE NAME: J Birds	MINE/PROSPECTING ID#: M-2005-050	MINERAL: Uranium and vanadium	COUNTY: Montrose
INSPECTION TYPE: Monitoring	WEATHER: Clear	INSP. DATE: April 30, 2024	INSP. TIME: 12:30
OPERATOR: Rimrock Exploration & Development, Inc.	OPERATOR REPRESENTATIVE: None	TYPE OF OPERATION: 110d - Designated Limited Impact

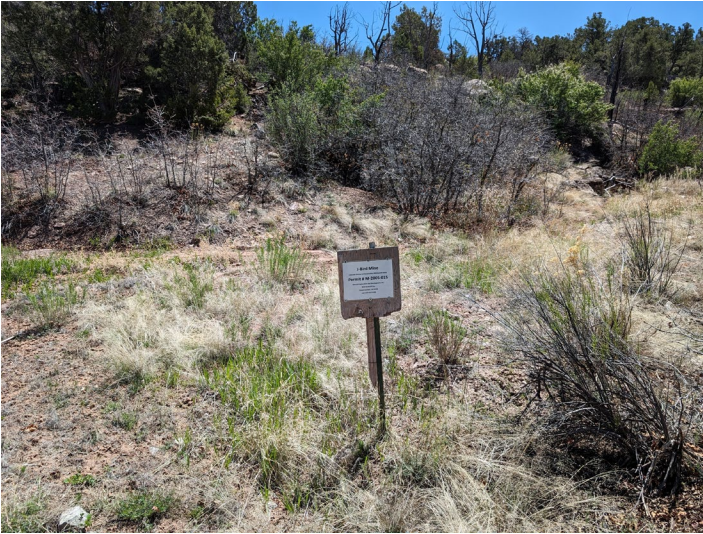
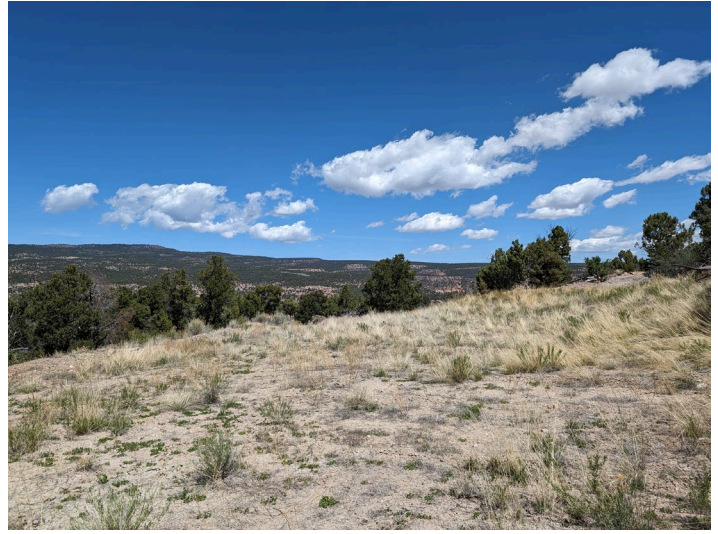
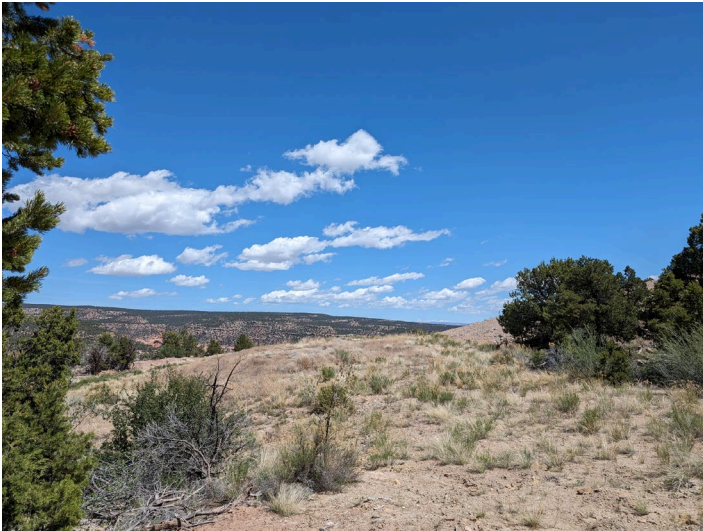
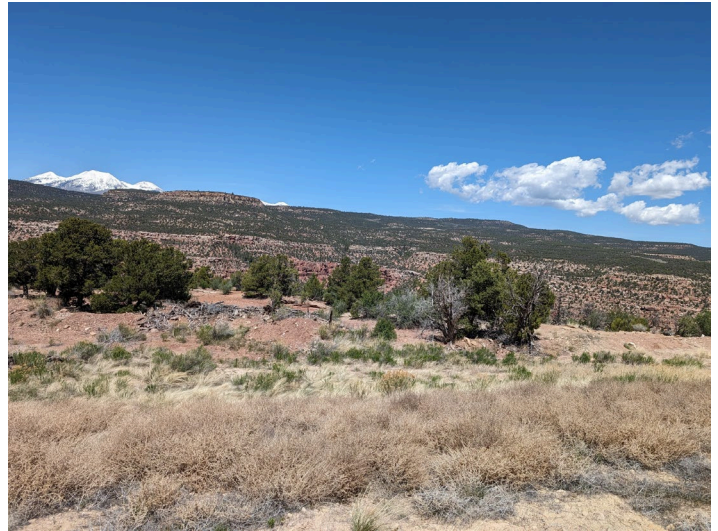
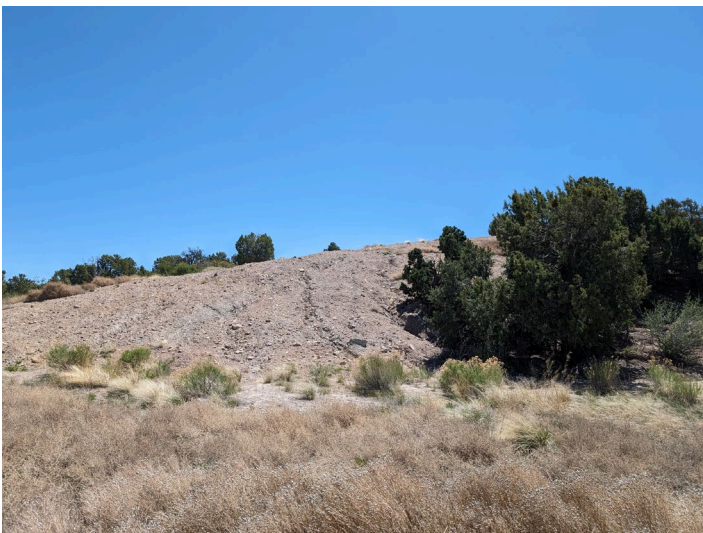
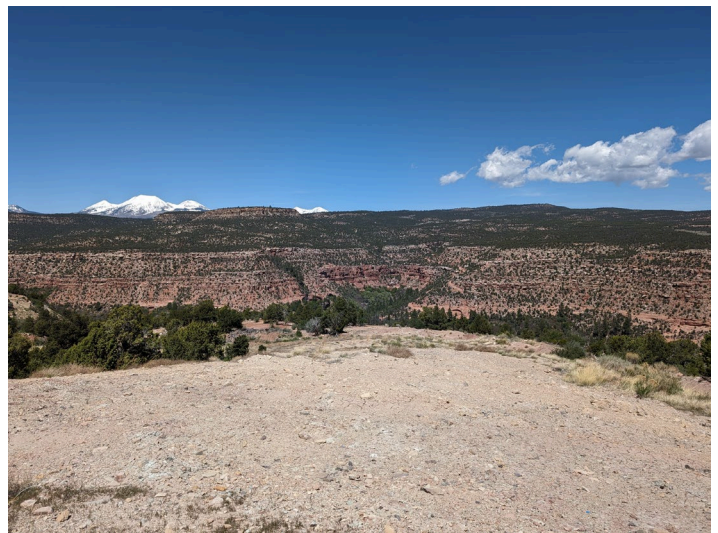
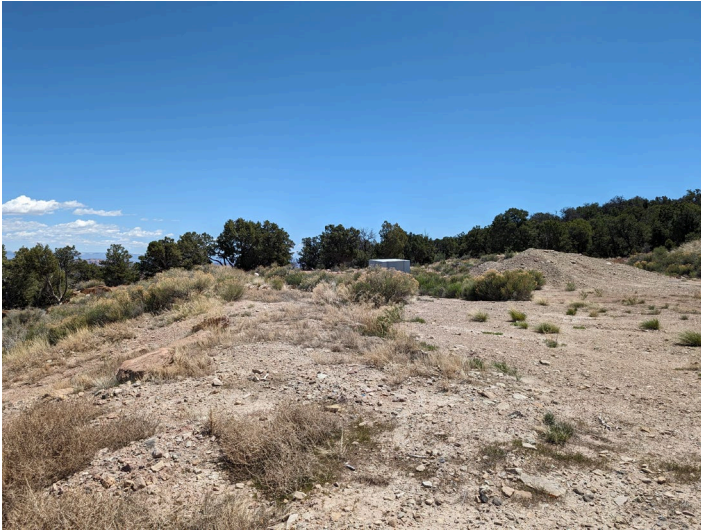
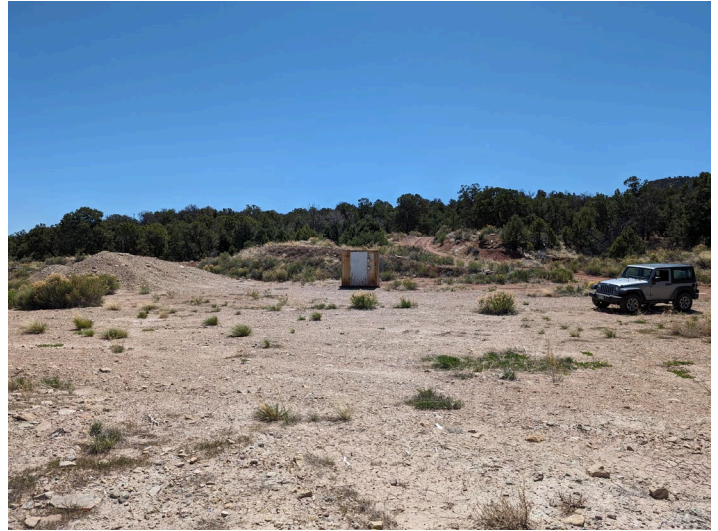
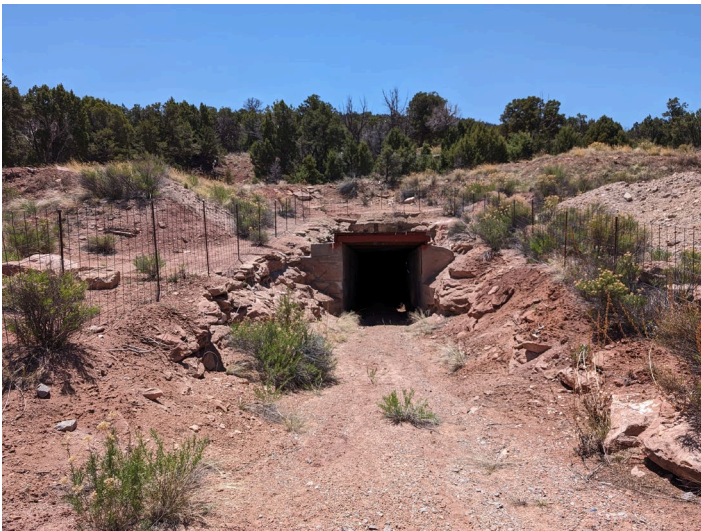
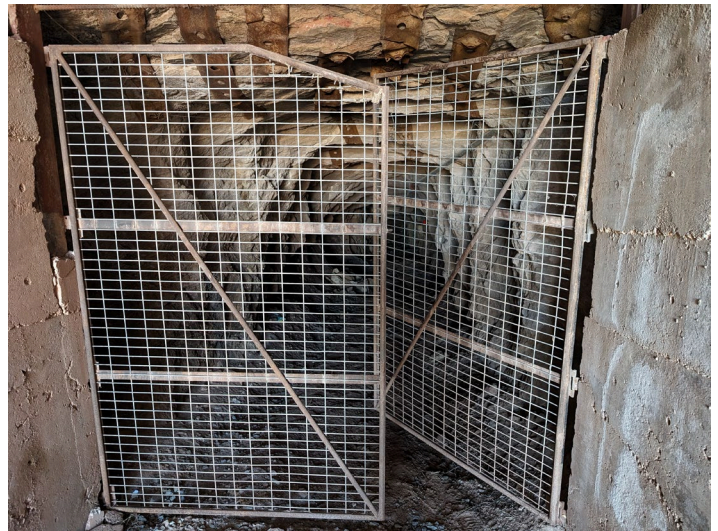
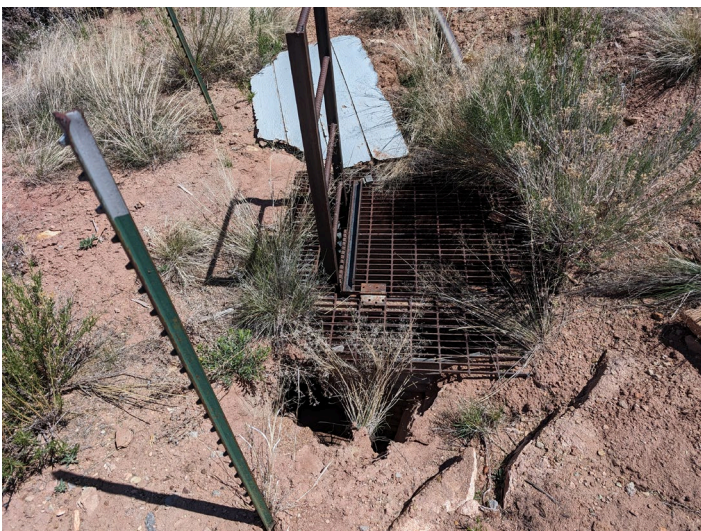
No evidence of any recent mining activity was observed. Conditions at the site were mostly unchanged from the Division's previous inspections.

The grate securing the portal entrance was unlocked. This has been noted as a problem. The grate shall be repaired/replaced and adequately secured in order to prevent unauthorized access into the mine.

An area around the venthole is collapsing again. This has been noted as a problem. This has been a recurring problem. The operator needs to stabilize the area around the venthole in order to prevent further erosion.

CORRECTIVE ACTIONS: Repair grate and lock securely to prevent unauthorized access into the mine. Provide photo documentation to the Division once this has been completed.

CORRECTIVE ACTIONS: Stabilize area around venthole and provide photo documentation to the Division once this has been completed.
