Inspection report

PERMIT INFORMATION

Permit Number: C-1981-028 Mine Name: Keenesburg Strip Mine Operator: Coors Energy Company Operator Address: Mr. Ben Moline P.O. Box 4030 Golden, CO 80402	County: Weld Operation Type: Surface Permit Status: Permanent Cessation Ownership: Private
	Operator Representative Present: None
Operator Representative Signature: (Field Issuance Only)

Inspection Start Date: November 12, 2024 Inspection Start Time: 13:45 Inspection End Date: November 12, 2024 Inspection End Time: 14:30		Inspection Type: Coal Complete Inspection Inspection Reason: Normal I&E Program Weather: Clear	
Joint Inspection Agency: None		Joint Inspection Contacts: 	
Post Inspection Agency: None		Post Inspection Contacts: 	
Inspector(s): Robert Zuber, P.E.	Inspector's Signature:

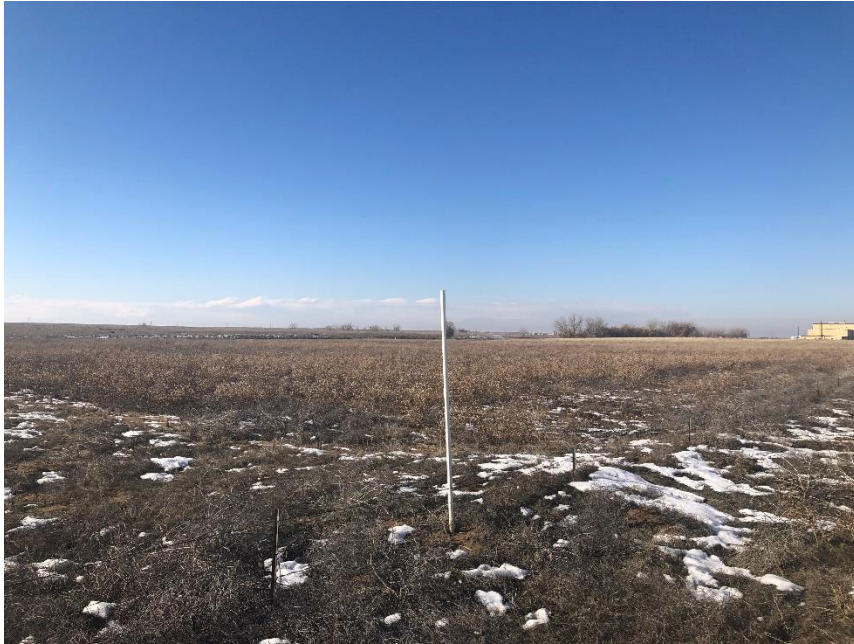
No erosion problems were seen on the parcels on the east side of the site, including Areas 34 and 38 (the southeast corner of the site); the reclaimed road by the entrance gate; or Areas 36, 42, and 44 (observed from afar).

Southest corner of site (Area 34)

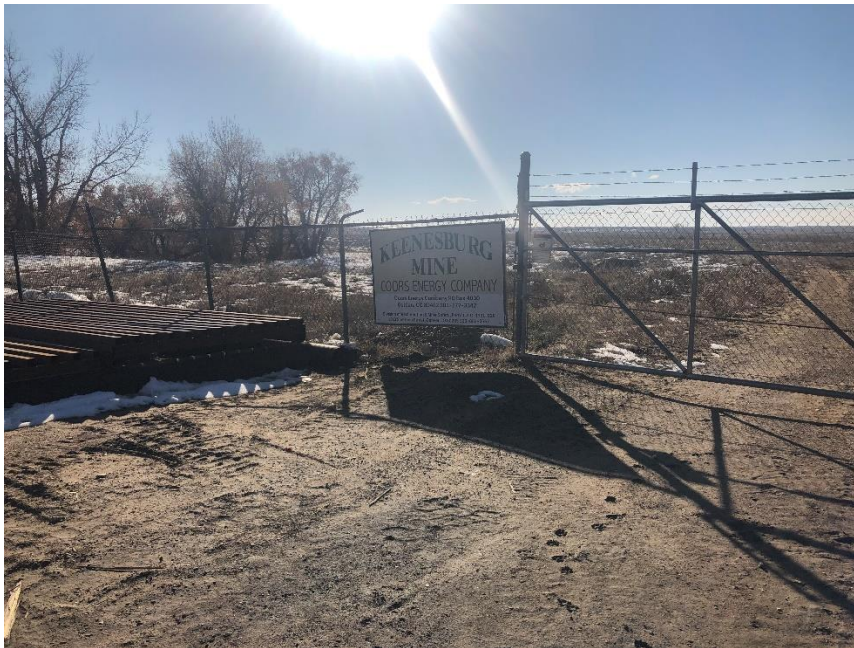
The entrance sign was in place and contained the necessary information. Boundary markers were observed at the southeast corner of the site.

Entrance sign

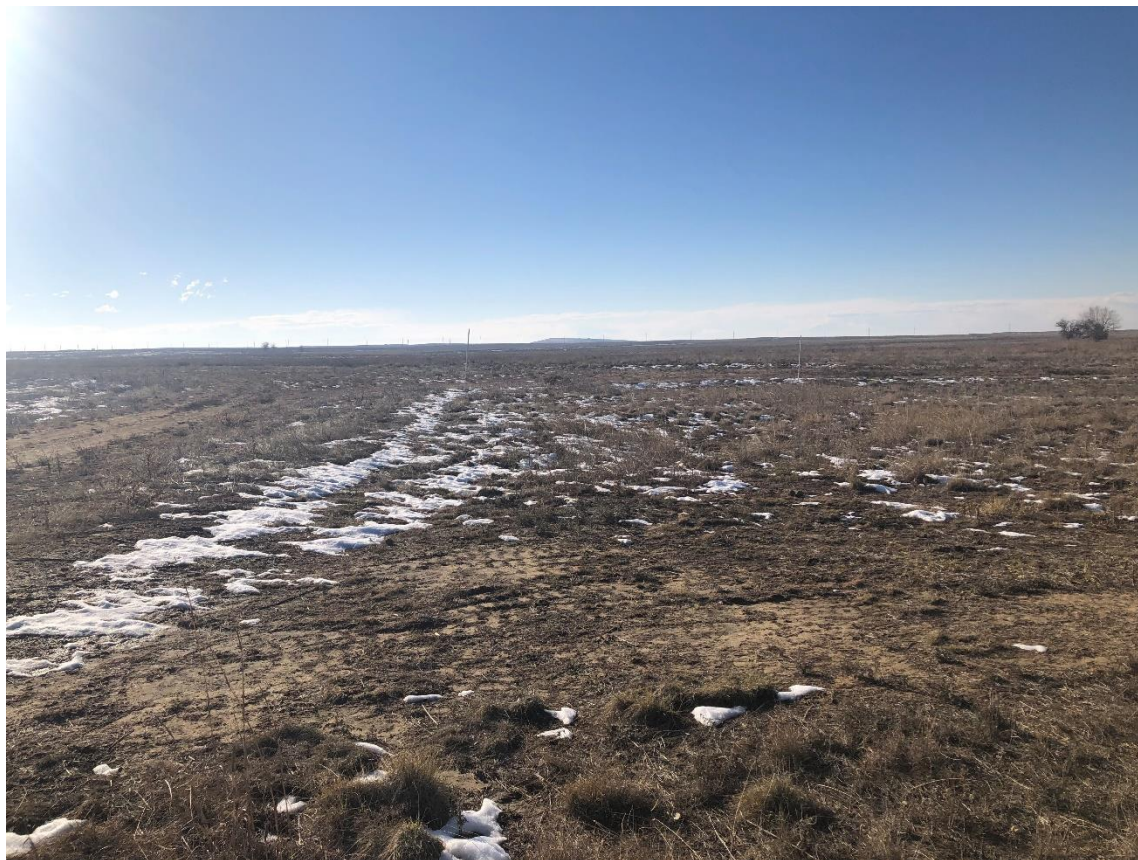
Area west of entrance gate
