Tomassuk Natural Resources LLC

JOKER PLACER PROJECT, FILE NO. P-2024-015, BADGER HOLE LLC, NOTICE OF INTENT TO CONDUCT EXPLORATION OPERATIONS, DEFECIENCY REVIEW NO. 2 ; December 9, 2024

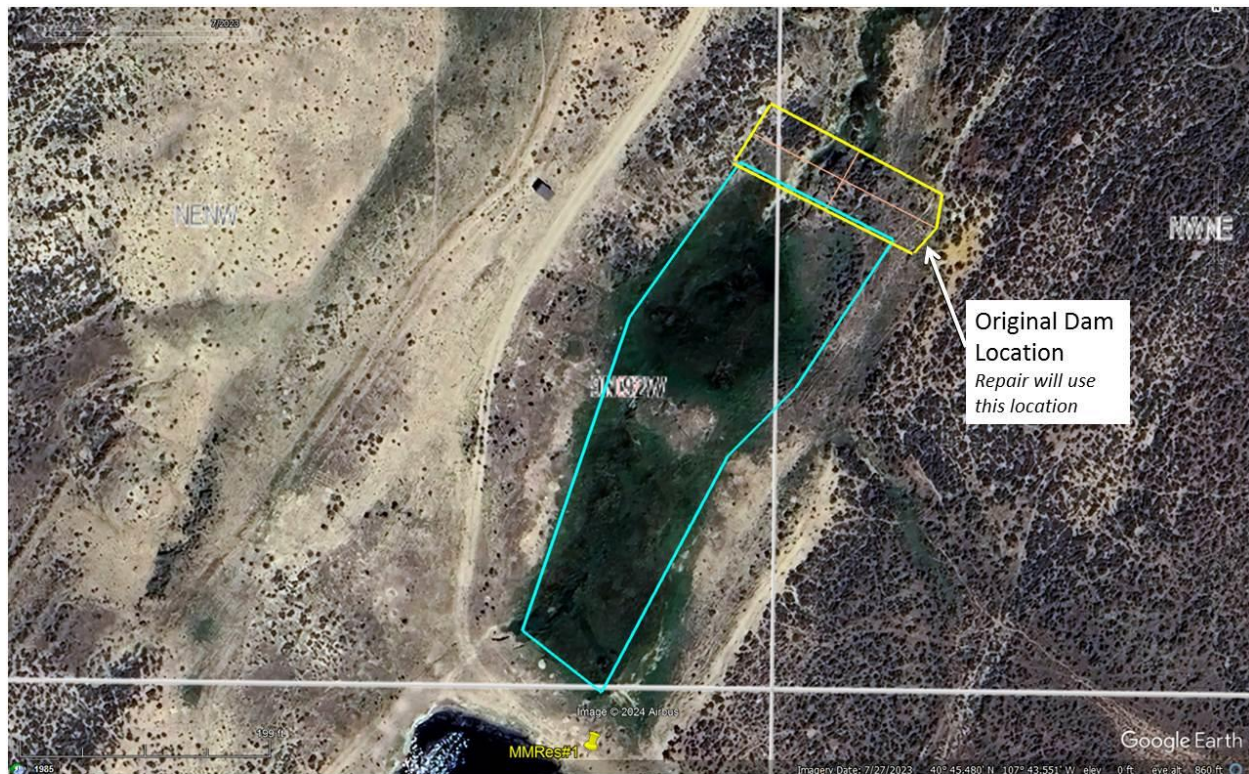
Minerals Mining Reservoir #2

Dam To be repaired

12' crest width, 2:1 sides = 52' width

160' length, 10' height

Center of dam 40° 45.506'N, 107° 43.515'W

Approx 3.82 ac-ft; max high water surface 1.1 ac

Immediately downstream from Pond 1 is the remains of Reservoir/Pond 2 and Dam (Minerals Mining Reservoir #2). This dam was breached several years ago. The general outline of the dam and pond location can be seen on Google Earth. An image of this is attached at the end of this letter.

The dam will be repaired, following good practice. If any maintenance is needed for the pond area, it will be addressed – however there is little that needs to be reconstructed as it is mainly the dried remnant of the original pond. As you can see from the satellite image, the main pond is downstream. A shallower part of the pond is on the upstream end, and will be used as a settling pond when needed. We do not anticipate large discharge into this settling pond due to the planned use of a “Jadair” Settling and Clarifying System, to be installed when processing and water use demands require. Any sediment that is released into this upstream part of the pond could be removed for reclamation, or could act as the actual reclamation and reseeded if required for this part of the pond.

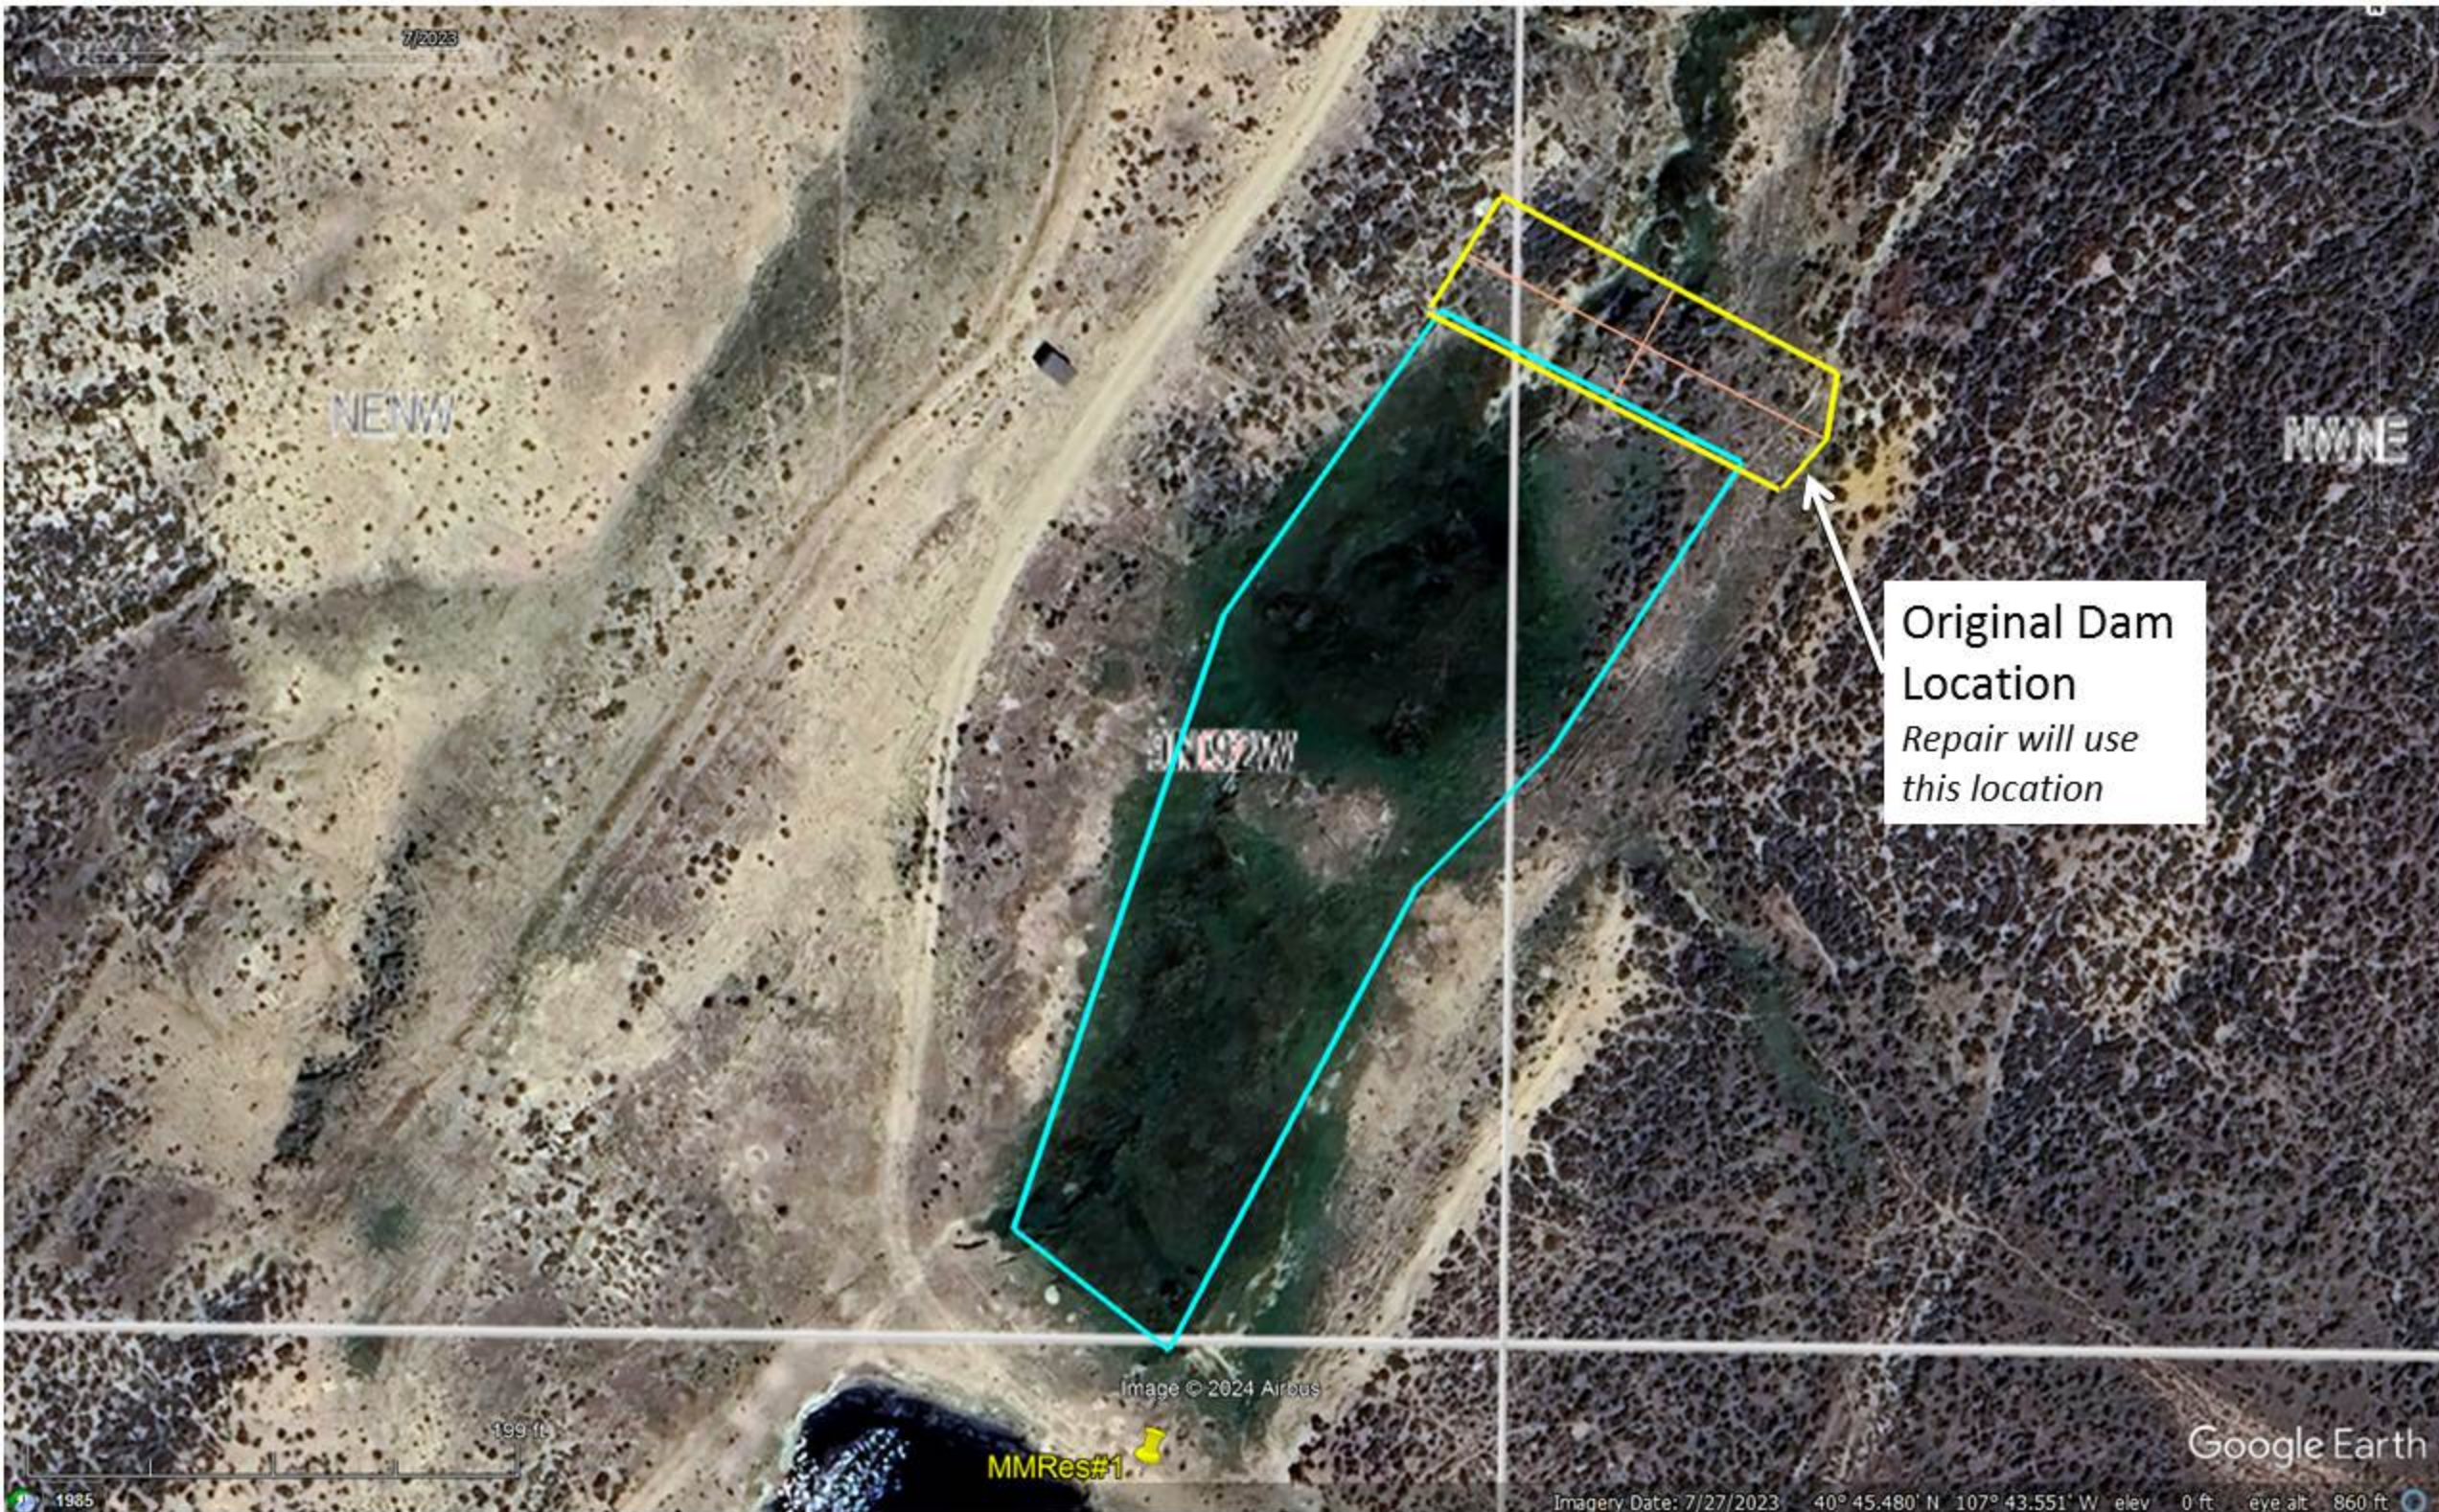
Minerals Mining Reservoir #2

Dam To be repaired

12' crest width, 2:1 sides = 52' width

160' length, 10' height

Center of dam 40° 45.506'N, 107° 43.515'W

Approx 3.82 ac-ft; max high water surface 1.1 ac
