U.S. DEPT. OF THE INTERIOR OFFICE OF SURFACE MINING

Mine Site Evaluation State Program

Denver Field Branch Mine Site Evaluation Narrative

Permittee: Twentymile Coal, LLC
Operator: Twentymile Coal, LLC
Site: Foidel Creek Mine

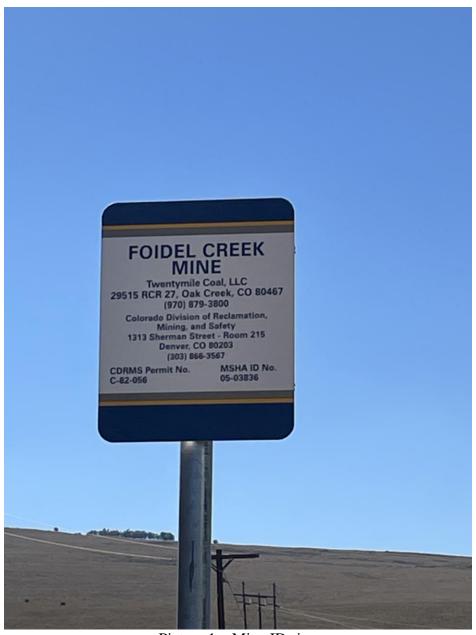
Picture 1 – Mine ID sign

The mine ID sign was in place at the main entrance and entrances to outlying facilities along CR27. The sign contained the information required by Rule (picture 1).

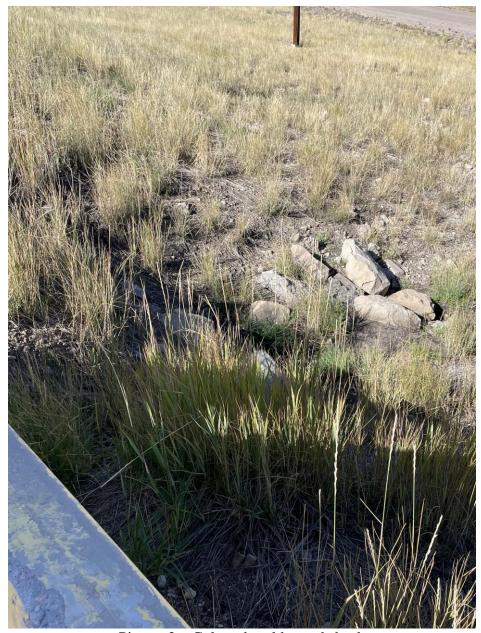
Picture 2 – Culvert by old guard shack

The culvert by the old guard shack that reports to Pond E is not shown on Map 24. The map needs to be updated to include this. The culvert was clear and in good condition (picture 2).

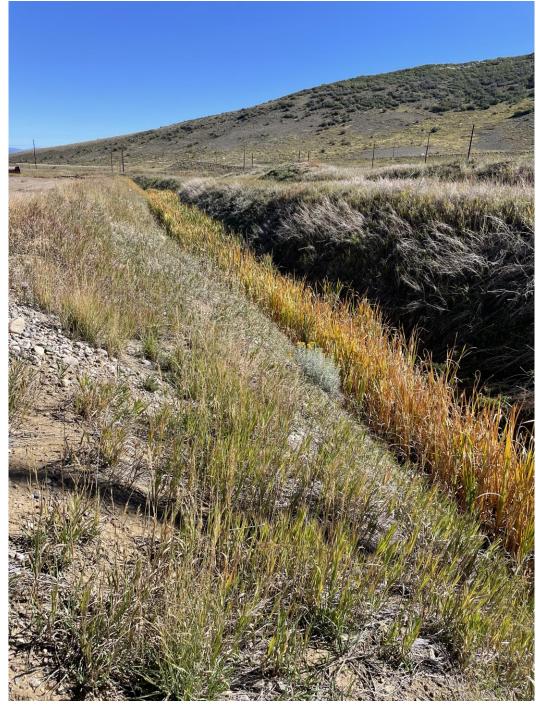
Picture 3 – Ditch G4

Ditch G4 flows into Pond G. The ditch was stable and well vegetated at the time of the inspection. No erosional problems were noted (picture 3).

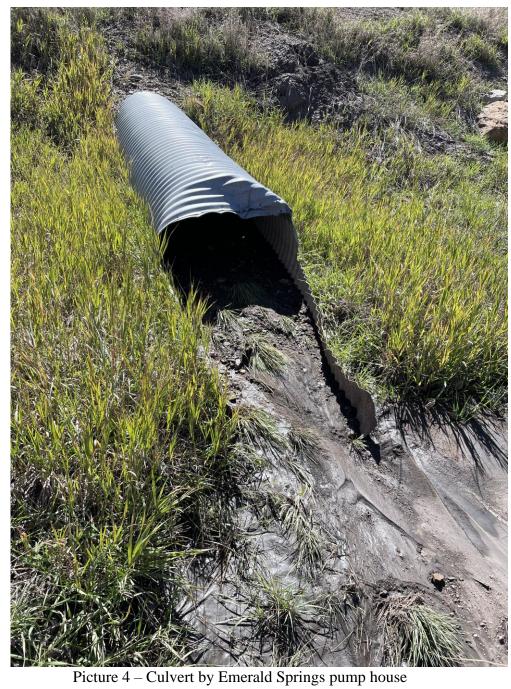
There is a culvert by the Emerald Springs Pump House that flows into Pond F that needs to be cleaned and repaired (picture 4).

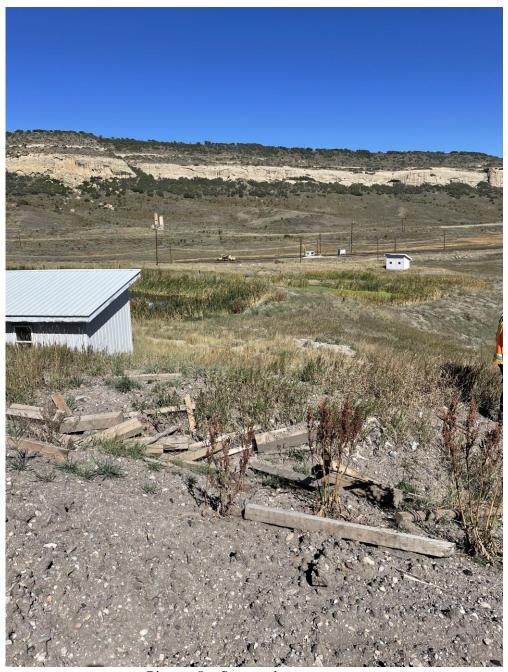
Picture 5 – Sewage lagoons

The sewage lagoons were stable and no problems were noted at the time of the inspection (picture 5).

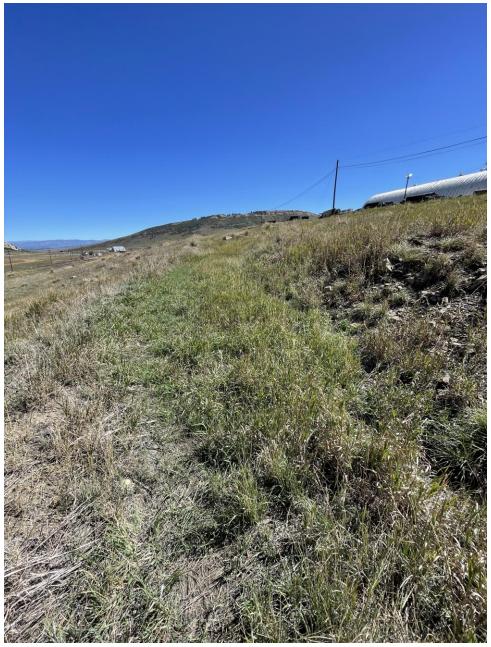
Picture 6 – Lower portion of ditch around welding shop

The perimeter ditch around the welding shop flows to Pond E. The ditch was well vegetated and stable and no erosional problems were noted at the time of the inspection. The lower portion of the ditch does need to be redefined (picture 6).

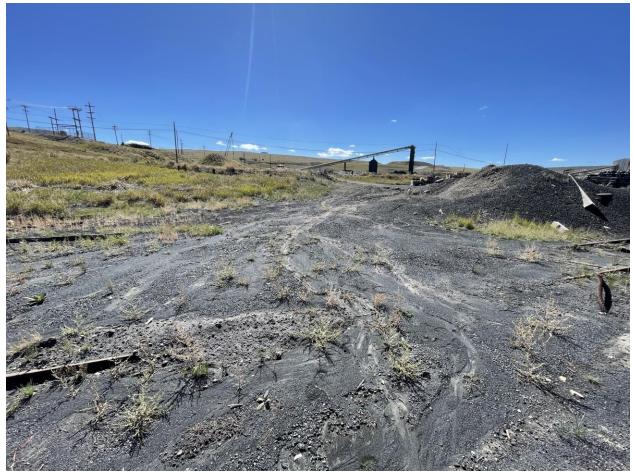
Picture 7 – Stoker loadout/storage area

There were signs of water flowing from the stoker coal loadout and storage area to the rail tracks (approximately 150 feet down the tracks). This area needs to be reconstructed and a berm needs to be installed to route the water to the west and Pond E. The material that has flowed here needs to be cleaned and removed from the tracks and surrounding area (pictures 7 and 8).

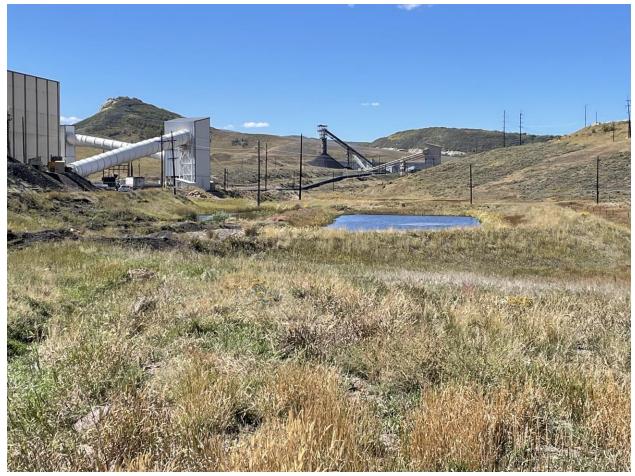
Picture 9 – Pond E

Pond E was full at the time of the inspection. The pond embankment was stable and well vegetated and there were no signs of erosion (picture 9). The south cell of the pond needs to be cleaned (picture 10).

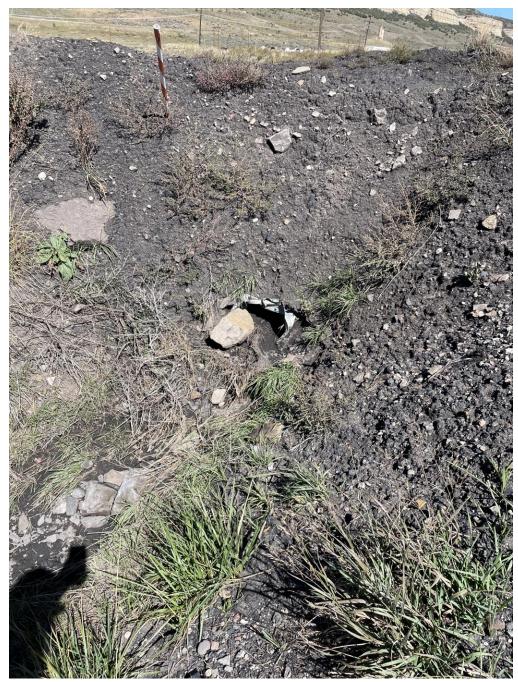
Picture 11 – Culvert from ditch E

The culvert from ditch E to Pond E needs to be cleaned and repaired (picture 11).

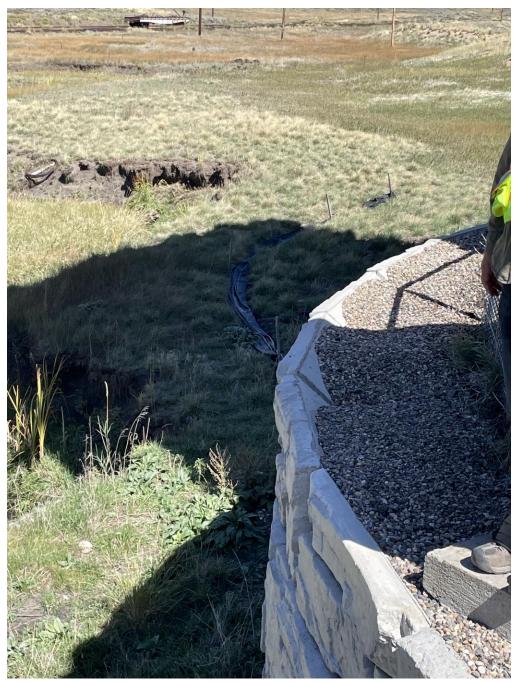
Picture 12 – Silt fence at stoker coal loadout

There is silt fence at (below) the stoker coal loadout that is down. This fence needs to be repaired or removed if no longer needed. The area is well vegetated and stable and no erosion or sediment problems were noted (picture 12).

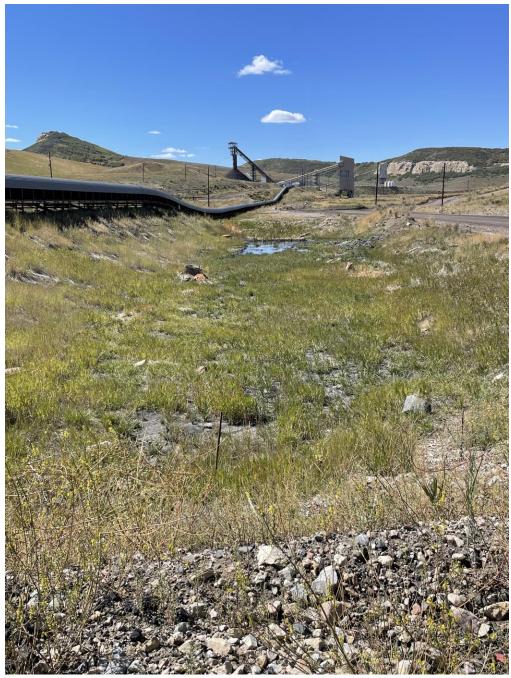
Picture 13 – SEA west of wash plant

The SAE by the belt line west of the wash plant contained water. The SAE was stable and appeared to be functioning as designed (picture 13).

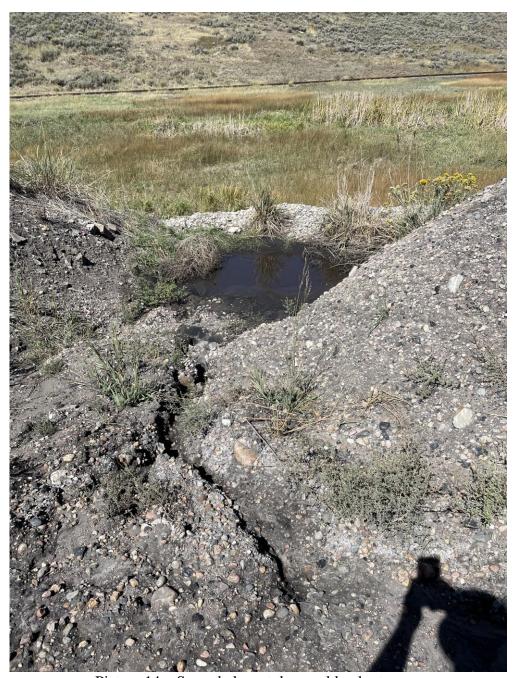
Picture 14 – Sump below stoker coal loadout

The sump below the stoker loadout on the north side needs to be cleaned out. There is some erosion at the inlet that needs to be monitored (picture 14).

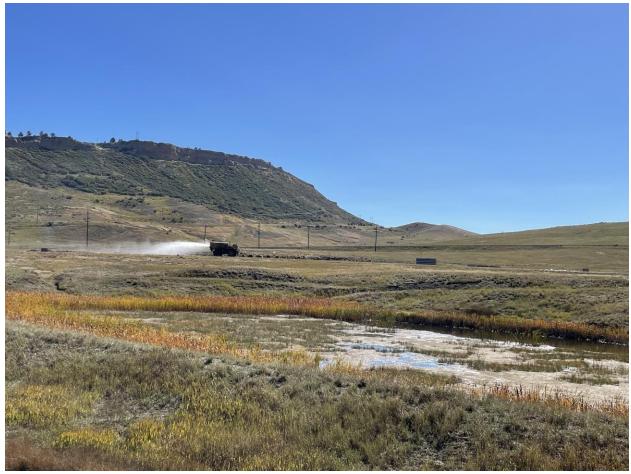
Picture 15 – Actively watering roads

The operator was actively watering the roads around the facilities area at the time of the inspection (picture 15).

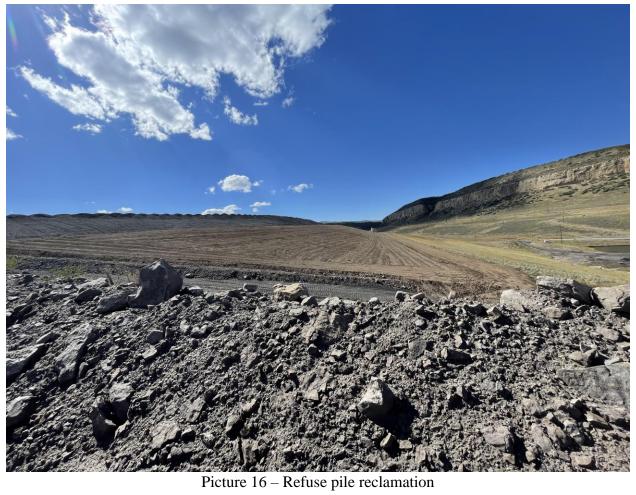
The recently reclaimed pile outslopes were stable. Subsoil and topsoil has been replaced and the area is ready for seeding (picture 16).
