Subject: Summary of Instrumentation Monitoring

4th Quarter 2024

Bowie Coal Waste Disposal Area No. 3

Paonia, Colorado

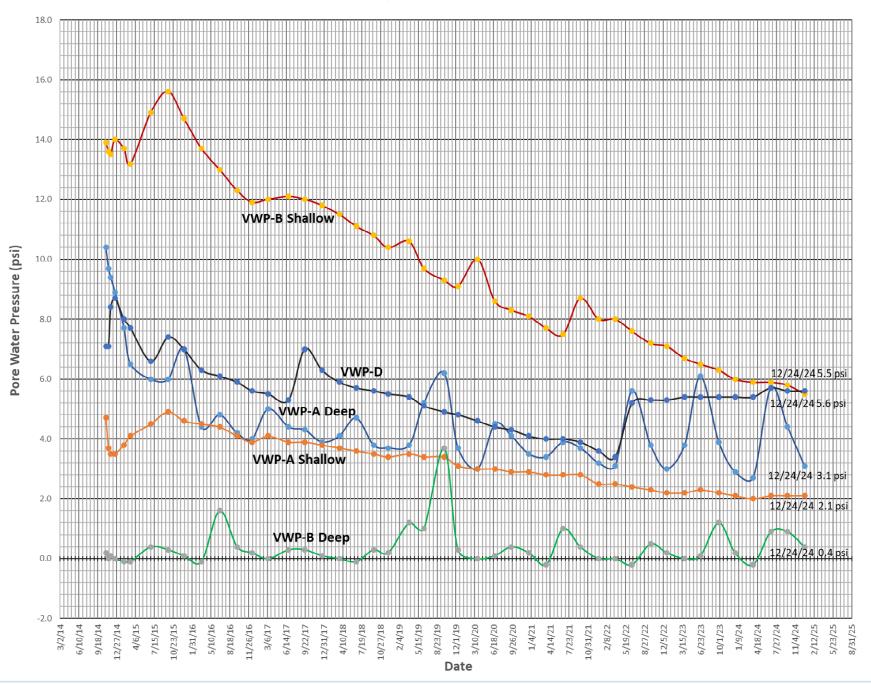
Figure 1 - Bowie Mine #2 - CWDA #3 Vibrating Wire Piezometer Data

We present a graph of measured pore pressures on the attached Figure 1 and numerically in Table 1 below. Table 1 is a summary of the initial, last year, last quarter, and current readings. In addition, we present the difference between the current pore pressures and those at the time of installation, the previous year, and the previous quarter.

As seen on Figure 1 and Table 1, when compared with the previous quarter, one VWP (VWP-A Deep) decreased a relatively large amount of -1.3 psi, two decreased slightly by -0.3 and -0.5 psi (VWP-B Shallow and VWP-B Deep), and two (VWP-A Shallow and VWP Deep) had no change in pore pressure. When compared with the 4th quarter of last year, three VWP's increased +0.2 psi, one decreased -0.5 psi, and one had no change in pore pressure. Since installation in 2014, five VWP's have generally decreased in pore pressure (by -1.5 to -8.4 psi), while VWP-B Deep has increased 0.2 psi in pore pressure. Although there is a general trend of decreasing pore pressure since installation, two piezometers (VWP-A Deep and VWP-B Deep) exhibit seasonal fluctuations in pore pressure since 2019 that roughly mirror each other. Also, VWP-D had a general decline in pore pressures through much of its history until the second quarter of 2022 when pore pressures rose and then have stayed at a similar elevated level since then.
