RE: Bowie No. 1 Mine
Permit No. C-1981-038
2024 Annual Reclamation Report

Annual Reclamation Report for Calendar Year – 2024

BOWIE RESOURCES LIMITED
BOWIE NO. 1 MINE
2024 ANNUAL RECLAMATION REPORT
PERMIT NO. C-81-038

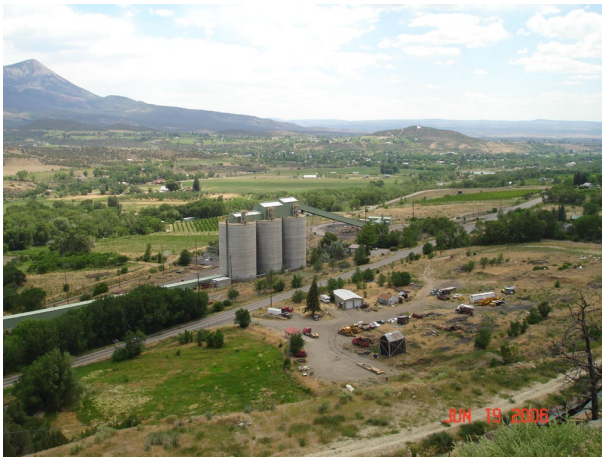
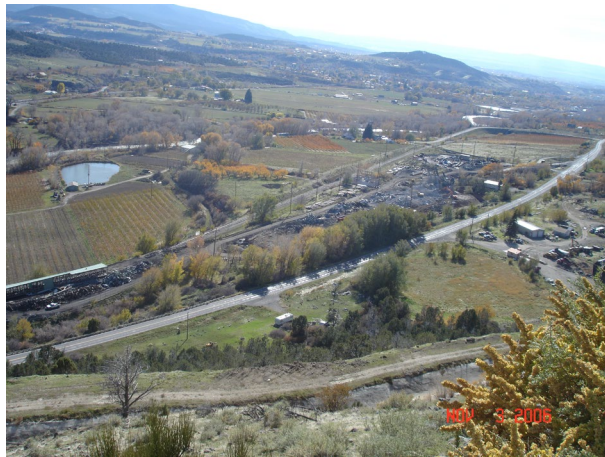
Bowie Resources LLC began partial reclamation of the Bowie No. 1 Mine Loadout facilities. The partial reclamation project consisted of demolition of the following structures:

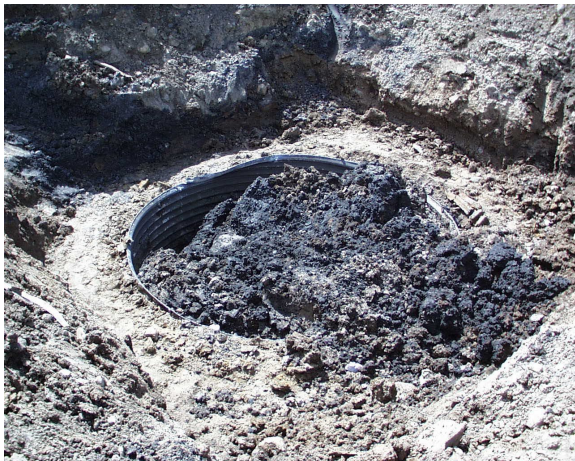
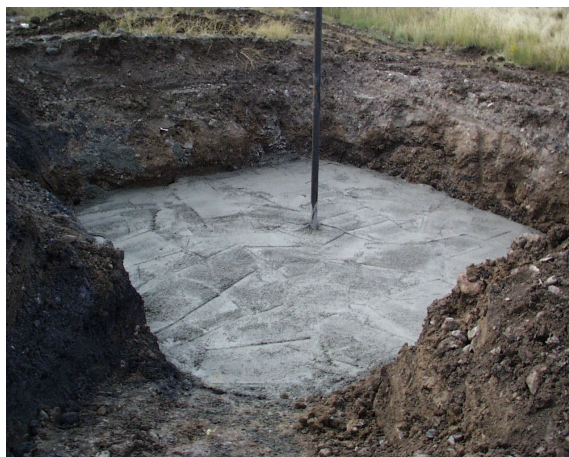
During the reporting period of 2003, Bowie Resources completed sealing the Bowie 1 West Mine ventilation shaft. A 12-inch concrete cap with steel reinforcement, extending 2 feet beyond the shaft liner was completed in September of this year. This included one 4-inch vent pipe as required and backfilling. The following photographs are of the shaft-sealing project.
