## Inspection report for Bowie #2, February 2025

# **PERMIT INFORMATION**

Permit Number: C-1996-083 Mine Name: Bowie No. 2 Mine Operator: Bowie Resources, LLC Operator Address: Mr. Basil Bear P.O. Box 1488 Paonia, CO 81428	County: Delta Operation Type: Underground Permit Status: Active Ownership: Private  Operator Representative Present: None			
Operator Representative Signature: (Field Issuance Only)

Inspection Start Date: February 20, 2025 Inspection Start Time: 07:45 Inspection End Date: February 20, 2025 Inspection End Time: 09:45			Inspection Type: Coal Complete Inspection Inspection Reason: Normal I&E Program Weather: Cloudy	
Joint Inspection Agency:		Joint Inspection Contacts:		
None				
Post Inspection Agency:		Post Inspection Contacts:		
None				
Inspector(s):	Inspecto	r's Sig	nature:	Signature Date:
Robert Zuber, P.E.	Phot D. The			
				2/26/2025

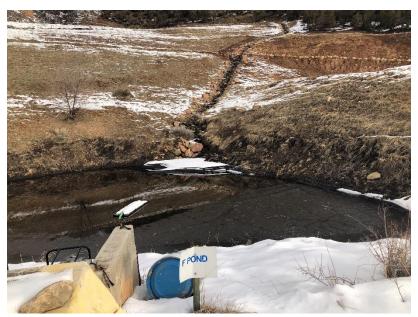
Four sediment ponds were inspected: B, F, J, and K. None of the ponds was close to discharging, but three of them contained significant volumes of water. Pond K was the exception; it was nearly dry. No significant problems were identified with embankments, spillways, inlet channels, or other features of the ponds.

Pond F with significant sediment recently deposited

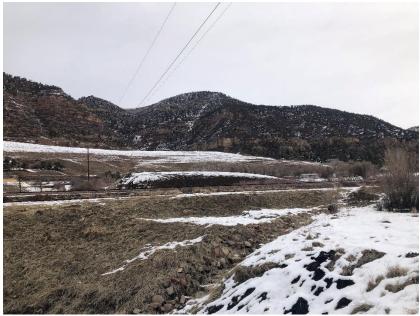
Gob Piles 1, 2, 3, and 4 appeared stable, and no significant erosion was observed. The overburden pile that is southeast of Gob Pile #2 has been reduced to a small amount of material, as most of it has been spread on this pile. A berm below the remaining pile appears to be functioning to prevent the material from being transported by runoff.

East portion of Gob Piles 1, 2, and 4 (from Pond J)

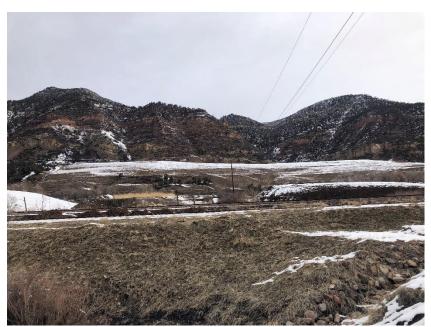
West portion of Gob Piles 1, 2, and 4 (from Pond J)

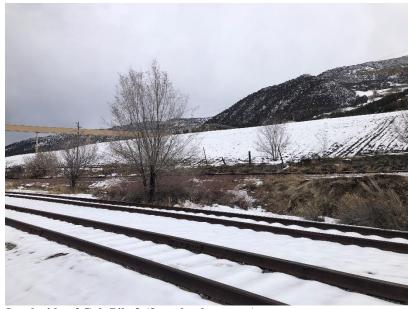
South side of Gob Pile 3 (from loadout area)

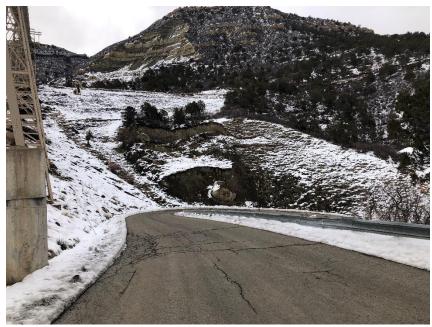
**Curve 10 Slide**

The road to the portals was in adequate condition. The slopes adjacent to this road are generally stable, except for the slide at Curve 10 (see Slides and Other Damage section).

No problems were seen on the slopes above and below the benches. The slides above the B Portal Bench and Curve 11 (noted in the past) look stable. The slide above Curve Number 10 also looked stable, compared to photographs taken in recent months.

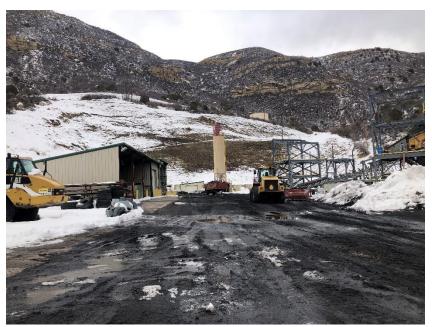
- Utility Bench
- D Portal Bench
- The B Portal Bench
- Material storage area beside Topsoil Stockpile A
- Conveyor corridors
- The Coal Stockpile Pad
- The area around the office
- The Preparation Plant and nearby water tank
- Pump House and Filter Building
- Old power plant
- The Unit Train Loadout

D Portal Bench and slope below Utility Bench

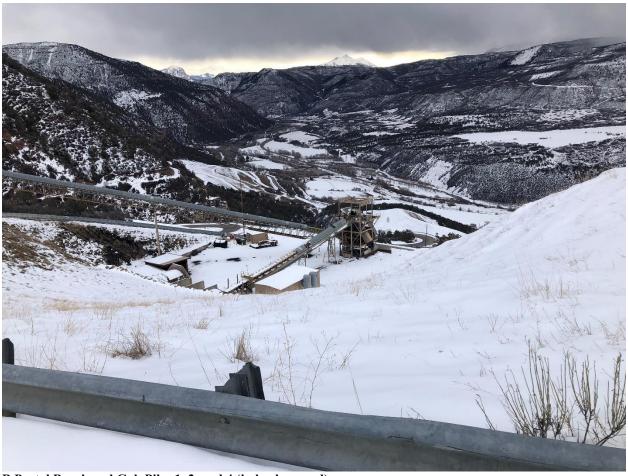
B Portal Bench and Gob Piles 1, 2, and 4 (in background)
