MINERALS PROGRAM INSPECTION REPORT

MINE NAME: Coaldale Quarry	MINE/PROSPECTING ID#: M-1977-247	MINERAL: Anhydrite, gypsum	COUNTY: Fremont
INSPECTION TYPE: Monitoring	WEATHER: Clear	INSP. DATE: January 29, 2025	INSP. TIME: 08:30
OPERATOR: Holcim (US) Inc.	OPERATOR REPRESENTATIVE: Mr. Josh Pierce & Mr. Eddy Senecal	TYPE OF OPERATION: 112c - Construction Regular Operation

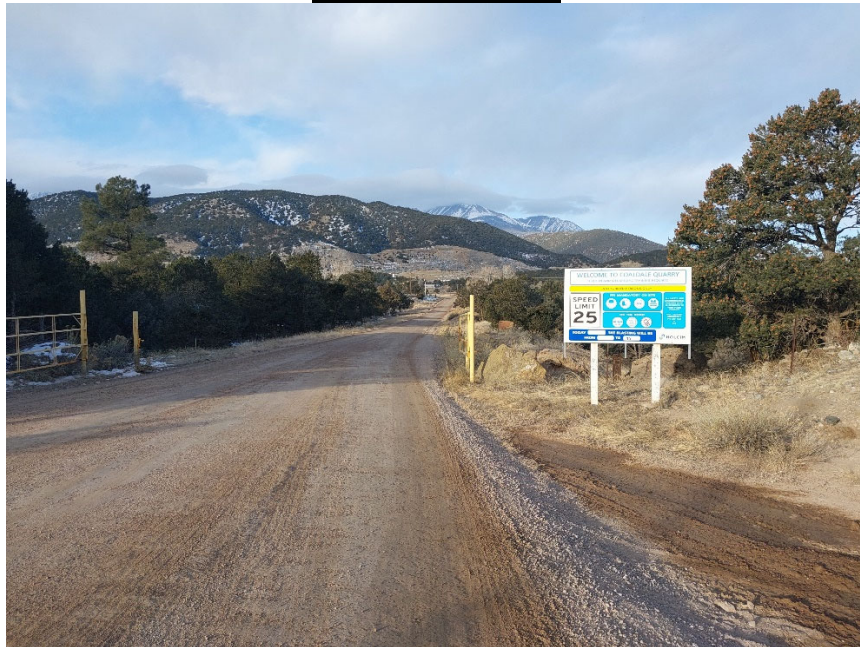
The mine site sign is not in compliance with Rule 3.1.12(1) as it was missing the MLRB permit number, see Photo #1. This is cited as a problem, see Problem #3 above for information about the corrective action(s) required. Permit boundary markers were in place and marked with white PVC tubes placed over t-post, see Photo #2.

Photo #1: Mine sign located on the north side of the entrance road, the operation name and operator's name are provided, but the MLRB permit number is not given. Entrance road is also seen to the left of the sign, looking west.

PROBLEM #3: The mine identification sign posted at the entrance of the mine site did not contain complete information required by Rule 3.1.12(1). The sign should contain the following information: the name of the Operator, a statement that a reclamation permit for the operation has been issued by the Colorado Mined Land Reclamation Board; and the permit number. The mine identification sign posted did not have a statement that a reclamation permit for the operation has been issued by the Colorado Mined Land Board or the permit number.

CORRECTIVE ACTIONS: The operator shall, at the entrance of the mine site, post a sign which shall be clearly visible from the access road with the following: the name of the operator, a statement that a reclamation permit for the operation has been issued by the Colorado Mined Land Reclamation Board; and the permit number. The operator shall submit photo documentation that a proper sign has been posted by the corrective action date.

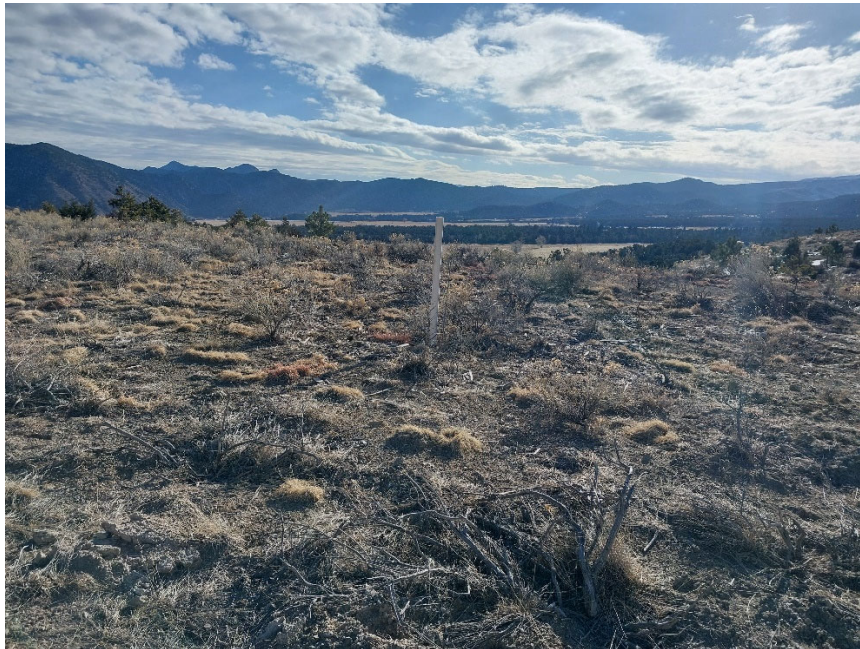
Photo #2: Example of a permit boundary marker, located east of the overburden and topsoil stockpile of the Quarry South area; looking east.

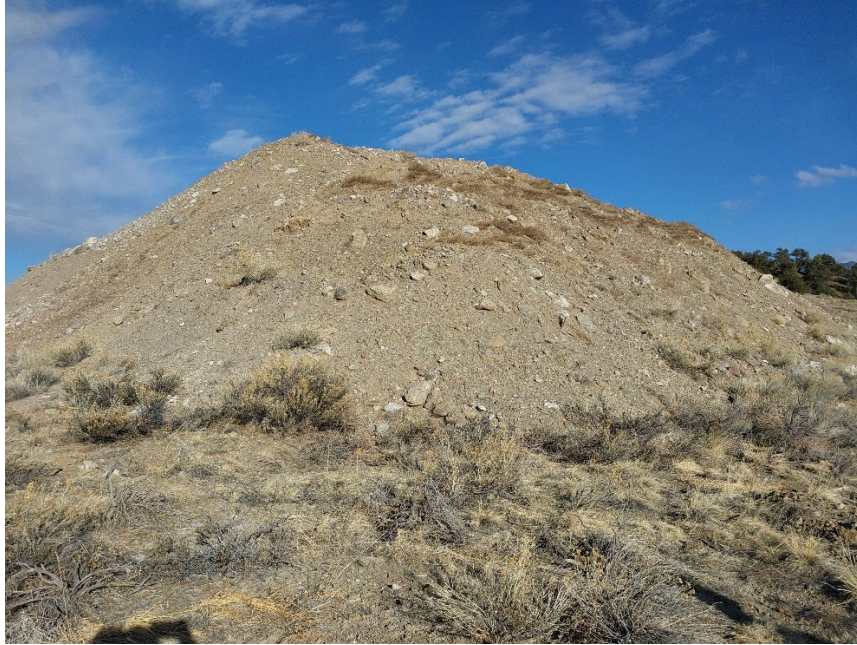
Photo #3: Topsoil stockpile for the Quarry South area, looking to the west.

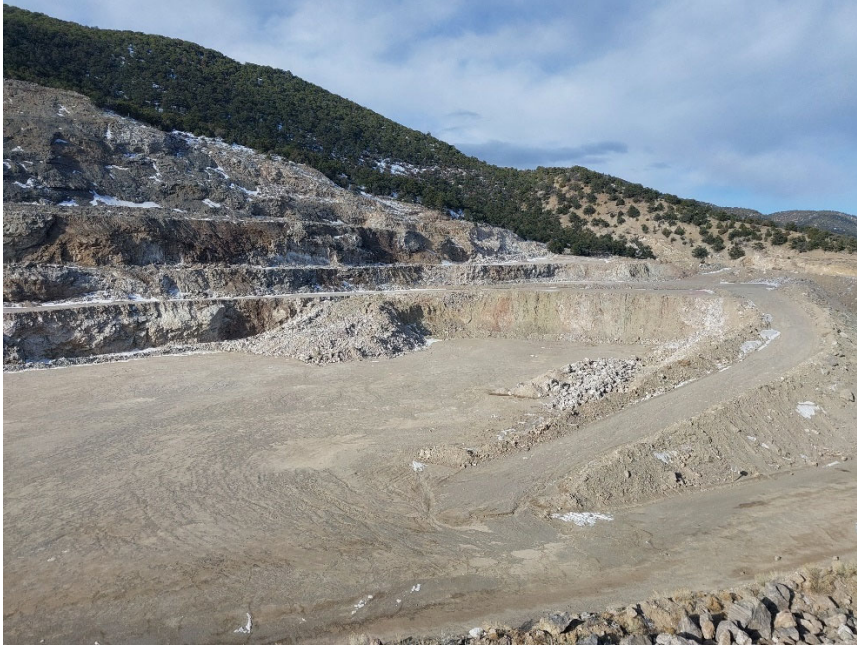
At the time of the inspection, Quarry North had three benches with each bench 30 feet or less in height. There was a pile of last season's blasted material observed at the foot of the highwall on the quarry floor in Quarry North and Quarry South; see Photos #4 and #5. At least two loads of processed materials had been loaded and hauled off site during the duration of the inspection.

Photo #4: Quarry North, blasted material is stockpiled at the foot of the highwall on the pit floor. The three benches can be seen. Looking west-northwest.

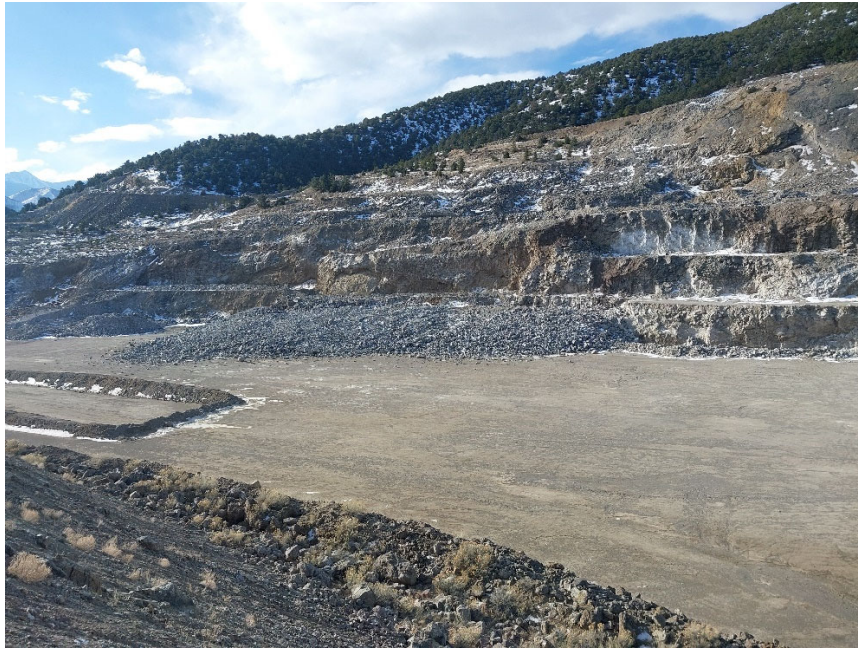
Photo #5: Quarry South, blasted material is at the foot of the highwall on the pit floor, looking to the southeast.

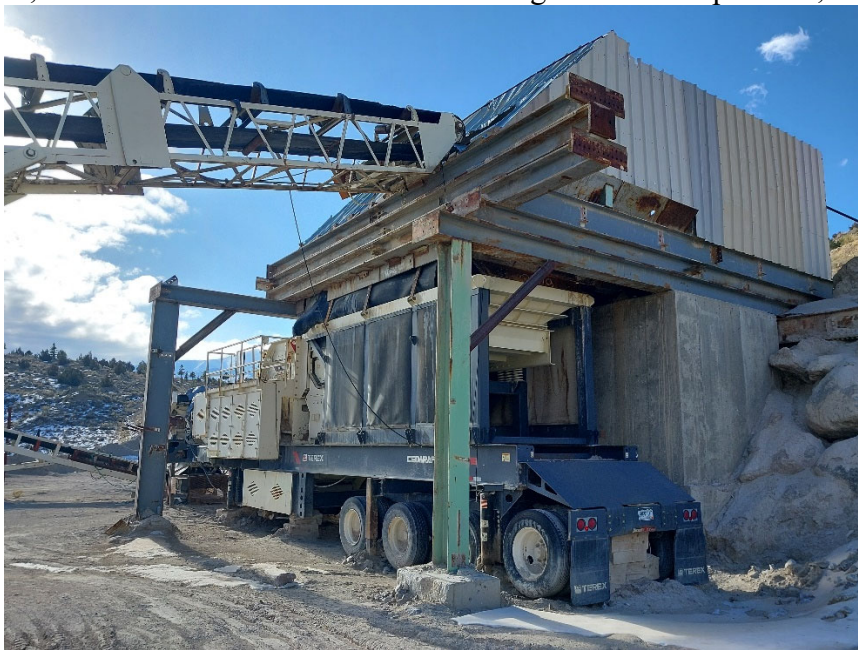
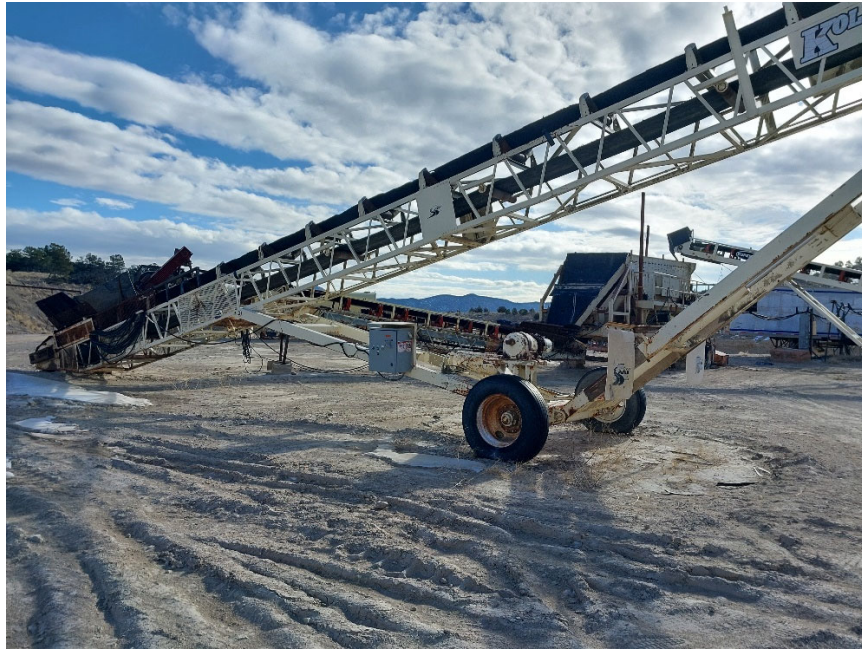
The processing facility, located in the central portion of the permitted area, appeared to be in good order. Processing was not occurring at the time of the inspection. The operation will start up processing again in March of 2025. There were no issues observed with the crushing and screening system setup. Water supplied for processing was sourced from a portable water tank, see Photos #6 - #8.

Photo #6: Processing facility.

Photo #7: Processing facility.

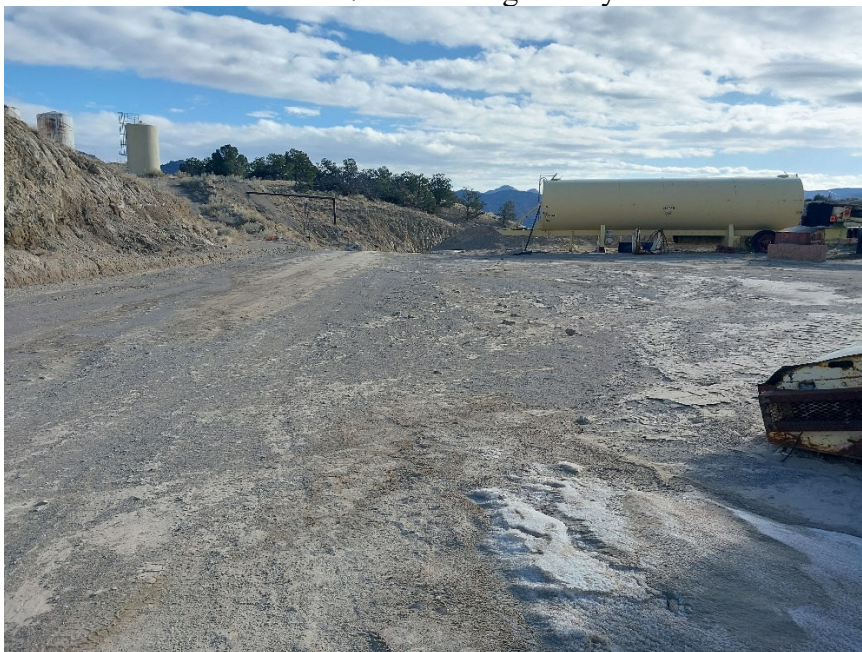
Photo #8: Portable water tank for the processing facility.

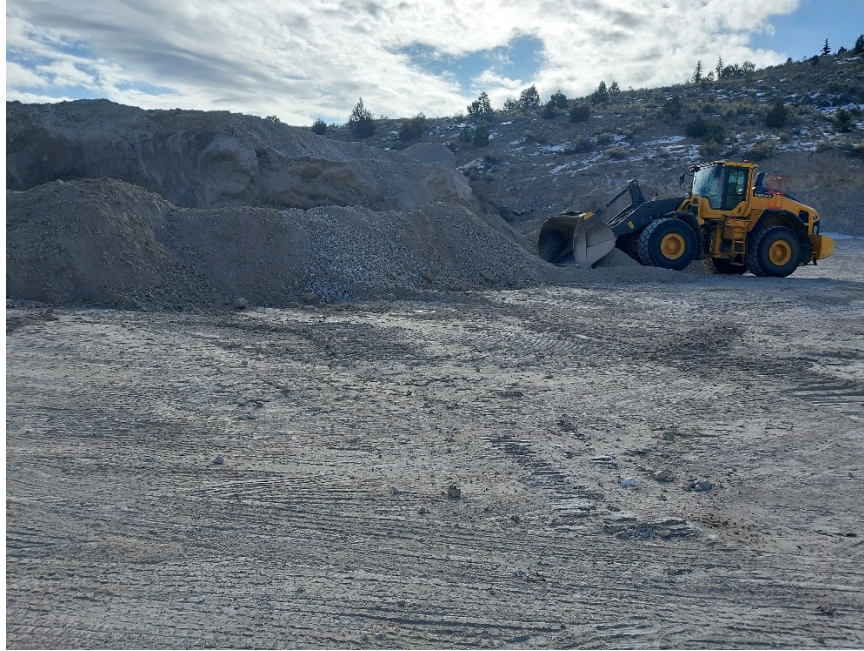
Photo #9: Product stockpile, tracks and freshly disturbance can be seen in the photo where material was loaded and hauled to the Portland Plant.

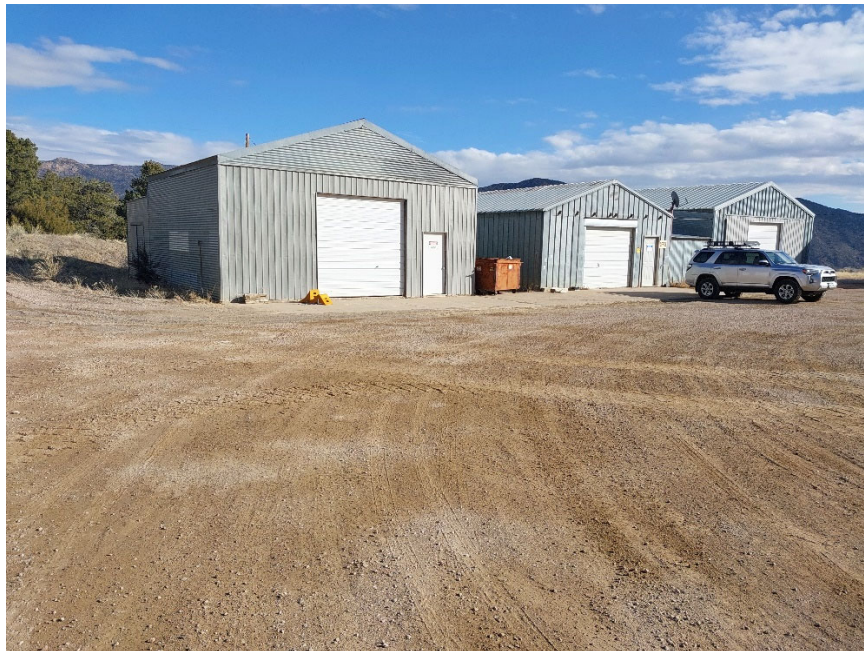
The mining plan utilizes drilling and blasting methods, with each blasting events going about 30 feet down. Blasted material is then transported to a portable crushing and screening system located in the central area of the permit area. Processed material are then loaded and hauled by a third party to the Portland Plant, also in Fremont County, about 55 miles east of the Coaldale Quarry. There are three buildings and shop area located on the east side of the permit area, see Photos #10 and #11.

Photo #10: The three buildings located on the east side of the permit area.

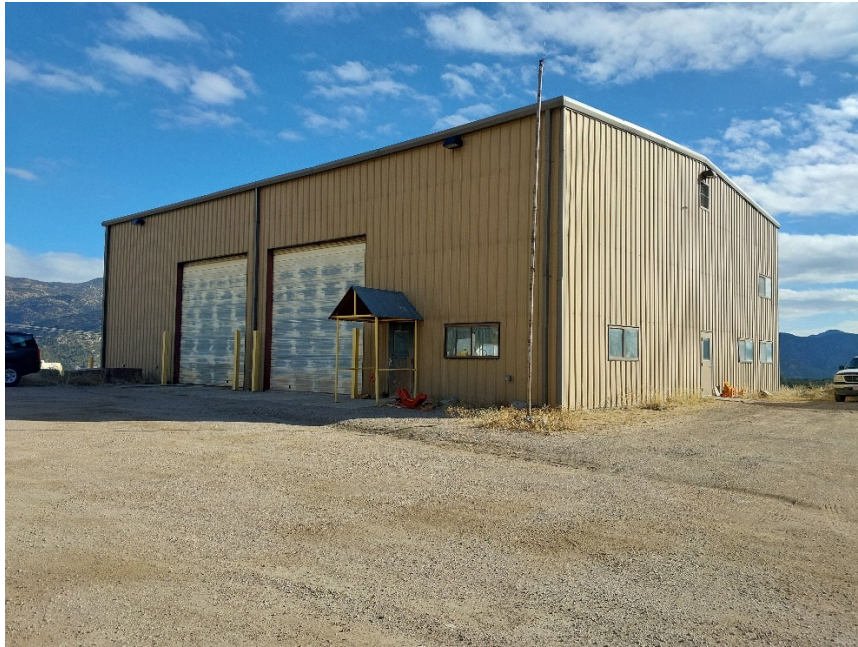
Photo #11: The shop located on the east side of the permit area.

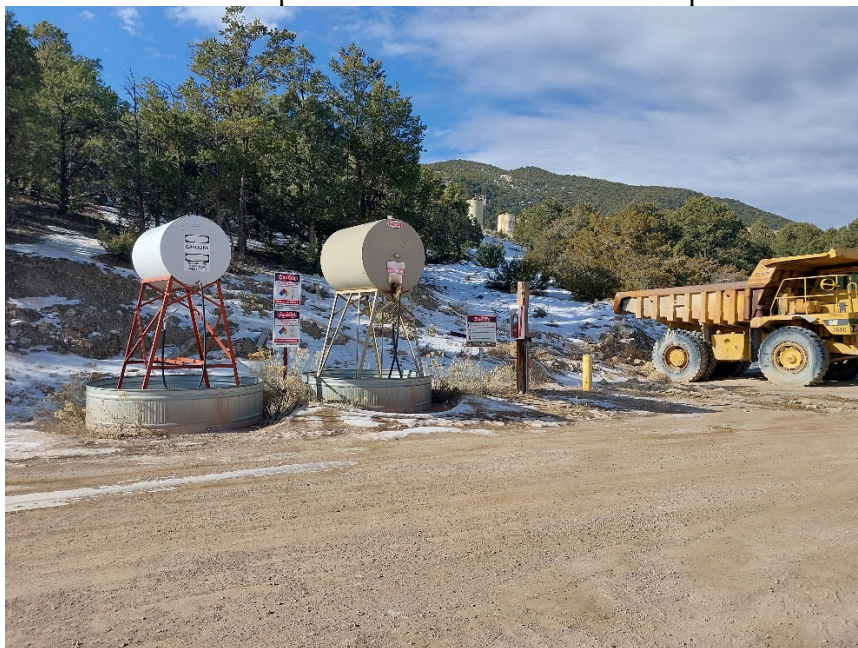
Fuel tanks with secondary containers were located near the building on the east side of the permit area, see Photo #12. There was also a fuel tank on a fifth wheel trailer stored on in the same area. According to Mr. Peirce and Mr. Senecal, the fuel tank was brought in by a third-party contractor. A pump system with a gauge and fuel/water separator is installed on the fuel tank and a five-gallon bucket placed at the foot of the post for the nozzle, assumed to be used to catch any dripping fuel. The pump system was leaking in several areas, primarily the fuel separator and the nozzle attachment. The ground around the area has been affected and the spill needs to be cleaned up and the leaks addressed, see Photos #13 and #14. This is cited as a problem, see Problem #1 above for details on the corrective action(s) required.

Photo #12: Fuel tanks with secondary storage.

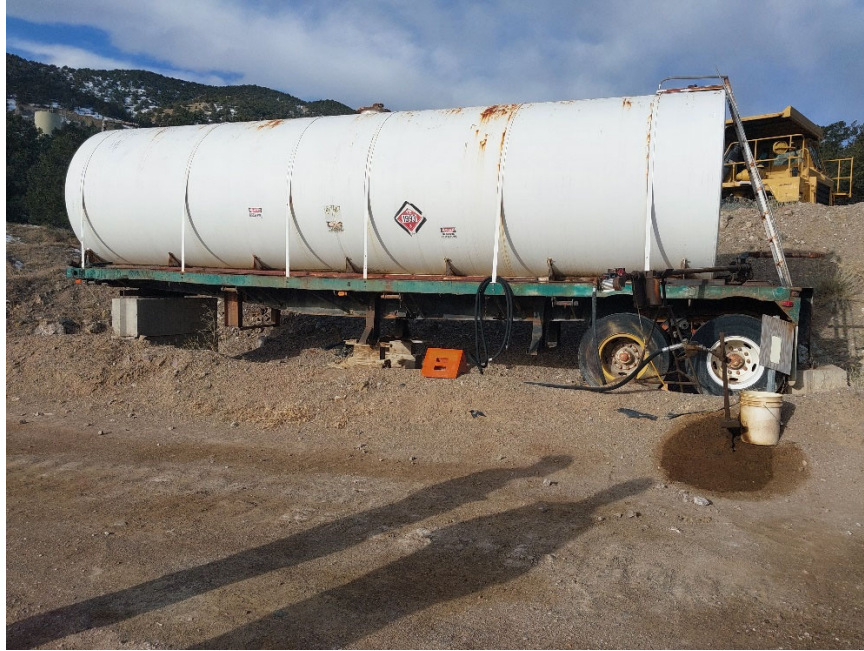
PROBLEM #1: A fuel leak/spill has occurred at the site which has impacted soils.

Photo #13: The portable fuel tank, the pump system and the post for the nozzle can be seen. At the base of the 5-gallon bucket, the discoloration of the ground indicates that the leak has been ongoing for some time and has spread.

CORRECTIVE ACTIONS: The operator shall immediately remediate the spill and submit a final report to the Division containing at least the following information:

- 1.) A description of how the spill was cleaned up containing at a minimum - the appropriate maps, volumes removed, sample locations, analytical data, and photo documentation.
- 2.) Evidence in the form of a receipt that the contaminated soil was disposed of by an approved method (such as sent to an approved landfill, land farming, recycling center, etc.).

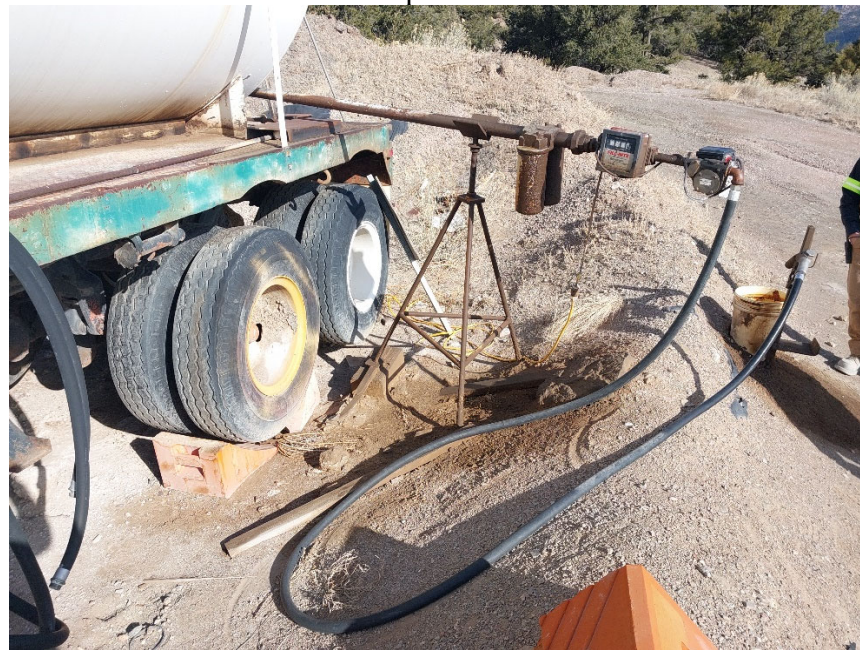
Photo #14: A closer look at the pump system on the fuel tank. The leak from the fuel/water separator can be seen on the separator and the ground below.
