Subject: Summary of Instrumentation Monitoring
1st Quarter 2025
Bowie Coal Waste Disposal Area No. 3
Paonia, Colorado

**SUBJECT: Summary Report, 1st Quarter 2025, Vibrating Wire Piezometers
January – March 2025, Bowie Mine #2
Coal Waste Disposal Area (CWDA) #3**

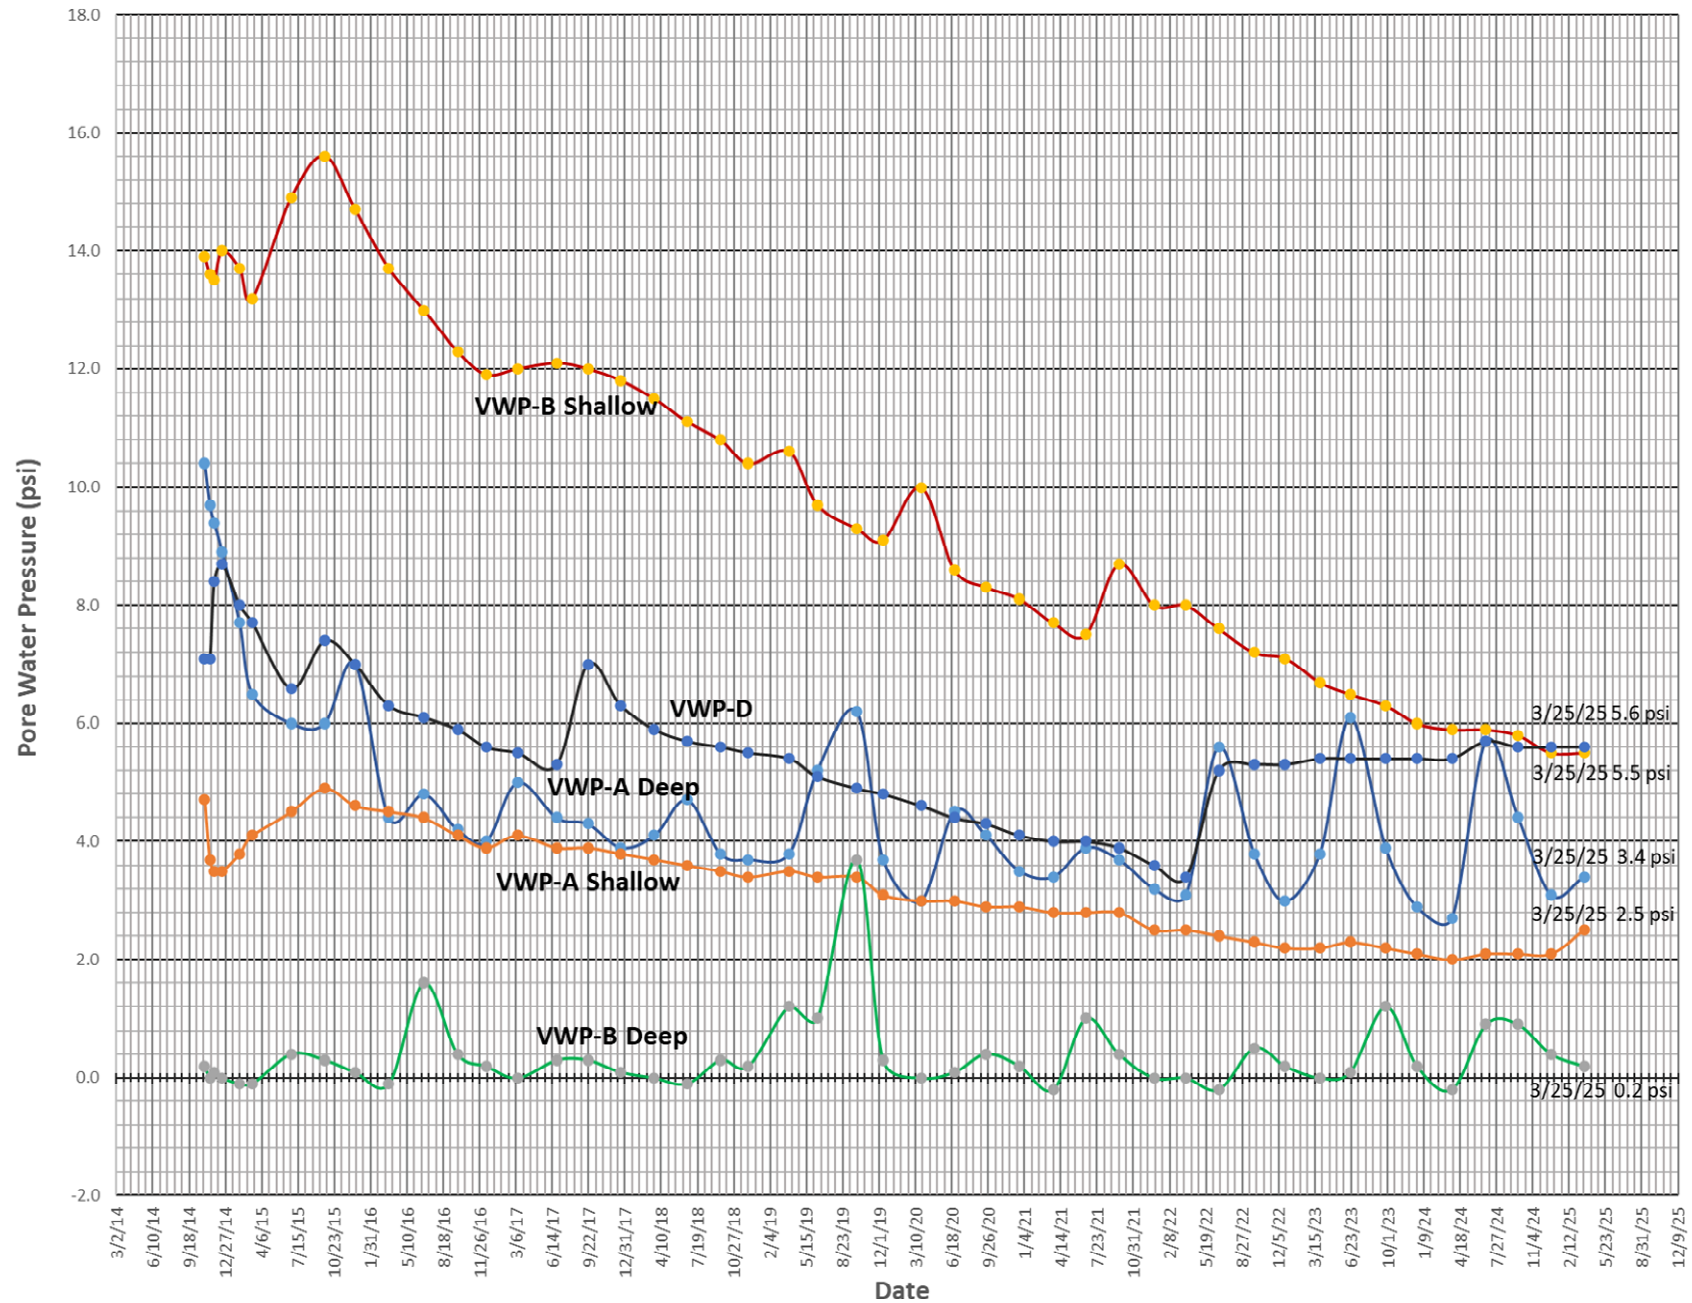
Figure 1 - Bowie Mine #2 - CWDA #3
Vibrating Wire Piezometer Data

We present a graph of measured pore pressures on the attached Figure 1 and numerically in Table 1 below. Table 1 is a summary of the initial, last year, last quarter, and current readings. In addition, we present the difference between the current pore pressures and those at the time of installation, the previous year, and the previous quarter.

As seen on Figure 1 and Table 1, when compared with the previous quarter, two VWP's (VWP-A Deep and VWP-A Shallow) increased 0.3 to 0.4 psi in pore pressure, one (VWP-B-Deep) decreased -0.2 psi, and two (VWP-B Shallow and VWP-D) had no change in pore pressure. When compared with the 1st quarter of last year, four VWP's increased 0.2 to 0.7 psi and one (VWP-B Shallow) decreased -0.4 psi in pore pressure. Since installation in 2014, four VWP's have generally decreased in pore pressure (by -2.2 to -8.4 psi), while one VWP (VWP-B-Deep) had no pressure difference. Although there is a general trend of decreasing pore pressure over time, two of the piezometers (VWP-A Deep and VWP-B-Deep) exhibit seasonal fluctuations in pore pressure since 2019 that roughly mirror each other. VWP-D had a general decline in pore pressures through much of its history until the second quarter of 2022 when pore pressures rose and then have stayed roughly the same elevated level since then.
