Re: Bowie No. 1 Mine  
Permit C-1981-038,  
ARR Adequacy response #1

RE: Bowie No. 1 Mine  
Permit No. C-1981-038  
2024 Annual Reclamation Report

Annual Reclamation Report for Calendar Year – 2024

BOWIE RESOURCES LIMITED  
BOWIE NO. 1 MINE  
2024 ANNUAL RECLAMATION REPORT  
PERMIT NO. C-81-038

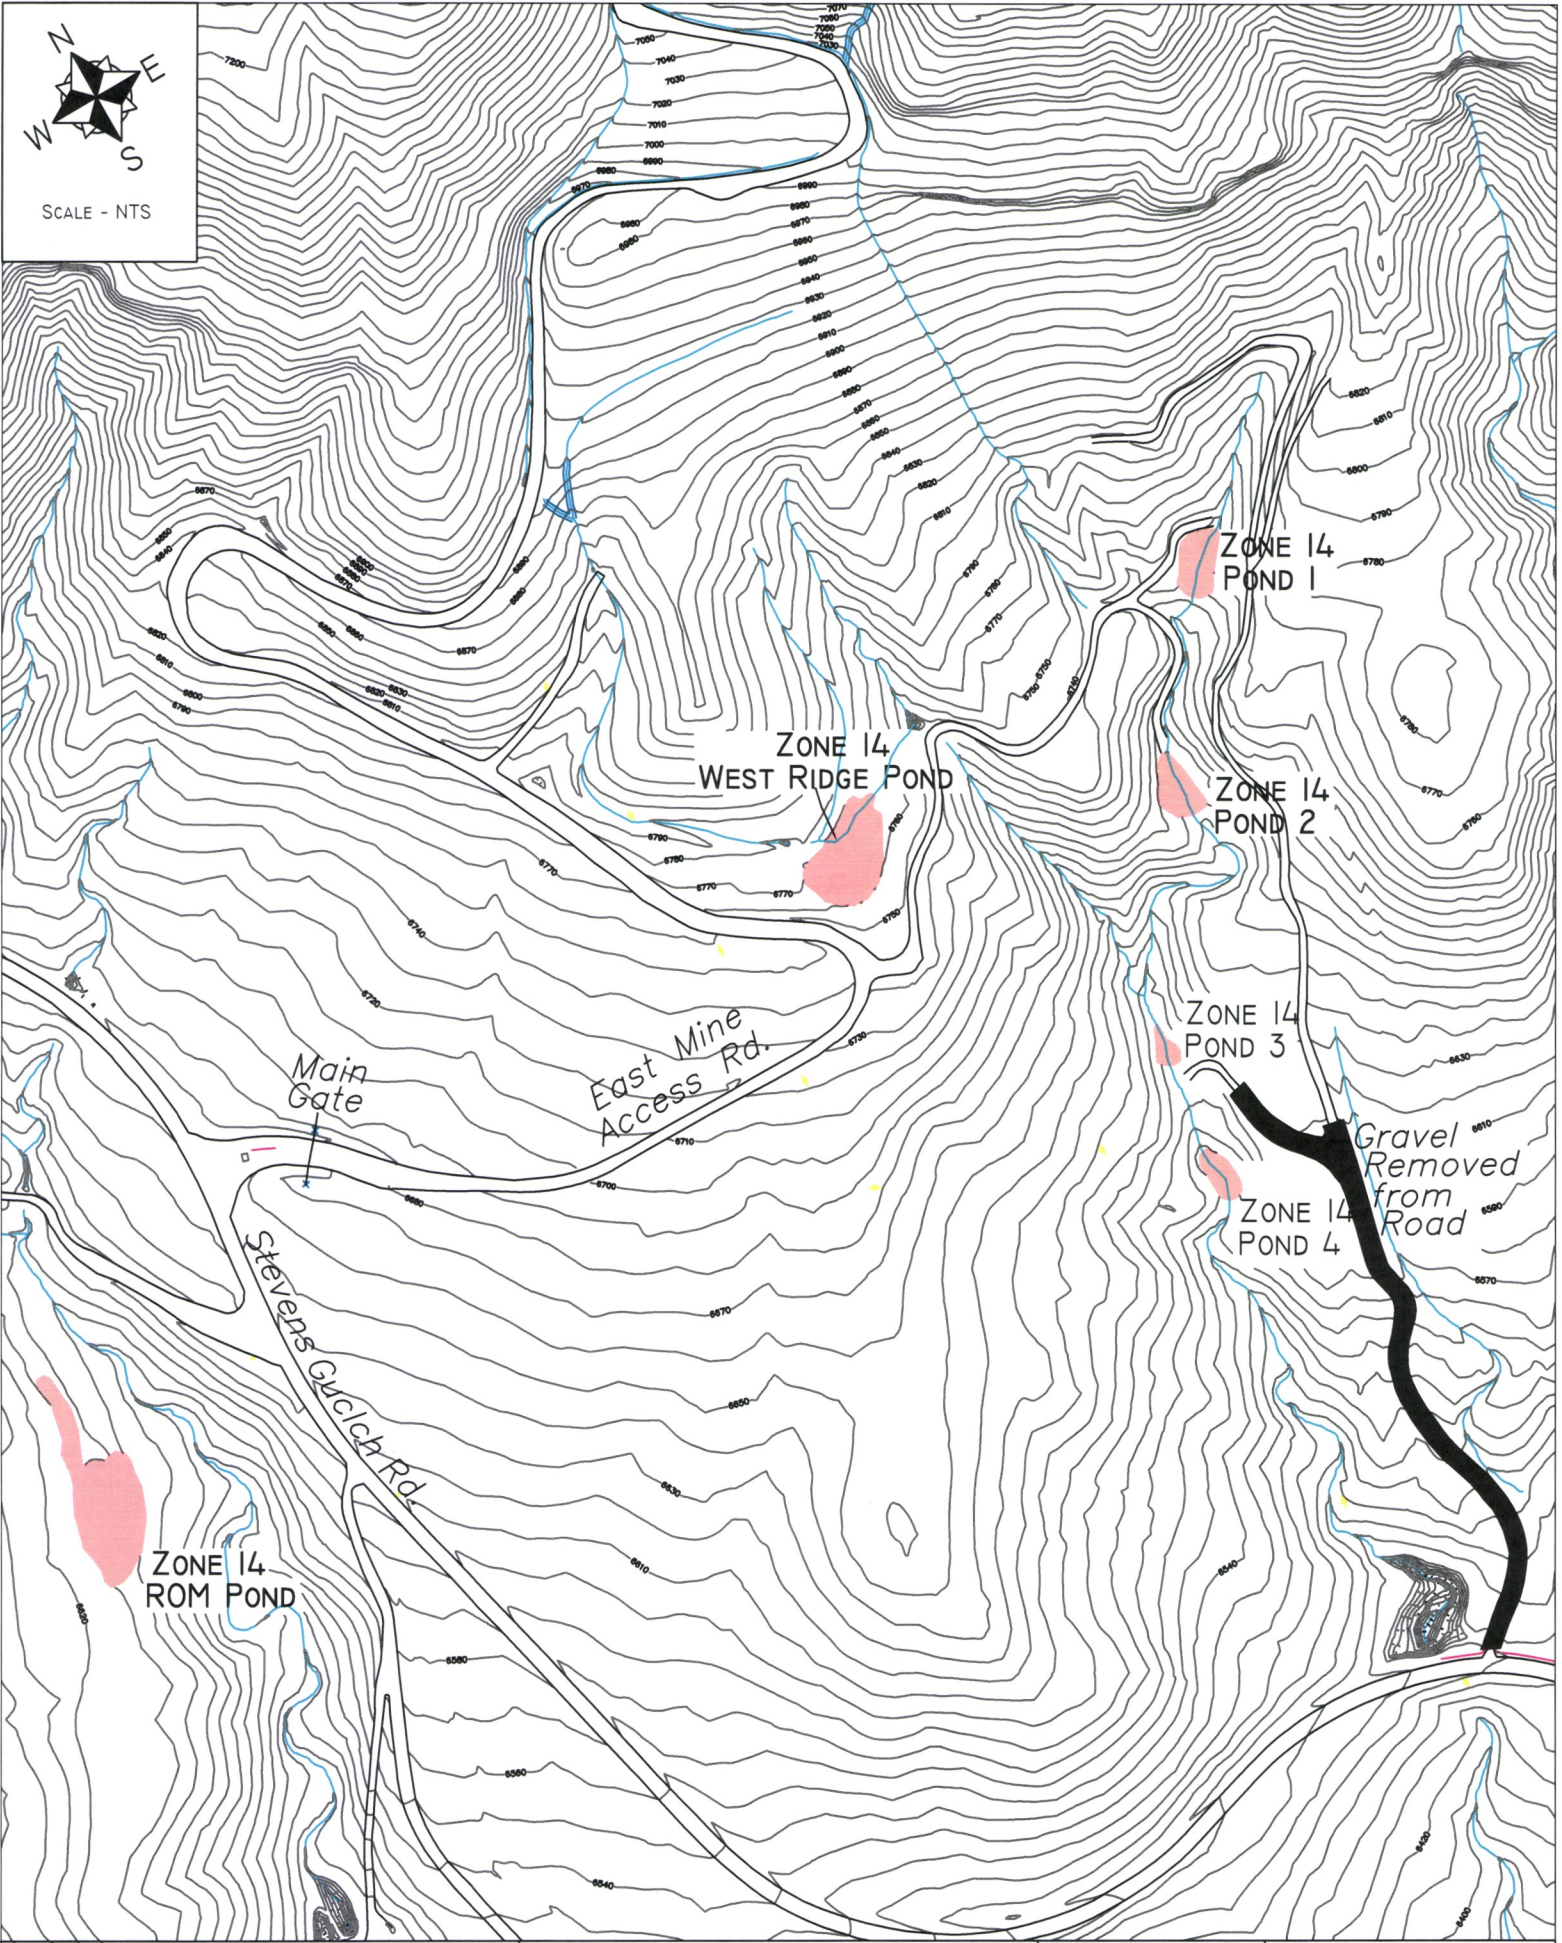
**2017 Reclamation**  
**Scale: NTS**  
**Drawn by: basil bear**  
**Page No. 3**

**2017: Reclamation Activities;** During RY2017, Bowie completed 3 projects, the first was the reclamation of 6 sedimentation control ponds located at the East Mine and ROM area (*shown on drawing "2017 Reclamation" as Zone 14*). Reclamation consisted of removing 4 bin-wall dams and 2 earth-fill ponds then re-contouring back to its Approximate Original Contour (AOC), Upon completing AOC, the disturbed areas were then reseeded with the approved seed mix (*shown below*) and covered with straw blankets. (*It should be noted that all available topsoil was used during the initial reclamation of the Bowie East Mine so no topsoil was available for RY2017 reclamation*).

The second item was the removal of gravel from the access road to Pond 3 and 4. This area can be seen on the attached drawing "2017 Reclamation".

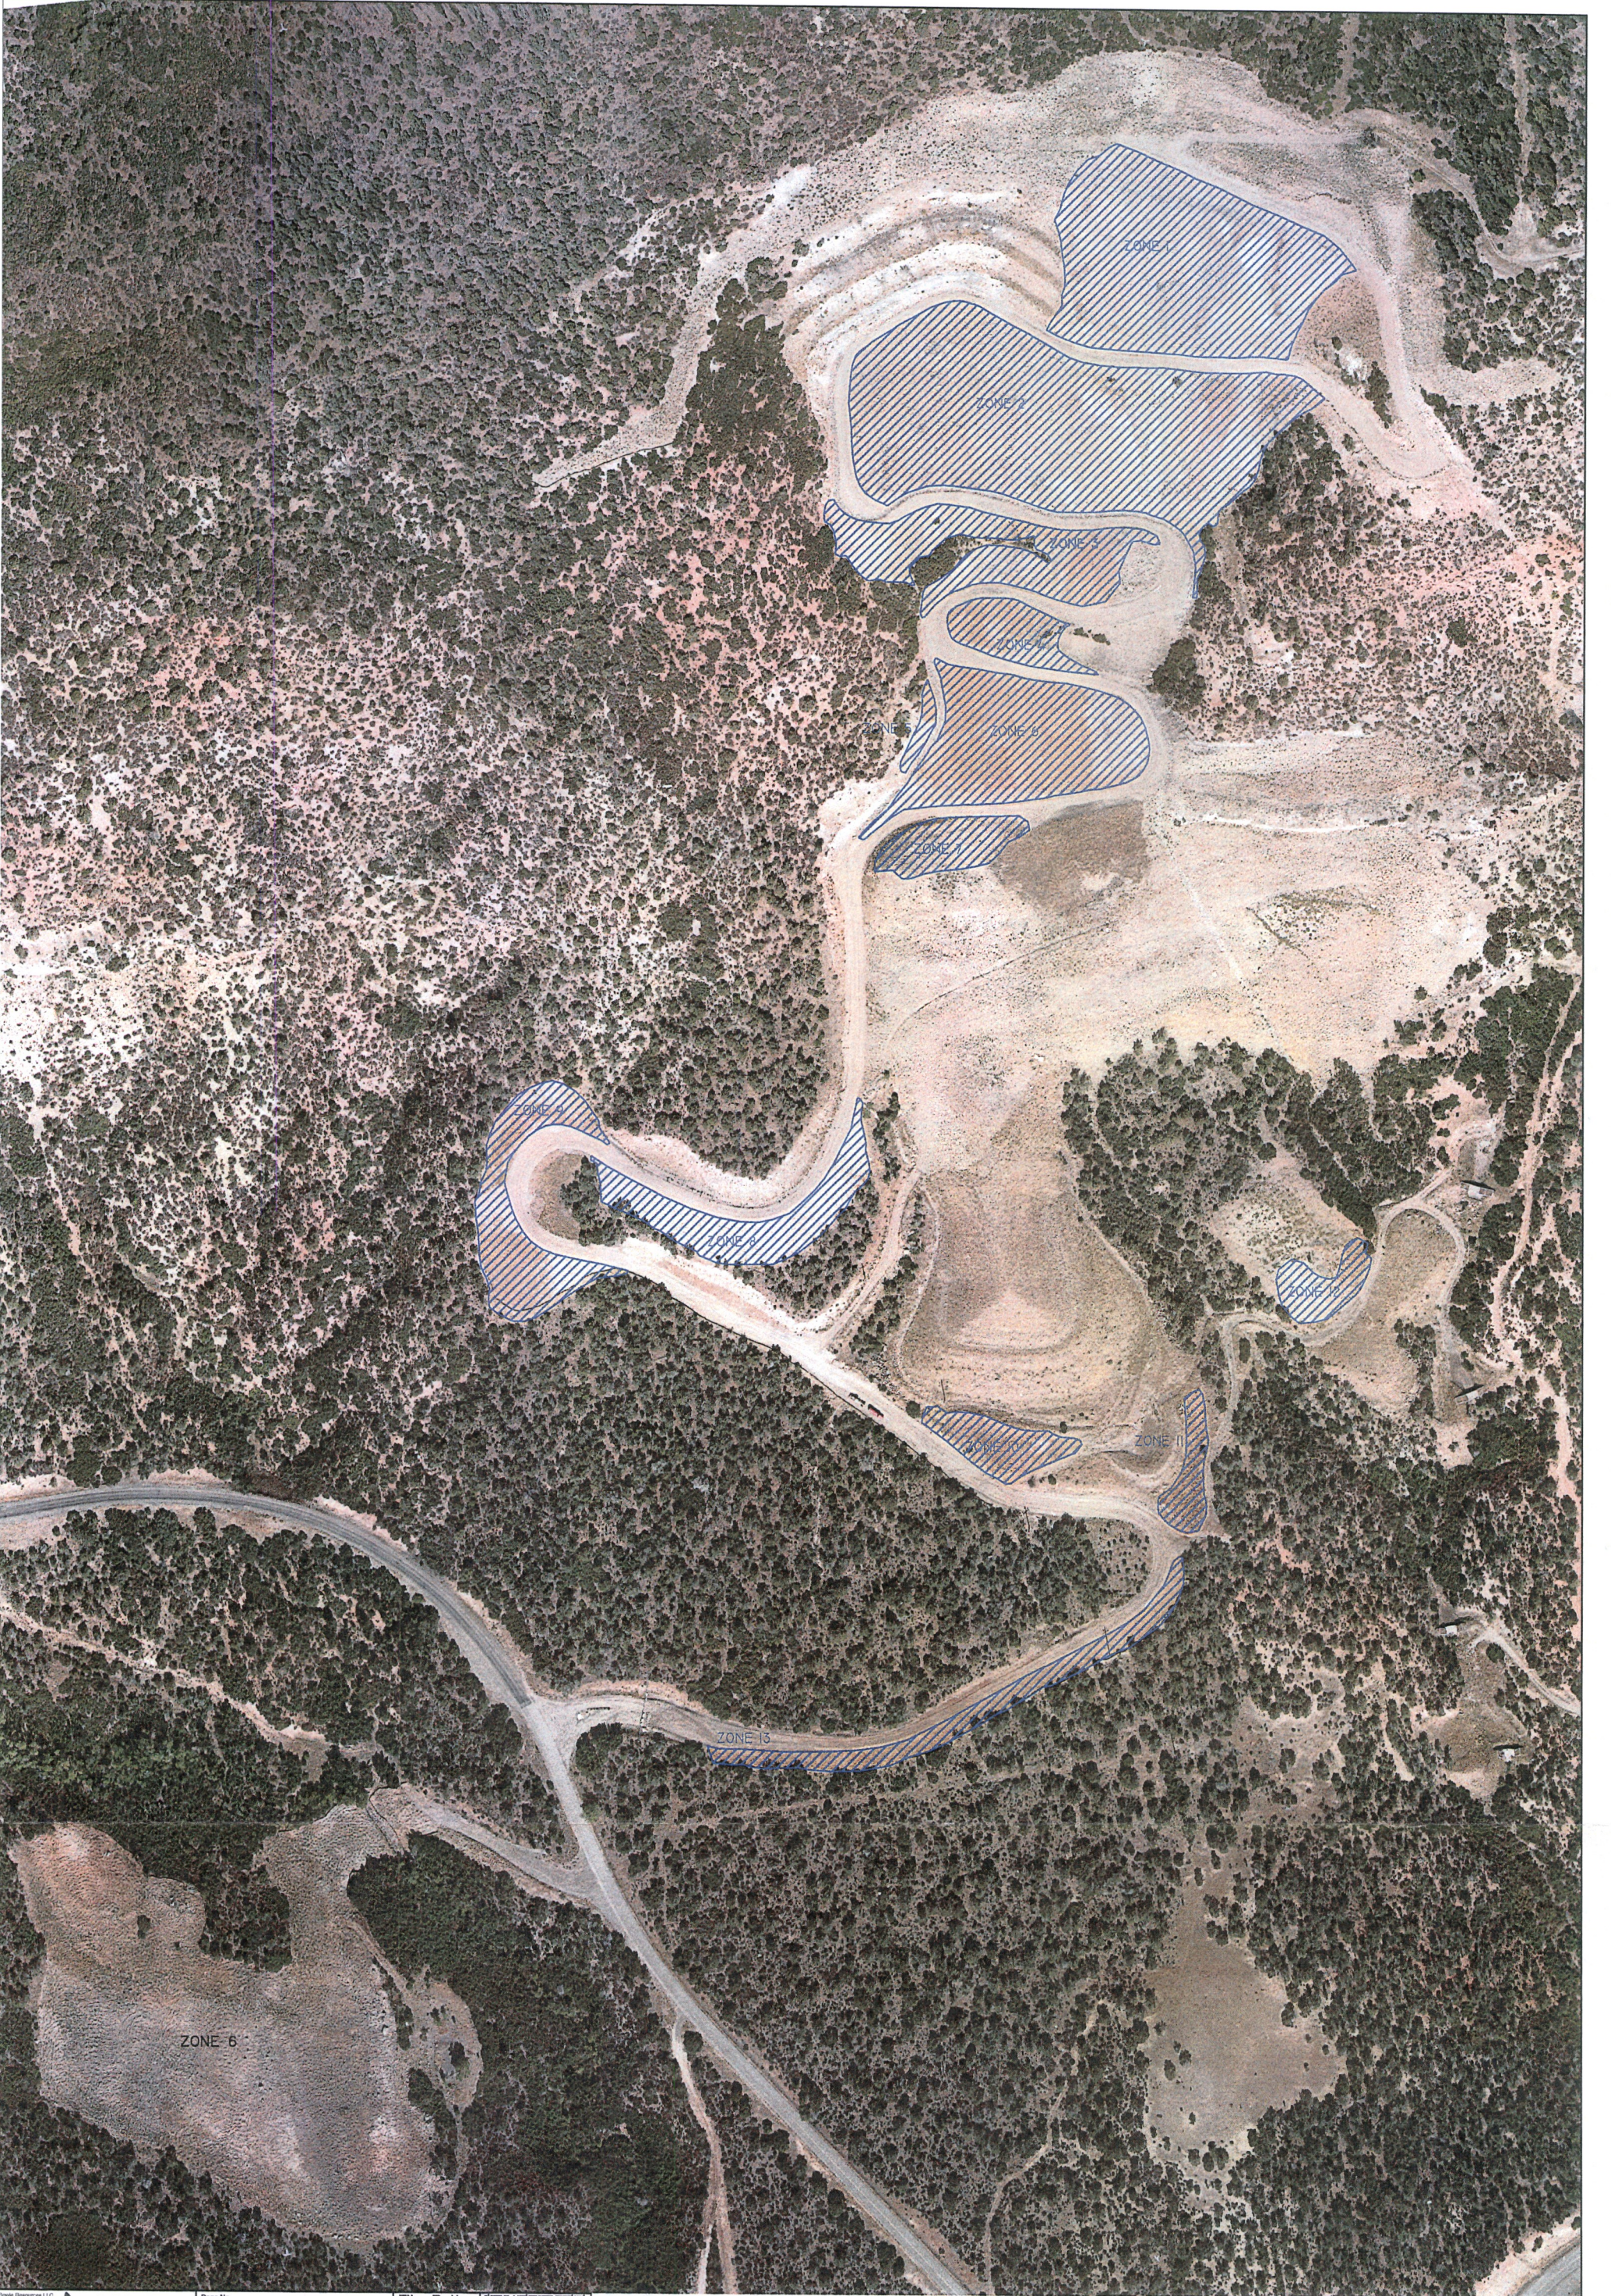
- 2012 Reclamation Activities:** Except for minor repair to ditch, #7 there was no reclamation activities during this reporting period.
- 2011 Reclamation Activities:** Reclamation activities for the reporting year 2011 consisted of additional hydro seeding of the Bowie No. 1 East Mine. Hydro seeding consisted of an approved permanent seed mix @ 32.2 PLS lbs. /acre, mulched with wood fiber mulch at a rate of 1,500 lbs. /acre and a tackifier (Star-tac 100) @ 90 lbs. /acre. The following areas were reseeded. (See 2011 Reclamation Map)

Zones	Description	Acreage	Top Soiled	Revegetated
Zone 1 (1-C, D)	Above Portal Bench	0.00	0.00	3.37
Zone 2 (4-C, 2-D, 2-E)	Portal/Office Bench	0.00	0.00	5.17
Zone 3 (2-D)	Substation	0.00	0.00	1.40
Zone 4 (1-E)	Belt Transfer	0.00	0.00	0.48
Zone 5 (2-A)	Rock Cut	0.00	0.00	0.47
Zone 6 (2-A)	Warehouse/Shop	0.00	0.00	1.93
Zone 7 (1-B)	Tire Shop Area	0.00	0.00	0.47
Zone 8	Access Road	0.00	0.00	0.92
Zone 9	Access Road	0.00	0.00	1.06
Zone 10 (5)	West Ridge Pile	0.00	0.00	0.45
Zone 11 (5)	Top Soil Pile	0.00	0.00	0.28
Zone 12 (5)	Access Road	0.00	0.00	0.33
Zone 13	Access Road	0.00	0.00	0.78
Totals			17.11

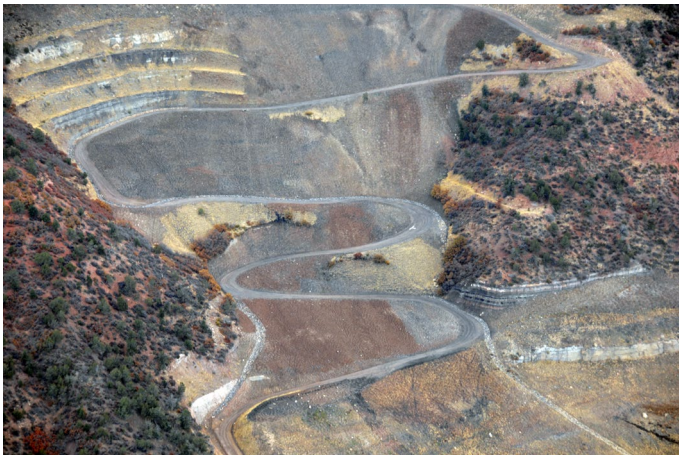
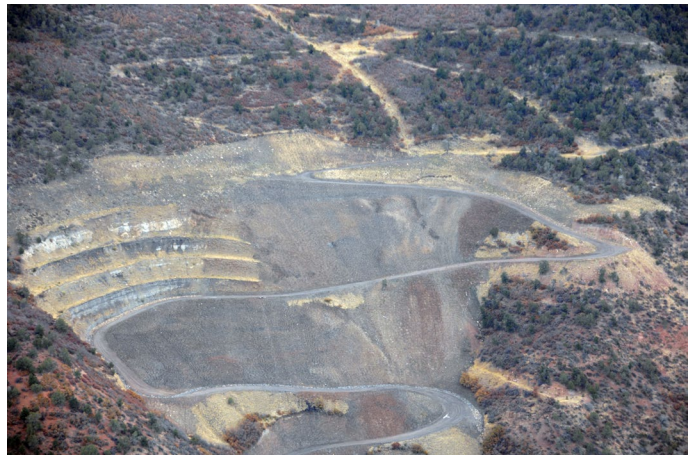
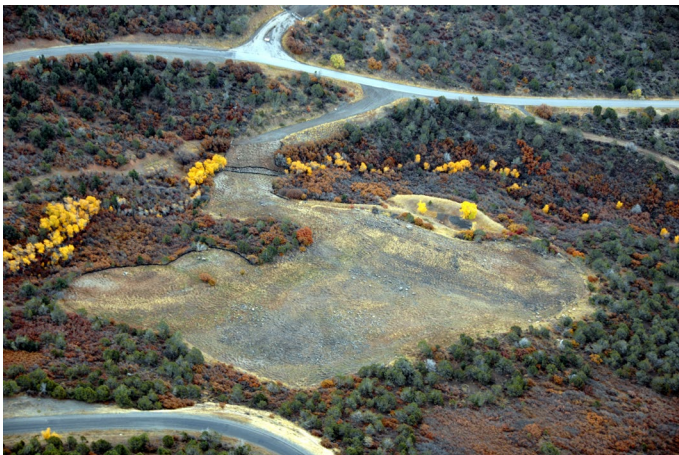
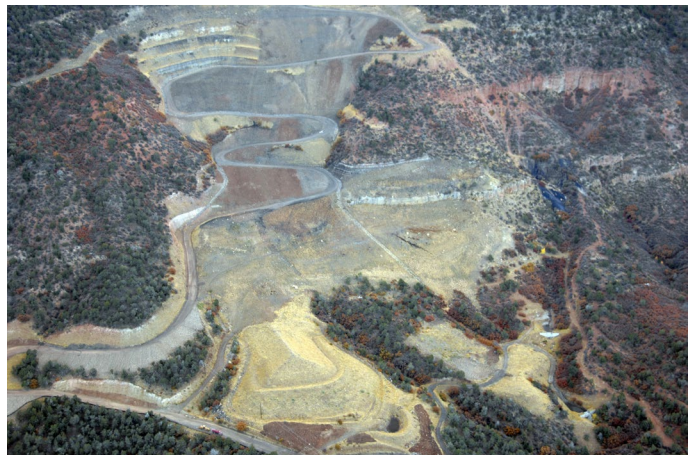
Reclamation 2009  
ROM Coal Stockpile Area

During the reporting year 2009, Bowie completed final grading of the Bowie #1 East Mine (*excluding required sediment control structures*). The 2009 reclamation activities, which was a continuation of the 2008 activities, included the final grading and hydro seeding with an approved permanent seed mix and mulched with wood fiber mulch at a rate of 2,000 lbs/acre of the following areas. (See "2009 Reclamation Map")

<b>Zones</b>	<b>Description</b>	<b>Acreage</b>	<b>Top soiled</b>	<b>Revegetated</b>
Zone 4-C	Portal Bench	4.54	2.89	No
Zone 2-E	Substation/Access Road	0.18	0.18	No
Zone 2-D	Access Road	0.61	0.00	No
Zone 1-E	Belt Transfer	0.35	0.07	No
Zone 2-A	Shop/Warehouse	2.15	1.63	No
Zone 4-B	Storage Bench	1.27	1.17	1.27
Zone 2-C	Access Road	0.93	0.00	No
Total		10.03	5.94	1.27

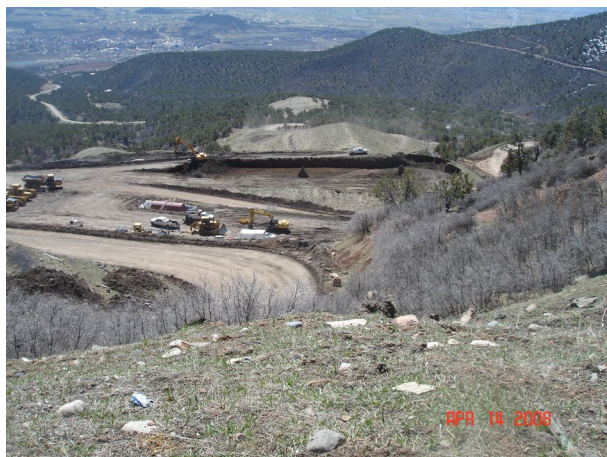
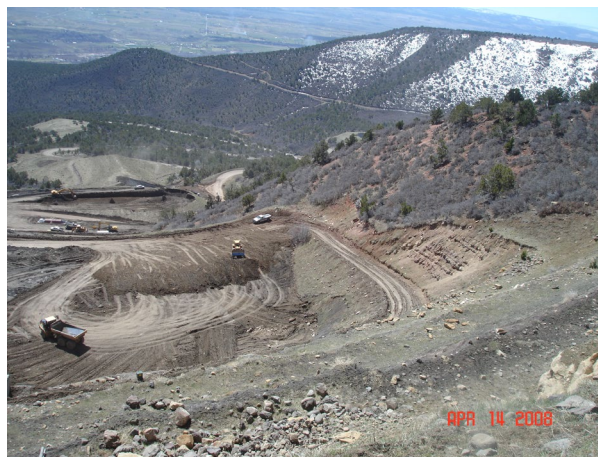
During the reporting year 2008, Bowie Resources LLC continued with the partial reclamation of the Bowie No. 1 East Mine. (*The 2008 reclamation is a continuation of the 2001 activities in which surface structures were removed.*) The 2008 reclamation consisted of returning portions of the disturbed area back to approximate original original contours and hydro seeding with a permanent seed mix and wood fiber mulch. The following zones were completed during the 2008 reporting period. (Reference attached Drawings “Reclamation Zones East Mines and “ROM Coal Stockpile Area”)

<b>Zones</b>	<b>Description</b>	<b>Acreage</b>	<b>Top soiled</b>	<b>Revegetated</b>
Zone 1-A	Crushing & Screening Level Fill	Yes	Yes	5.93
Zone 1-B	Shop & Warehouse Level Fill	Yes	Yes	3.11
Zone 1-D	Substation Level Fill	Yes	Yes	0.34
Zone 2-B	Portal Level Fill	No	No	
Zone 3-A	Diversion Channel Cut	Yes	Yes	
Zone 3-B	Diversion Channel Cut	Yes	Yes	
Zone 3-C	Diversion Channel Cut	Yes	Yes	6.98 (Total)
Zone 4-A	Rock Cut above Crushing & Screening	Yes	Yes	1.42
Zone 4-D	Rock Cut below Fan Level	No	Yes	3.65
Zone 5-A	Waste Rock Disposal Site	Yes	No	7.04
Zone 6-A	R.O.M. Coal Stockpile & Access Road	Yes	Yes	11.16
Totals				39.63

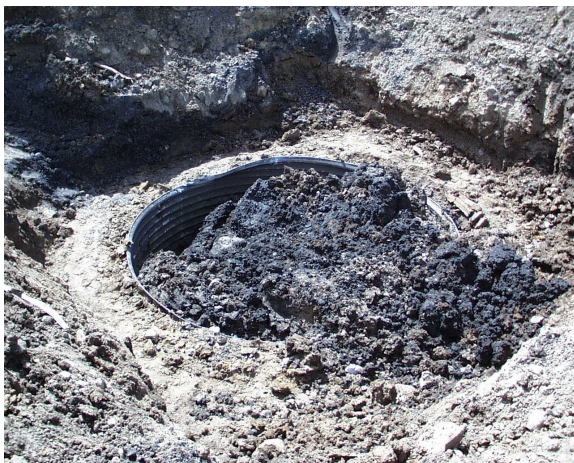
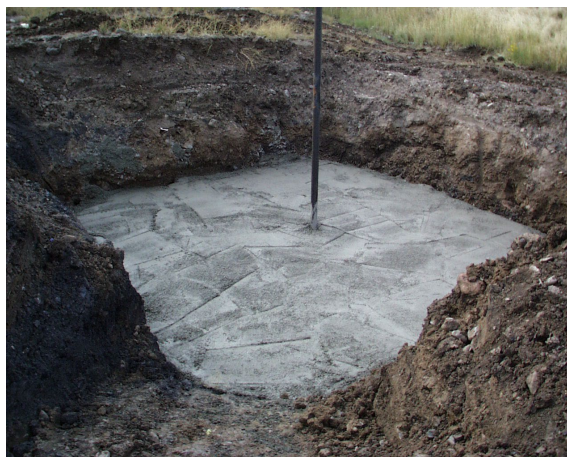
During the reporting period of 2003, Bowie Resources completed sealing the Bowie 1 West Mine ventilation shaft. A 12-inch concrete cap with steel reinforcement, extending 2 feet beyond the shaft liner was completed in September of this year. This included one 4-inch vent pipe as required and backfilling. The following photographs are of the shaft-sealing project.

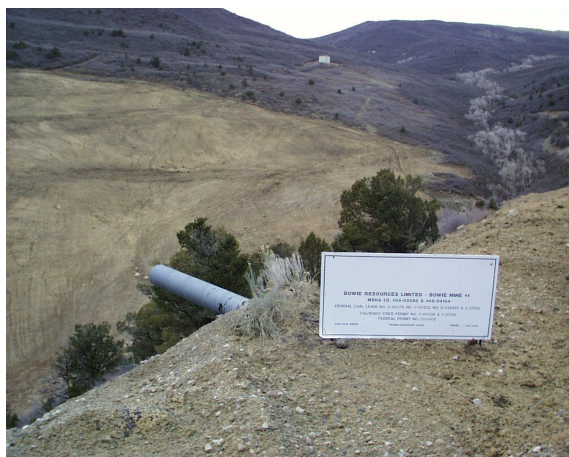
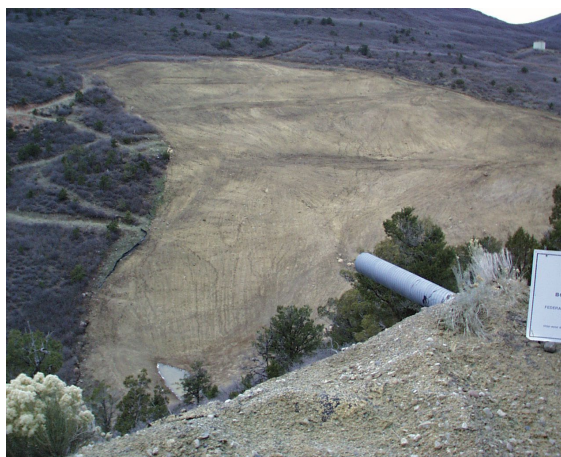
For the reporting year 2002, Bowie Resources, Ltd., continued with the reclamation of the Bowie No. 1 West Mine Site. Reclamation consisted of distributing and grading of nearly 49,000 yrd<sup>3</sup> of subsoil and topsoil back to its approximate original contour. Two new sedimentation control ponds have been established near the bottom of the reclaimed area. Upon completion of the grading, the entire area was hydro-seeded with the approved permanent seed mix and using cellulose mulch at a rate of 1,500 pounds per acre and a tackifier at 100 pounds per acre. In conjunction with the hydro seeding, a fertilizer was applied at a rate that applied at least 30 pounds per acre of nitrogen and 60 pounds of phosphorus.

reporting period the ventilation shaft located at the Bowie No. 1 West Mine was re-filled due to settling. Approximately 2,500 yrd<sup>3</sup> was placed into the shaft. As required by the Mine Safety and Health Administration, CFR 30 Part 75.1711-1 beginning from the bottom of the coal seam and extending upward for a distance of 150 feet, the shaft was filled with non-combustible material. The remaining portion of the shaft was filled with other available material.

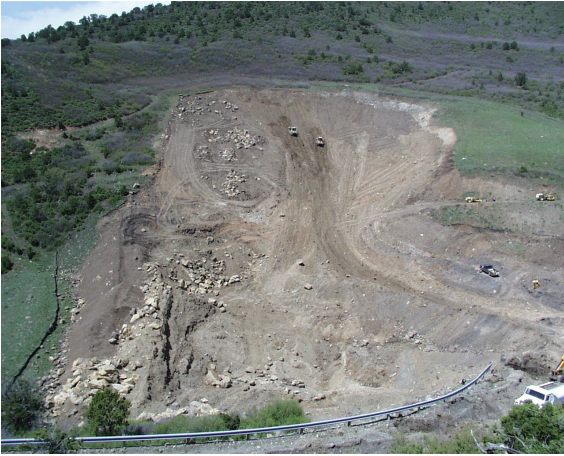
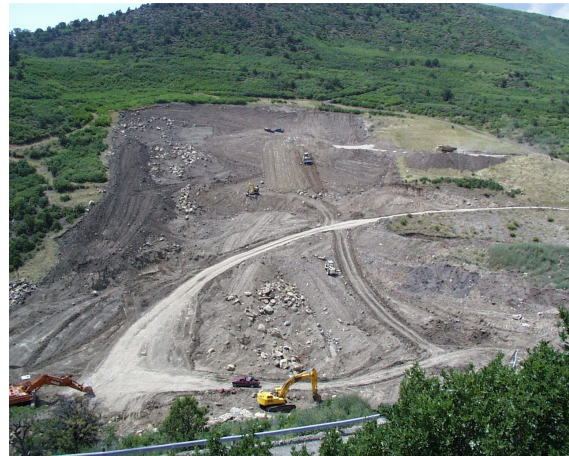
During the year 2001, the Bowie No. 1 West Mine continued to be reclaimed. At the end of the 2001 reporting year, Bowie Resources Ltd. had completed approximately 80 percent of the backfilling. Topsoil located on the fill outcrops was moved to a temporary storage location during the backfilling process. The West Mine Ventilation Shaft was filled during this same period.

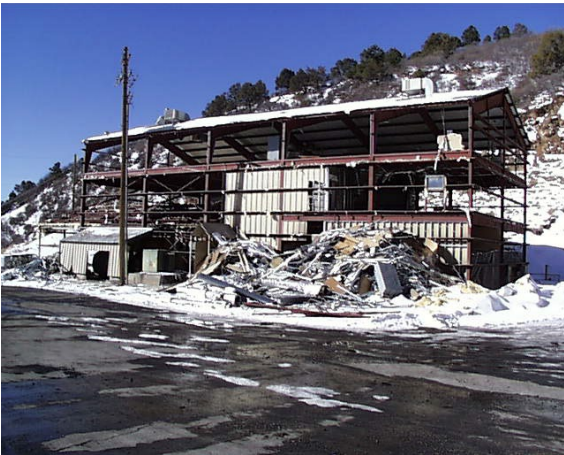
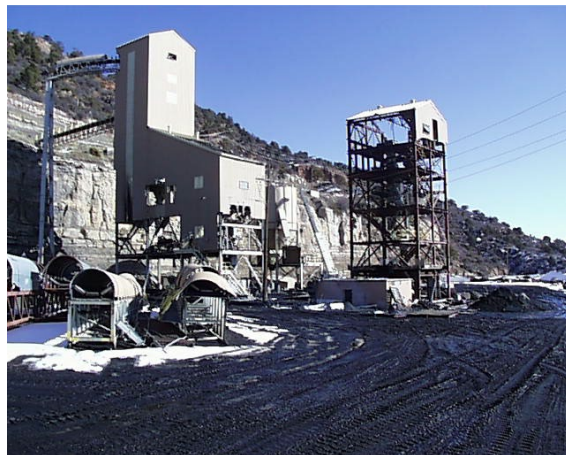
The Bowie East Mine reclamation during 2001 consisted of demolition and removal of permanent structures. The following structures were removed; bathhouse/office, storage tanks, MCC buildings, fire house, belt structures, transfer towers, shop/warehouse, tire shop, loading bin, fire house, belt structure, the majority of the 2,000-ton bin, guard shack, sewage treatment plant, crushing and screening plant, truck loadout, and stacking tube.

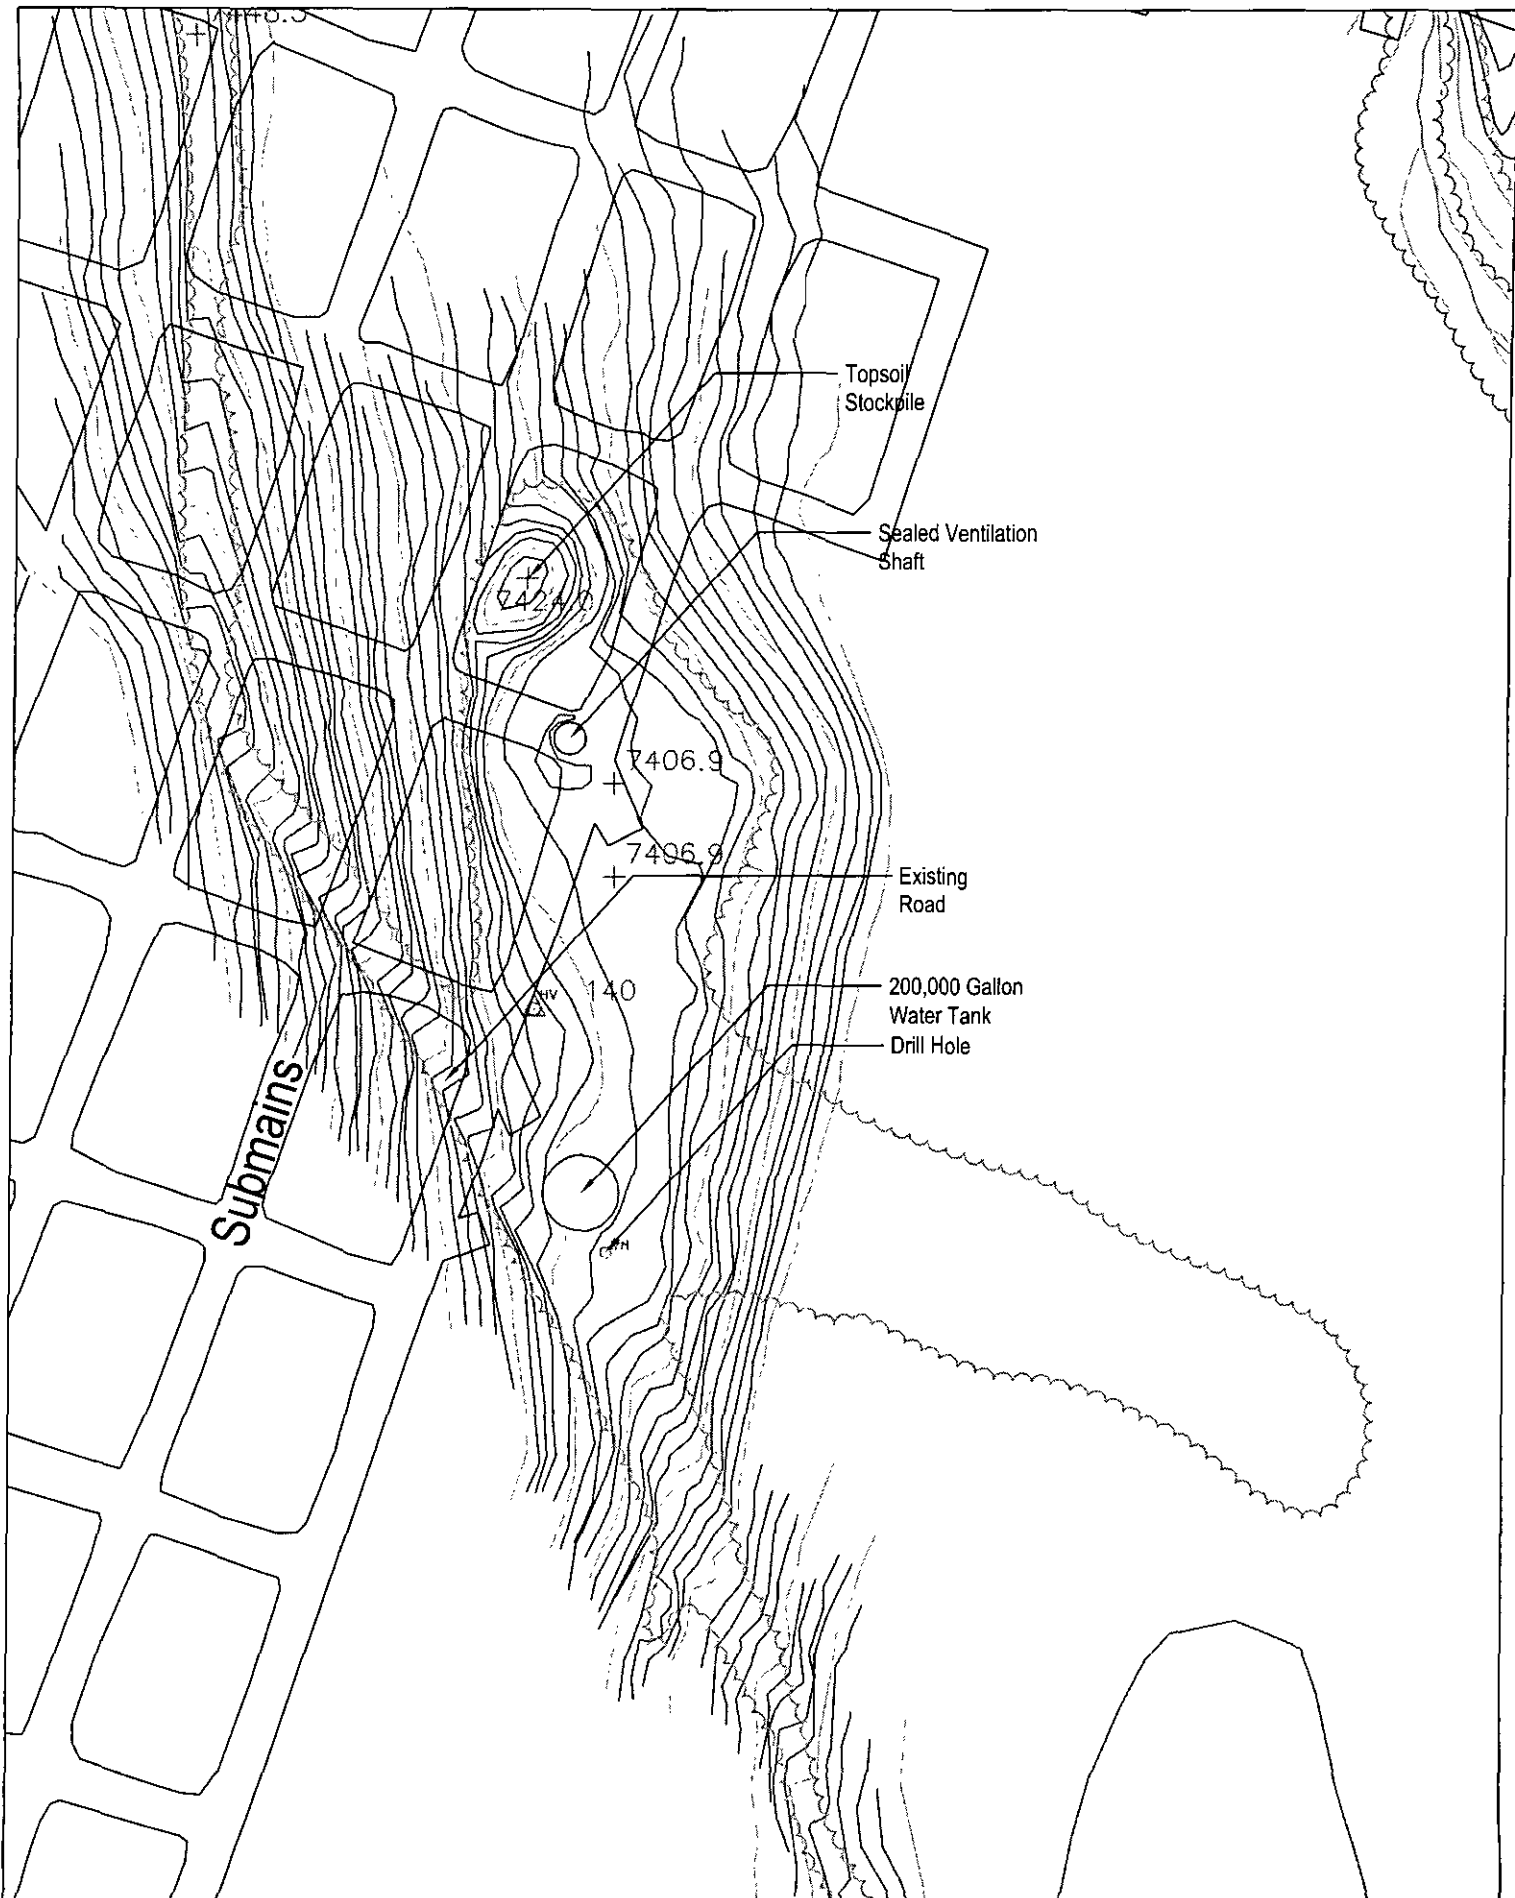
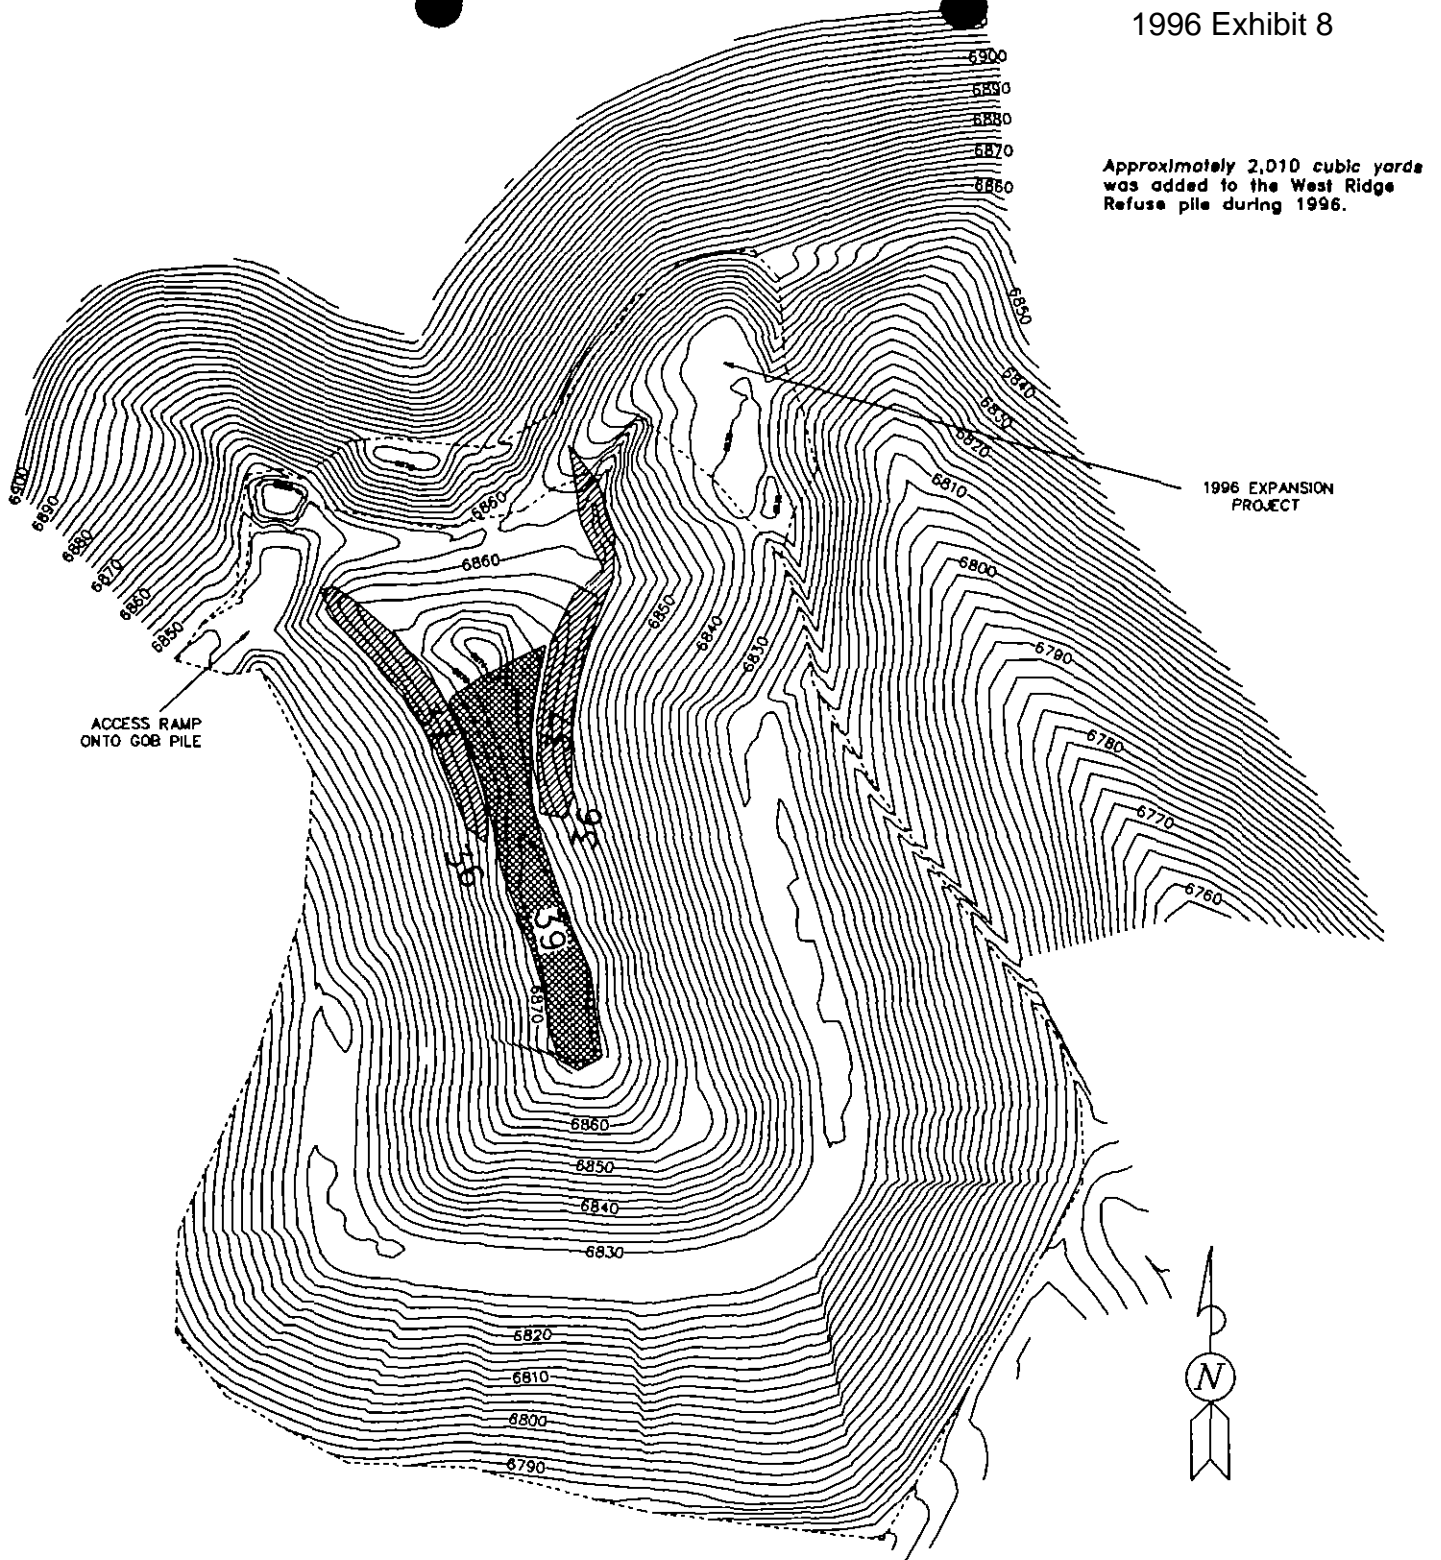
# West Ridge Waste Disposal Pile Exhibit 8

No additional acreage was newly disturbed by mining or construction activity during the 1995 calendar year. Reclamation activities conducted included seeding and mulching operations on the outcrops of the west ridge waste pile. (See locatoin37, exhibit 8). This area was seeded during the month of December using permanent seed mix (mix no. 5 less shrub species). Also reseeded during this period was a small area around the fan area using a temporary seed mix, (see table 6 for seed mix). This area was also seeded during the month of December.

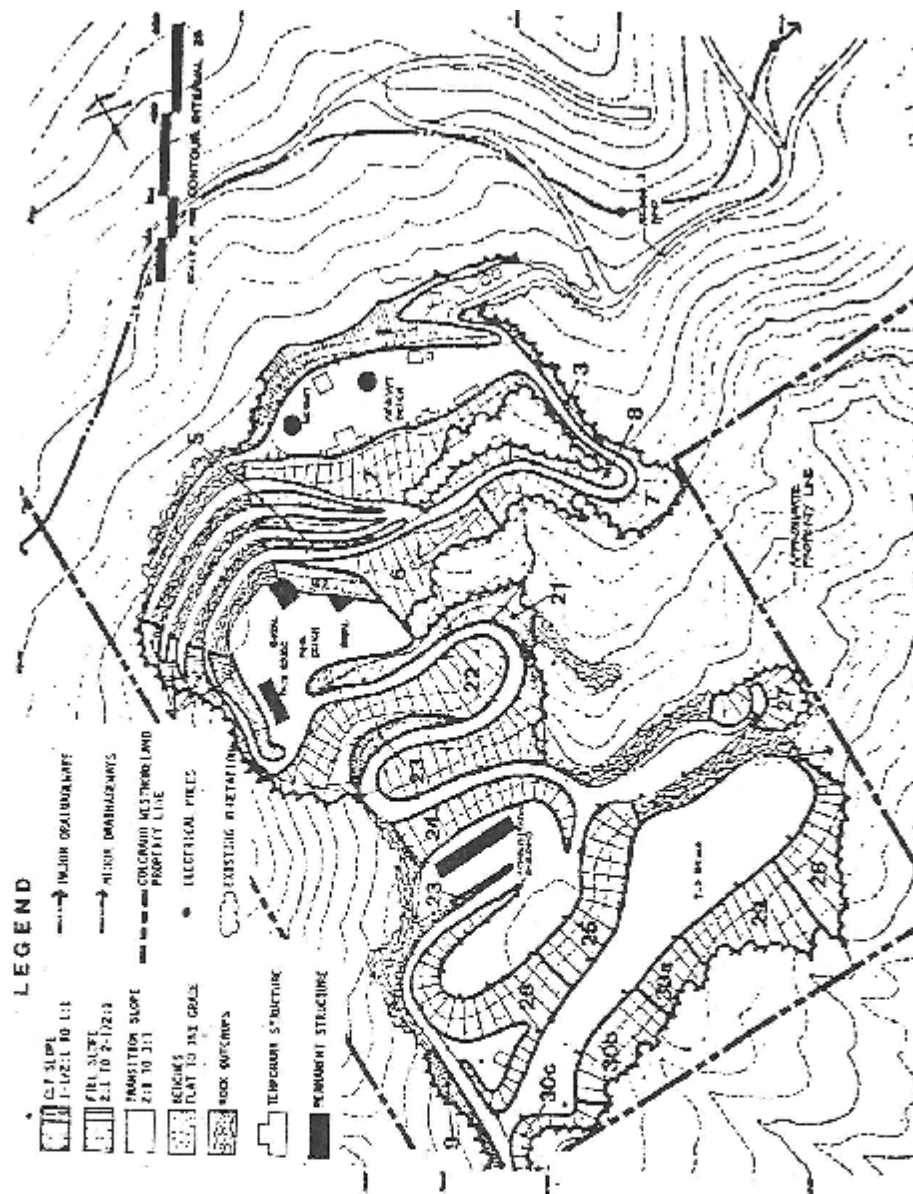
Exhibit 4 1978 Revegetation Program Sparsely Vegetated and Washout Areas Within the Test Plots Access Road to Main Mine Facilities (Part 1).

Revegetation of cut and fill slopes was accomplished in 1978 on previously seeded but sparsely vegetated and eroded slopes stemming from excessive water runoff caused by the lack of an effective water diversion system.
