# Inspection reports

Here are the inspection reports for the Foidel Creek Mine, C-1982-056 and Hayden Gulch LO, C-1992-081. Have a good week, **Brock**

# **INSPECTION INFORMATION**

Inspection Start Date: July 16, 2 Inspection Start Time: 07:30 Inspection End Date: July 16, 20 Inspection End Time: 11:00			Inspection Type: Coal Partial Inspection Inspection Reason: Normal I&E Program Weather: Clear	1
Joint Inspection Agency:		Joint Inspection Contacts:		
None				
Post Inspection Agency:		Post Inspection Contacts:		
None				
Inspector(s):	Inspector	r's Sig	gnature: Signature	Date:
Brock Bowles	Brak Sauls			
			July 18, 2025

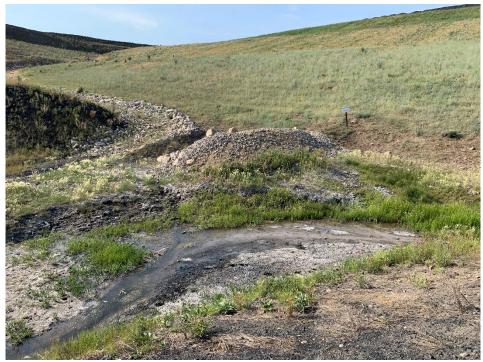
Photo 1 - B Ponds, south cell facing west

Ponds B contained water and were discharging (photo 1). The sump above the ponds contained water and was discharging to the B ponds. The ditch between the BOB area and the sump was free of obstructions.

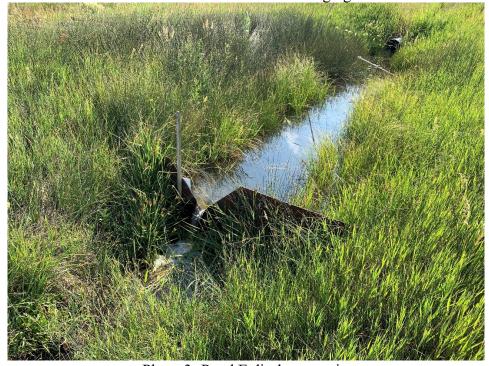
Photo 2- Waste Pile underdrain discharging to Pond D

Pond D and the pit pond contained water. The Pond D embankment was well vegetated and appeared to be stable. The waste pile underdrain was discharging water to Pond D (photo 2).

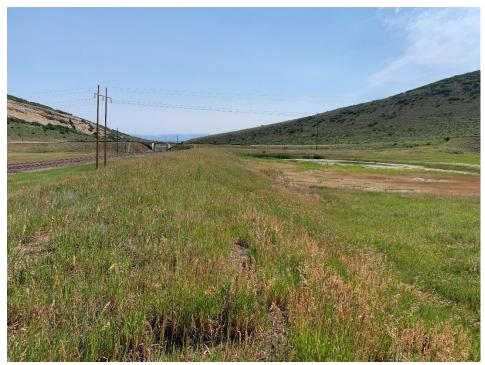
Photo 3- Pond E discharge weir.

Pond E contained water and was discharging. The primary spillway was free and clear of obstructions (photo 3).
