Re: M-1977-392 Dawson Mine, Elbert County, Colorado  
Corrective Action Extension Request and Update

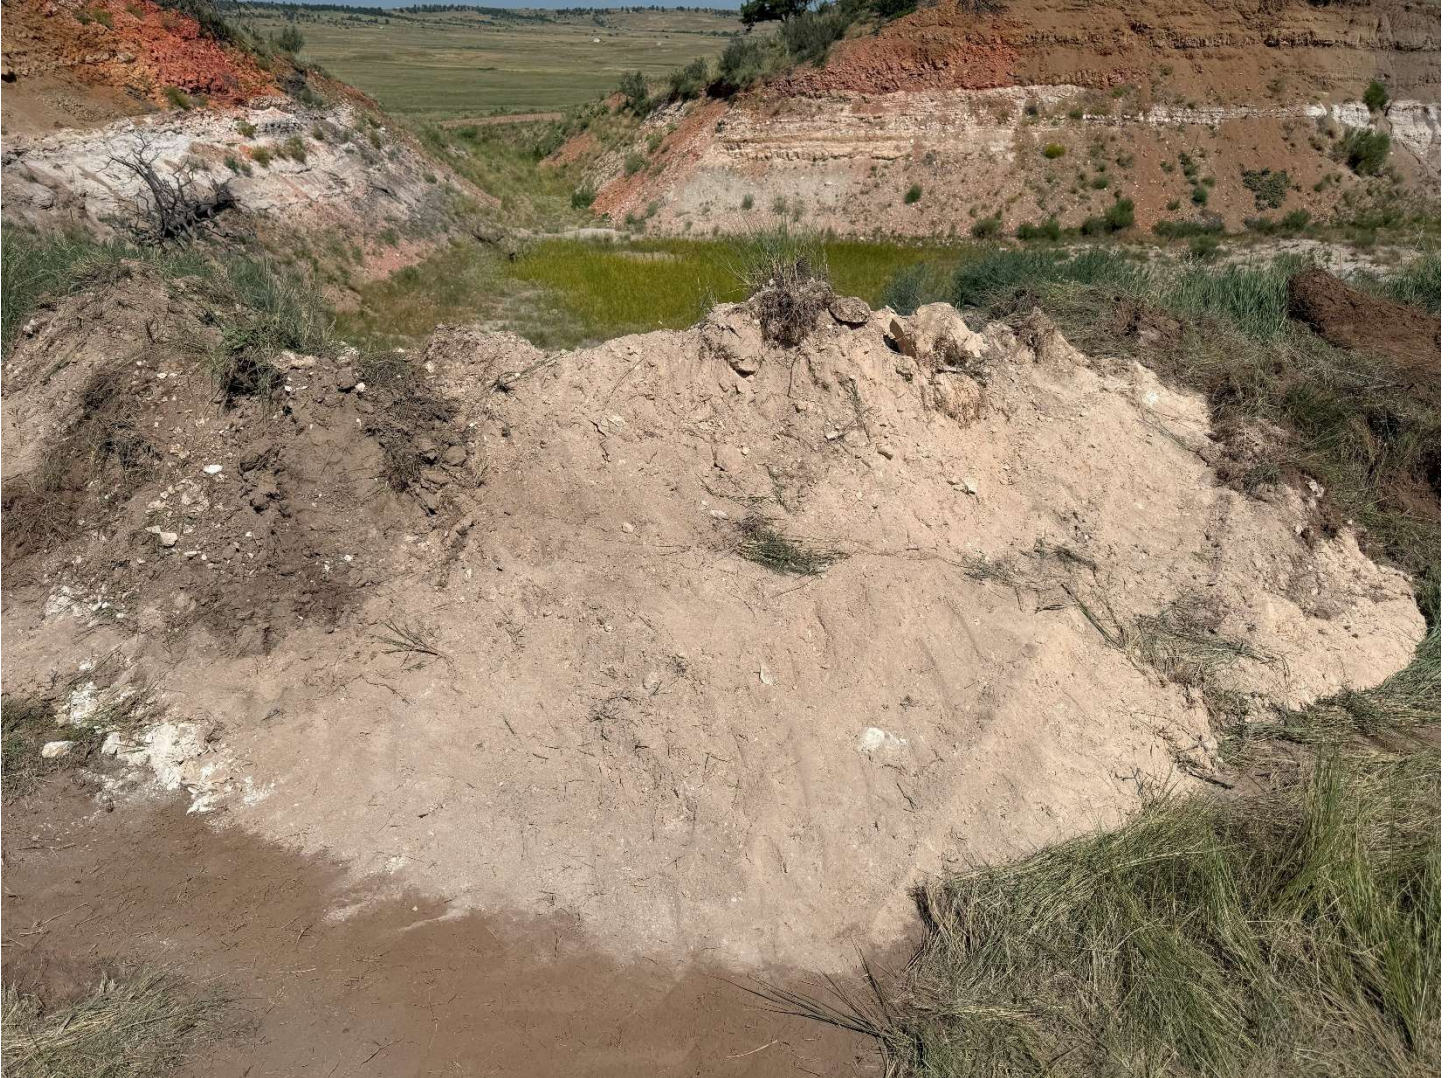
***PROBLEM #1:*** Erosion rills and gullies were observed throughout the portion of the permit area that lies south of the access road, including a significant erosion feature that's present on the southern highwall of the East Pit.

General Shale repaired the upper berm along the south wall and increased the height of the berm. Picture below is from the top of the hole in the berm looking north.

***CORRECTIVE ACTIONS:*** The operator shall provide photo documentation to the Division verifying erosion gullies and ruts have been repaired, and that the site has have been reconstructed and stabilized to prevent erosion damage by the corrective action date.
