MINERALS PROGRAM INSPECTION REPORT
PHONE: (303) 866-3567

MINE NAME: Ranch Land Rock Pit #2	MINE/PROSPECTING ID#: M-2003-021	MINERAL: Gravel	COUNTY: Fremont
INSPECTION TYPE: Monitoring	WEATHER: Clear	INSP. DATE: July 23, 2025	INSP. TIME: 12:00
OPERATOR: Ranch Land LLC	OPERATOR REPRESENTATIVE: Kurt Thurmann & Mike Krauth	TYPE OF OPERATION: 112c - Construction Regular Operation	
REASON FOR INSPECTION: Normal I&E Program	BOND CALCULATION TYPE: Complete Bond	BOND AMOUNT: \$192,337.00	
DATE OF COMPLAINT: NA	POST INSP. CONTACTS: None	JOINT INSP. AGENCY: None	
INSPECTOR(S): Jocelyn Carter	INSPECTOR'S SIGNATURE:

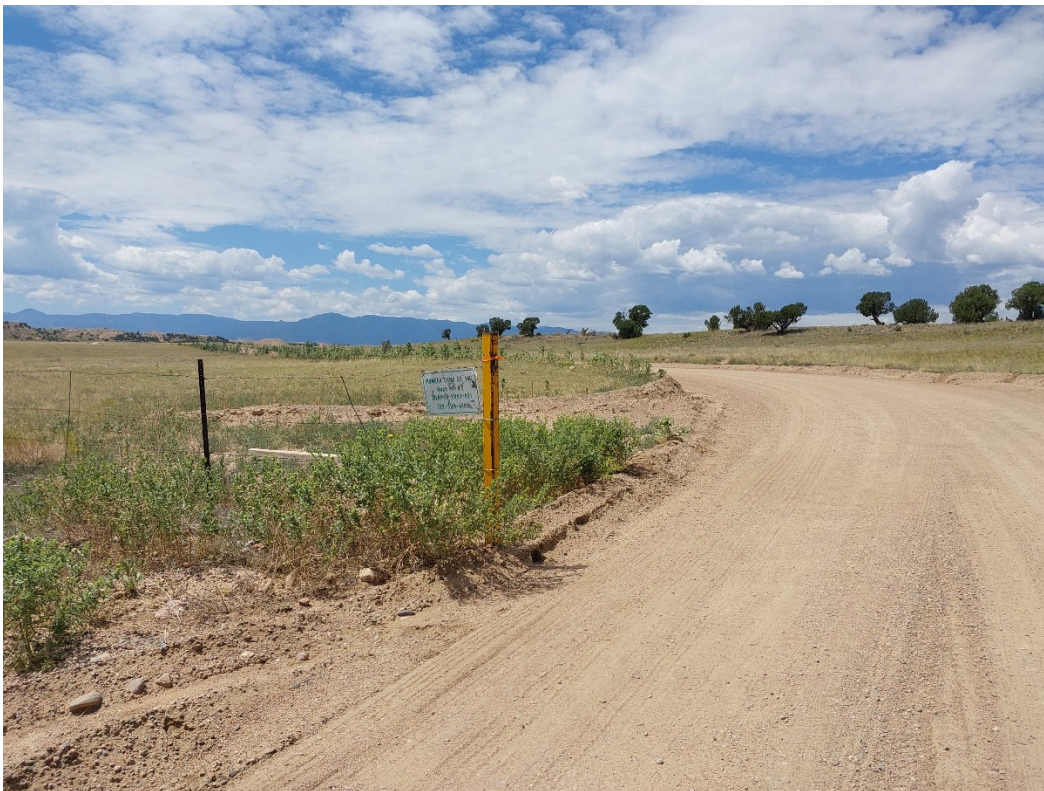
PROBLEM #4: The posted mine sign at the site entrance is not accurate. This is a problem for failure to post a mine identification sign as required by Section 3.1.12(1) of the rule. The Operator shall, at the entrance of the mine site post a sign, which shall be clearly visible from the access road, with a minimum size equaling one hundred and eighty-seven (187) square inches, such as eleven (11) inches in height and seventeen (17) inches in width, with appropriate font size, with the following: the name of the Operator, a statement that a reclamation permit for the operation has been issued by the Colorado Mined Land Reclamation Board; and the permit number.

The mine sign is posted at the Minnequa Canal crossing just to the north of the permitted area along the access road, see Photo #1. The posted mine sign shows the name Pioneer Sand Co Inc as the operator and according to permit records, Holcim purchased the lease on January 20, 2023. A problem is being cited for the mine sign being inaccurate according to Rule 3.1.12(1)(a), see **Problem #4** above for information about the required corrective action.

Photo #1: Mine sign posted along the access road. The sign does not show the appropriate Operator name.

CORRECTIVE ACTIONS: The operator shall, at the entrance of the mine site, post a sign which shall be clearly visible from the access road with the following: the name of the operator, a statement that a reclamation permit for the operation has been issued by the Colorado Mined Land Reclamation Board; and the permit number. The operator shall submit photo documentation that a proper sign has been posted by the corrective action date.

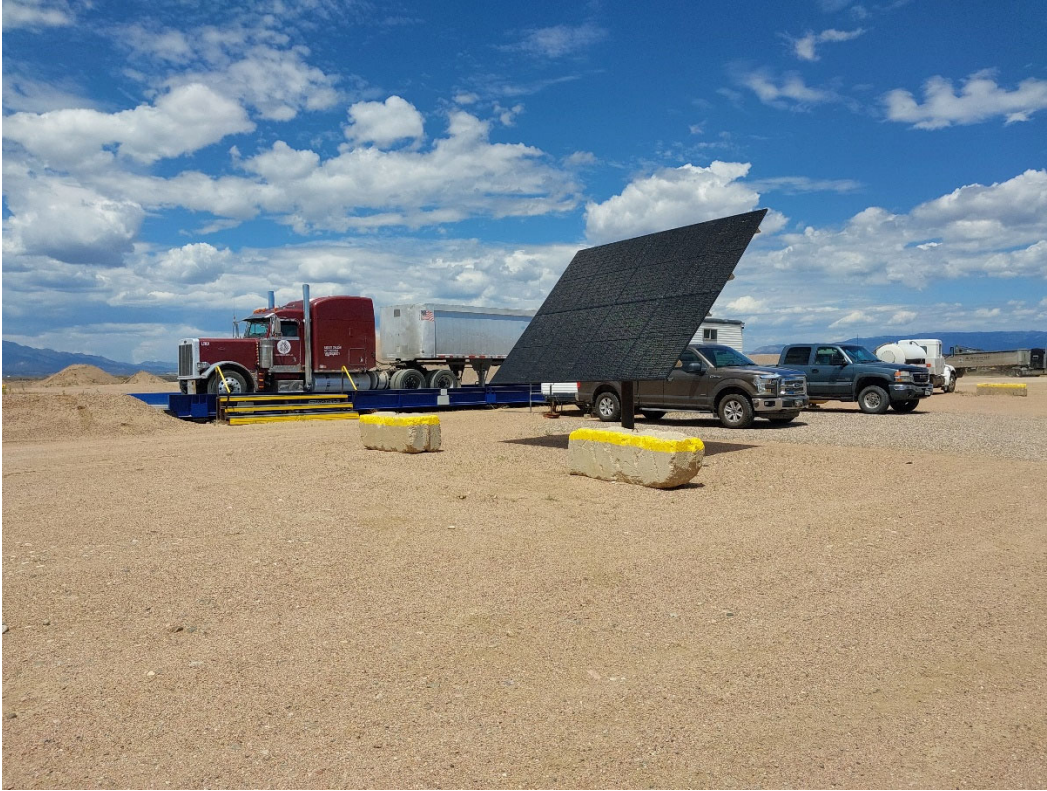
There was screening facilities on the site at the time of the inspection; the screening equipment is portable, see Photo #4. There is a scale and a scale house adjacent to the fuel tank on site, see Photo #3. The scale and scale house is in good condition. There is also a stand with 8 solar panels adjacent to the scale house, see Photo #2; there is a cement footing at the base of the support post.

Photo #2: View of the installed solar panel in front of the scale, with a truck weighing material prior to delivery, and the scale house, behind the panels.

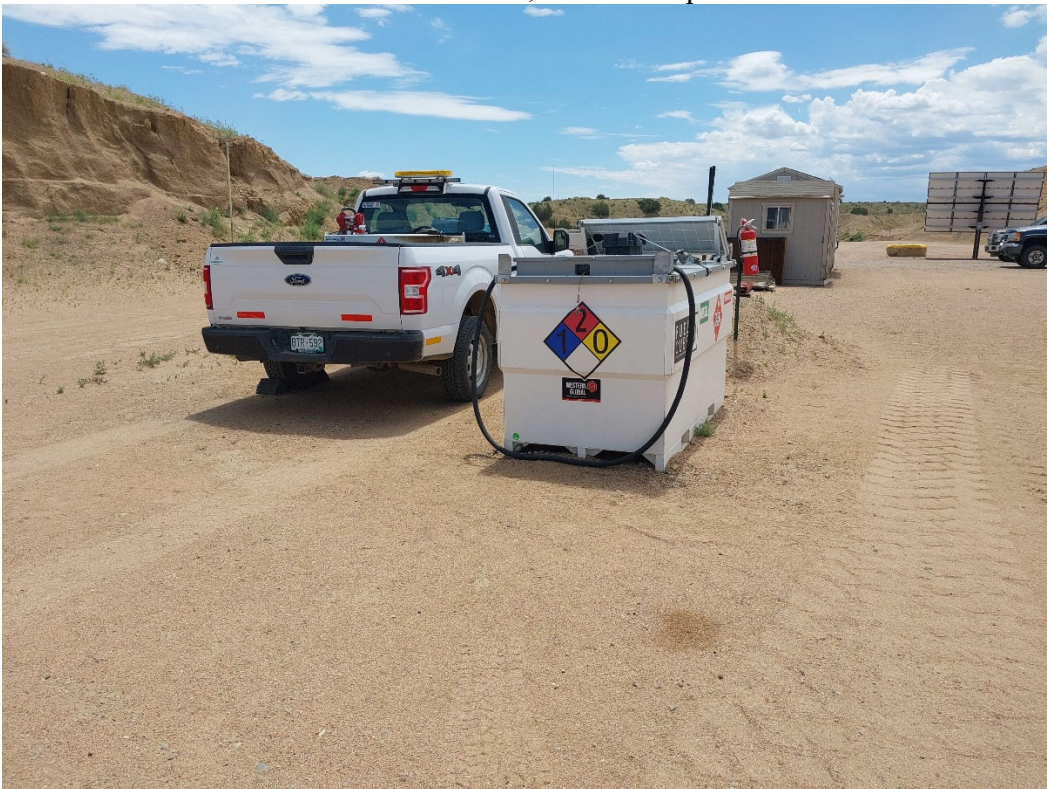
Fuel is stored in a secured vessel on site adjacent to the scale in Phase 6, see Photo #3.

Photo #3: View of the fuel tank with the scale house behind it and the back side of the solar panels can be seen in the background of the right side.

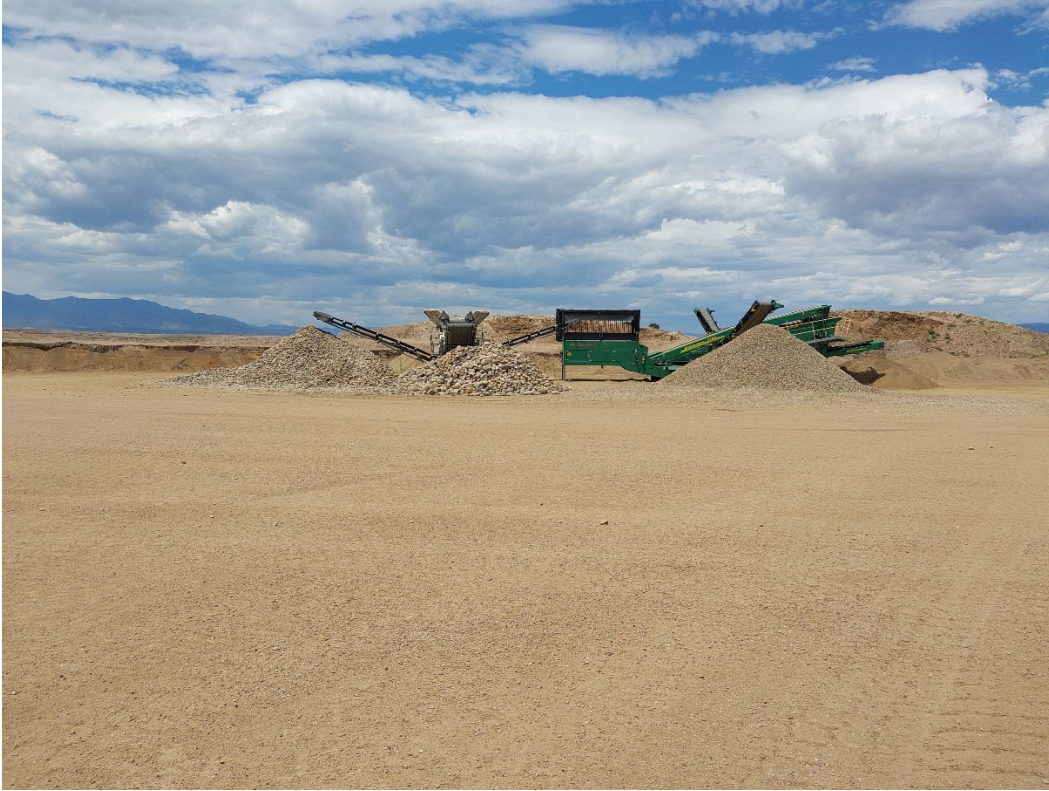
Photo #4: View of the portable conveyors and screening equipment located on the north side of the current disturbed area.

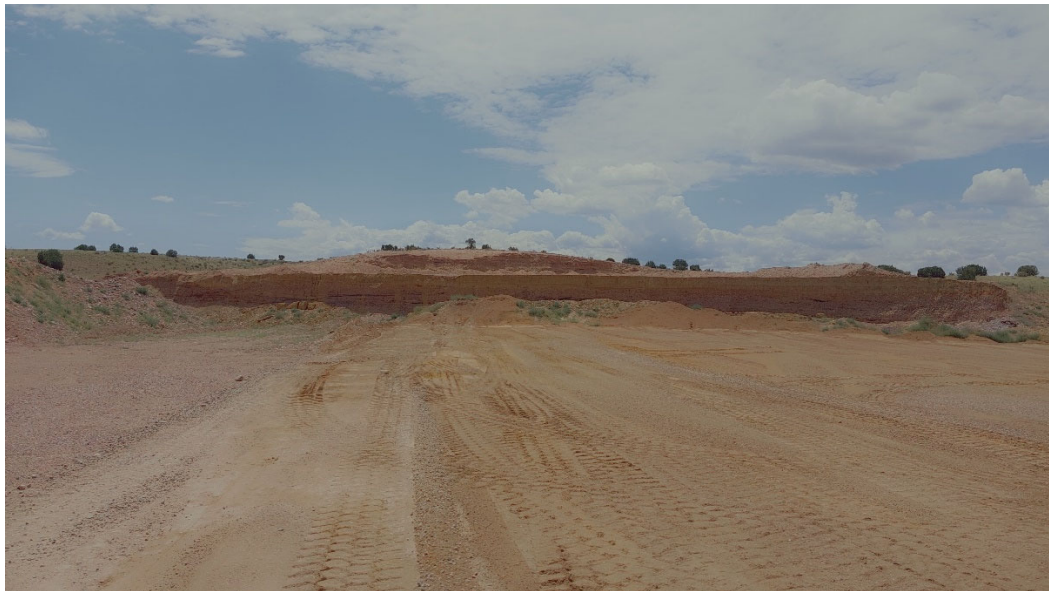
Photo #5: View of the highwall, along the south side of the current disturbed area.

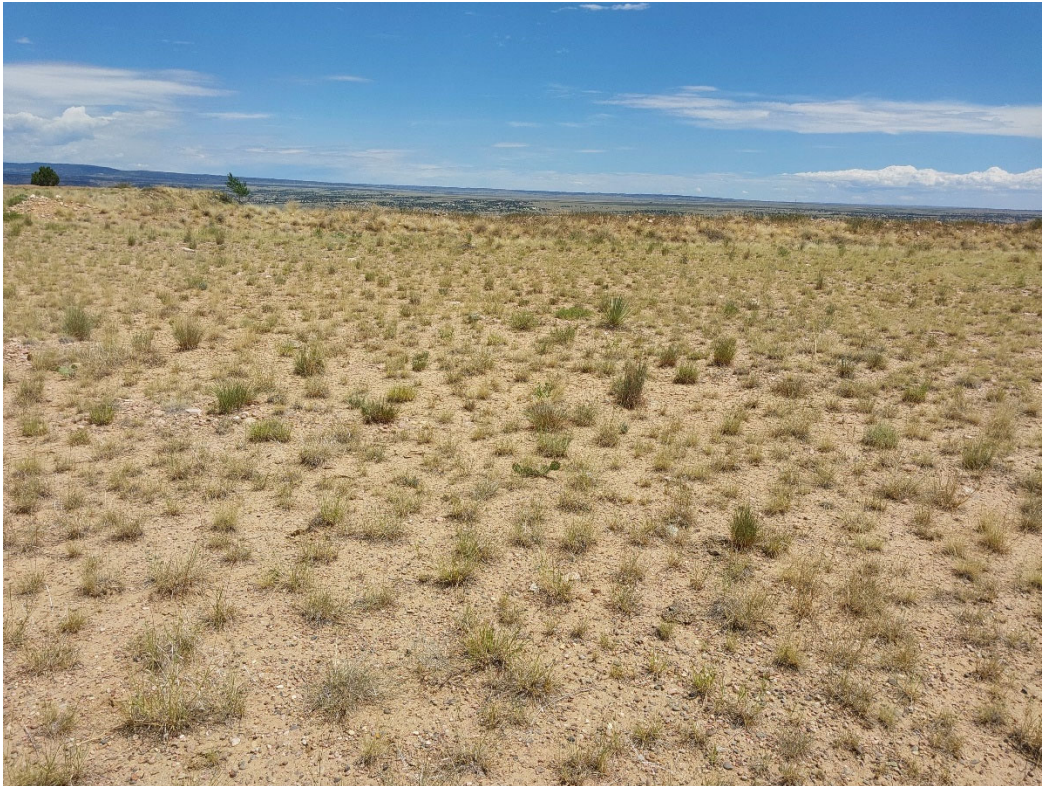
There did not appear to be noxious weeds in the disturbed areas of the mining operation or in the reclaimed area of Phase 1 that was inspected. The last time the Phase 1 area was reseeded was by Pioneer Sand Co Inc. and prior to Holcim purchasing the mining contract.

Photo #6: View of the reclaimed area in Phase 1 of the permit area. The vegetation is sparse but is well established.

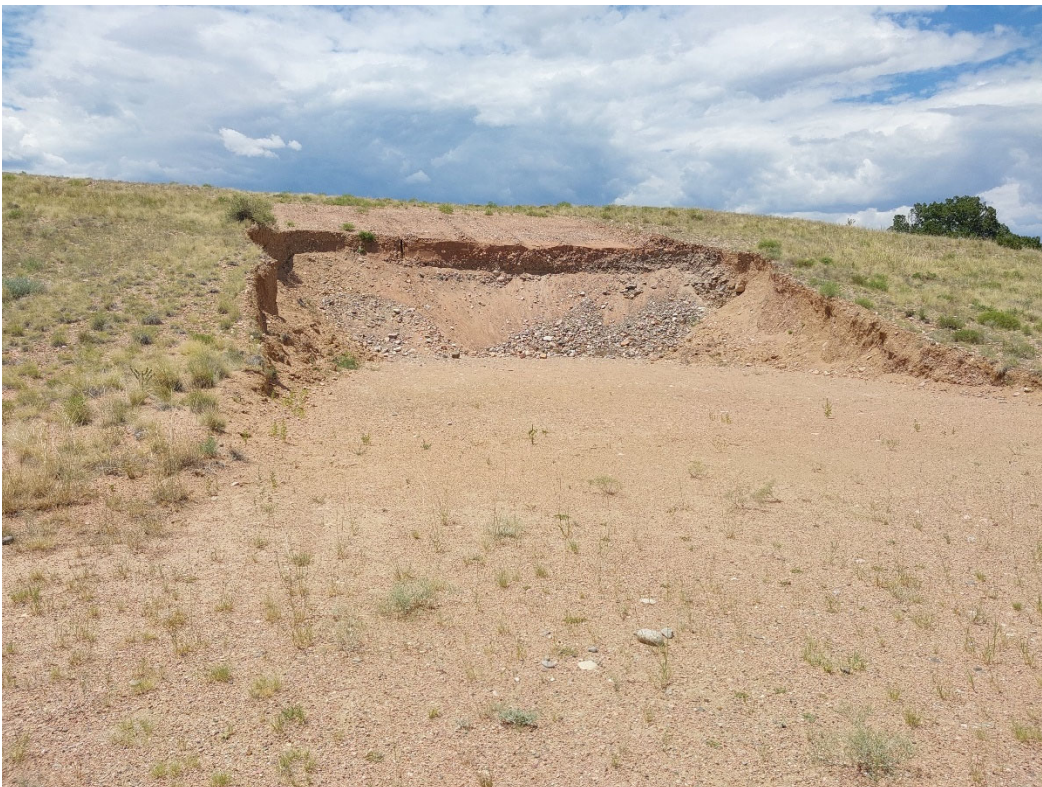
PROBLEM #3: A test pit was extracted and material was stockpiled in an area that has already been reclaimed

in Phase 1 of the permit area.

Phase 1 of the mining area has been reclaimed. Overall, the backfilling and grading is in good condition with 3H:1V or greater slopes. There is a small section of recently excavated and material stockpiled on the old pit floor, see Photos #7 and #8. According to Mr. Thurmann, during a recent shift in management among Holcim – WCR, Inc. a test pit was done in the reclaimed area. A problem is being cited for this, see **Problem #3** above for details about the corrective actions required to address this.

Photo #7: View of the excavated test pit in the reclaimed area.

CORRECTIVE ACTIONS: If the materials tested show to be viable for production, the Operator shall submit a Technical Revision, along with the \$216 application fee, to update the mining plan to fully describe the mining activities on site by the corrective action due date.

If mining the material tested is not going to be pursued, the Operator shall backfill and grade the extracted pit with the stockpile of material and provide photos of the completed earthworks to the Division by the corrective action due date.

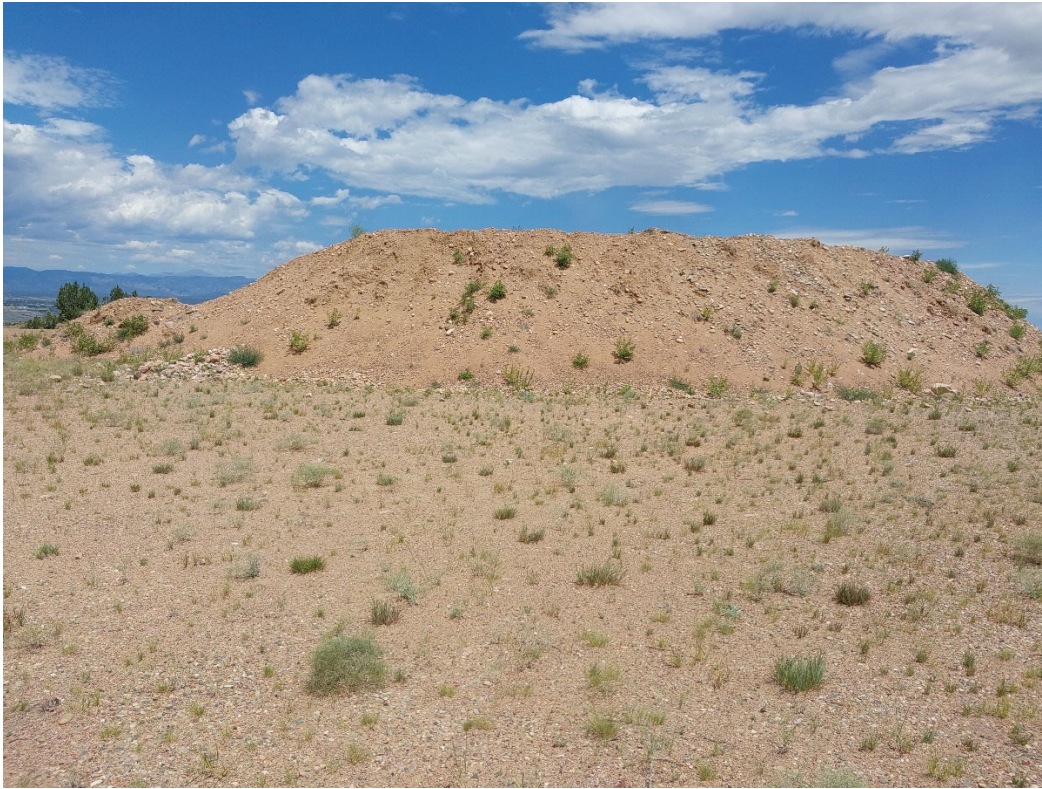
Photo #8: Stockpile of extracted material from test pit on the reclaimed pit floor.
