Bowie #2 inspection report

Permit Number: C-1996-083 Mine Name: Bowie No. 2 Mine Operator: Bowie Resources, LLC Operator Address: Mr. Art Etter P.O. Box 1488 Paonia, CO 81428	County: Delta Operation Type: Underground Permit Status: Active Ownership: Private
	Operator Representative Present: Ken Pitt, Tom Troyer
Operator Representative Signature: (Field Issuance Only)

Inspection Start Date: September 3, 2025 Inspection Start Time: 12:45 Inspection End Date: September 3, 2025 Inspection End Time: 14:30		Inspection Type: Coal Complete Inspection Inspection Reason: Normal I&E Program Weather: Clear	
Joint Inspection Agency: None		Joint Inspection Contacts:	
Post Inspection Agency: None		Post Inspection Contacts:	
Inspector(s): Robert Zuber, P.E.	Inspector's Signature:

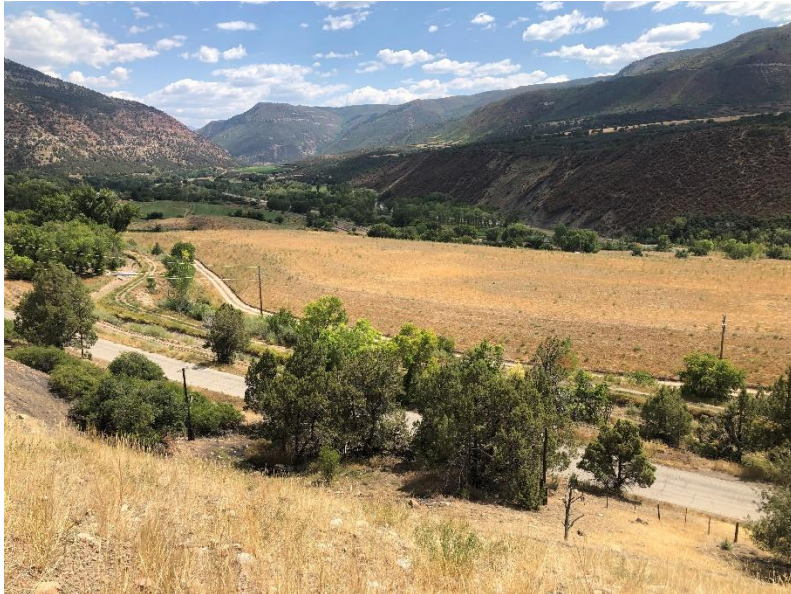
Gob Piles 1, 2, 3, and 4 appeared stable, and no significant erosion was observed.

Gob Pile #3

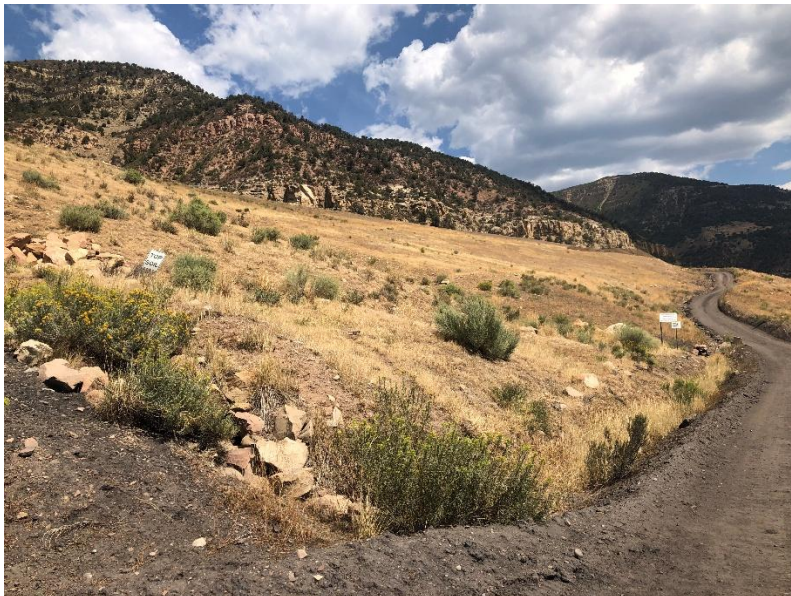
Topsoil stockpiles appeared to be stable.

Topsoil Stockpile, with Gob Pile #2 in background

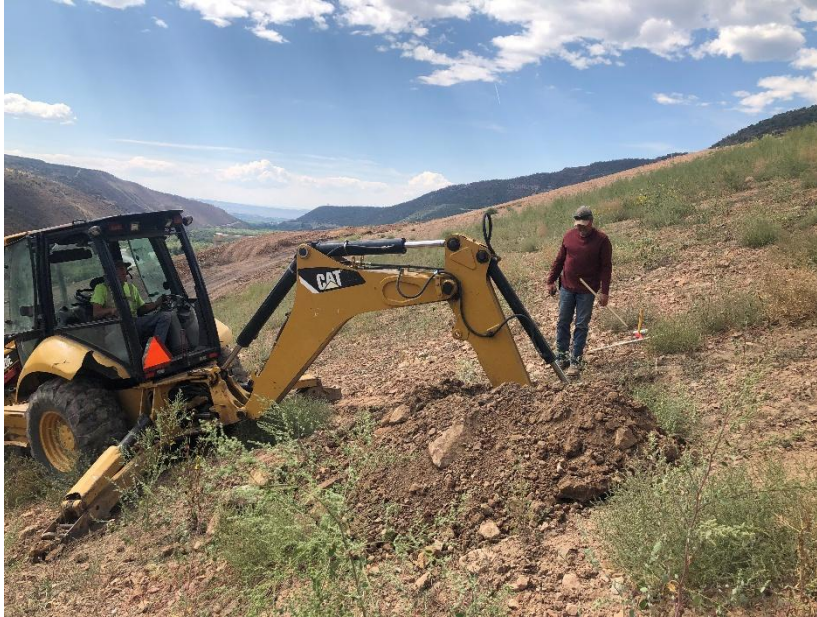
The depth of soil on Gob Pile #2 was approximately five feet deep at the location that was checked in the presence of the inspector. Tom Troyer indicated that depths were approximately four feet at dozens of locations. This is in line with the specification in Volume IX of the PAP for this permit, which states that coverfill depth should be approximately 3.5 feet, and topsoil depth should be 6 inches.

BRL staff checking coverfill depths at Gob Pile #2

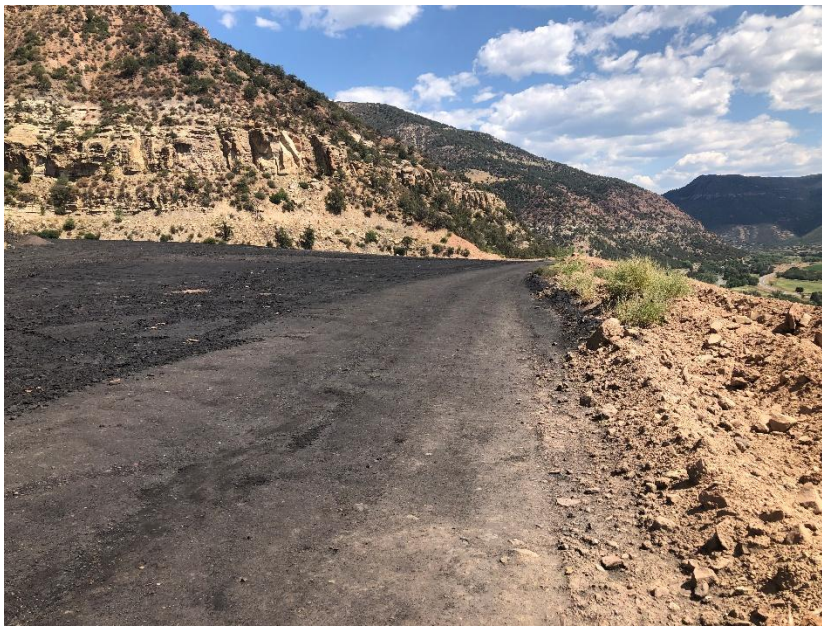
Upper portion of Gob Pile #2

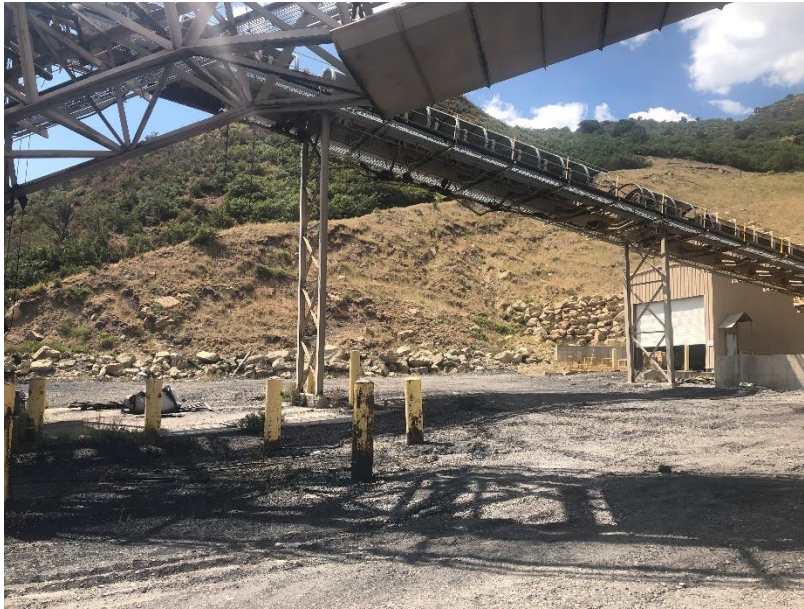
No problems were seen on the slopes above and below the benches. The slides above the B Portal Bench and Curve 11 (noted in the past) look stable. The slide above Curve Number 10 also looked stable, compared to photographs taken in recent months.

B Portal Bench

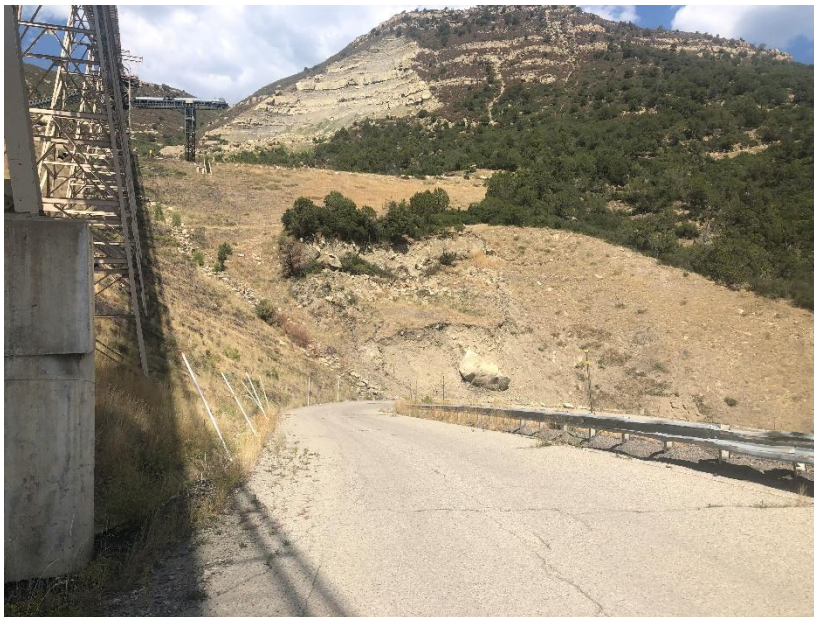
Slide at Curve 10

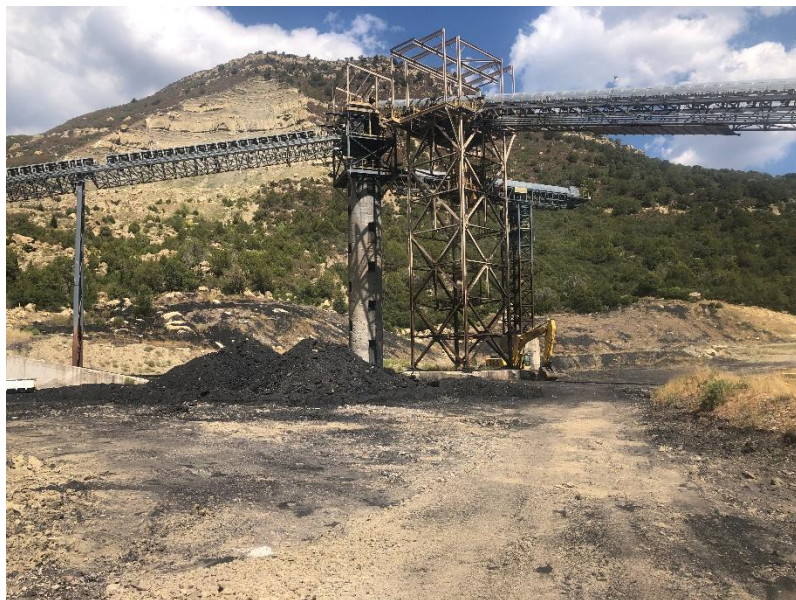
Piles of waste material on D Portal Bench

Piles of coal waste were seen at the D Portal Bench. BRL needs to haul the piles to Gob Pile #2 prior to winter.

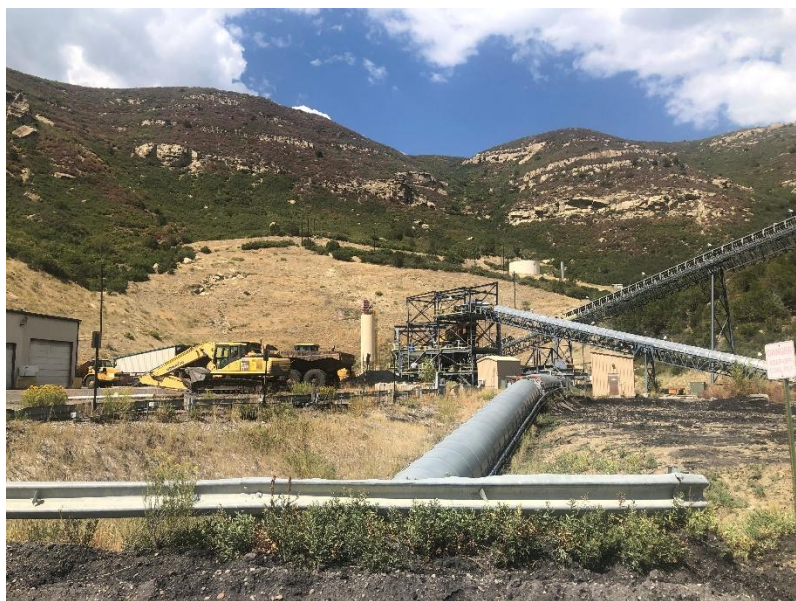
- Utility Bench
- D Portal Bench
- B Portal Bench
- Conveyor corridors
- The Coal Stockpile Pad
- The area around the office
- The Preparation Plant and nearby water tank
- Pump House and Filter Building
- Old power plant

Hillside below the Utility Bench

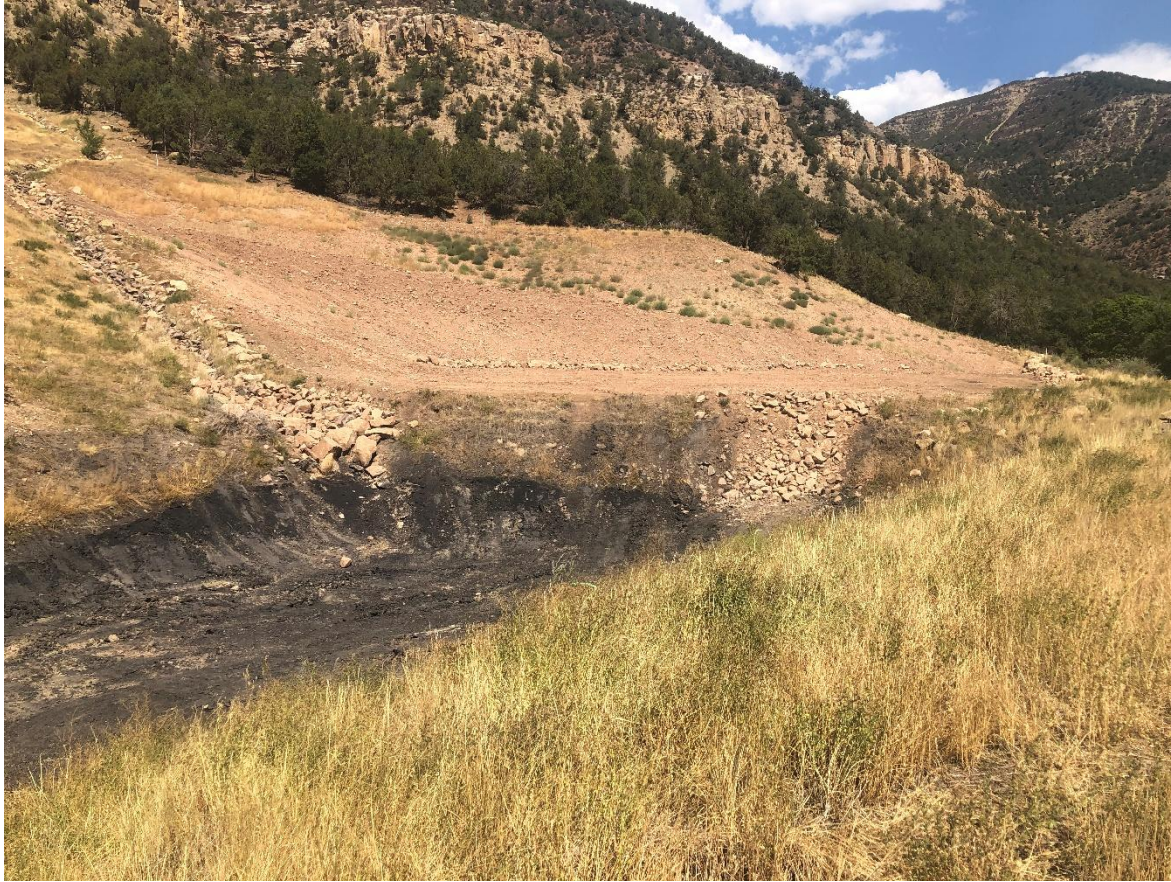
Five sediment ponds were inspected: B, C, D, F, and J. None of the ponds were close to discharging. Most of them were dry; the exception, Pond J, held a very small amount of water. No significant problems were identified with embankments, spillways, inlet channels, or other features of the ponds.

Pond F and former site of soil pile
