### PERMIT INFORMATION

| <b>Permit Number:</b> C-1981-028<br><b>Mine Name:</b> Keenesburg Strip Mine<br><b>Operator:</b> Coors Energy Company<br><b>Operator Address:</b><br>Mr. Ben Moline<br>P.O. Box 4030<br>Golden, CO 80402 | <b>County:</b> Weld<br><b>Operation Type:</b> Surface<br><b>Permit Status:</b> Permanent Cessation<br><b>Ownership:</b> Private |

### INSPECTION INFORMATION

| <b>Inspection Start Date:</b> September 5, 2025<br><b>Inspection Start Time:</b> 08:20<br><b>Inspection End Date:</b> September 5, 2025<br><b>Inspection End Time:</b> 09:45 | | <b>Inspection Type:</b> Coal Complete Inspection<br><b>Inspection Reason:</b> Normal I&E Program<br><b>Weather:</b> Cloudy | |

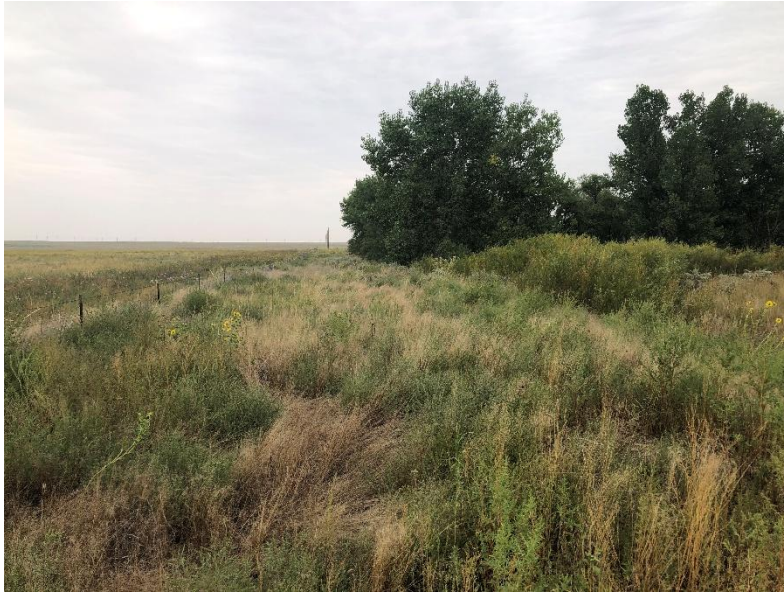
Sediment Pond 2 and the Dugout Pond contained no visible water; both ponds have large amounts of vegetation on their bottoms. Neither was discharging during the inspection, and there were no signs that the ponds had discharged recently. No problems were observed.

**Area below Sediment Pond 2**

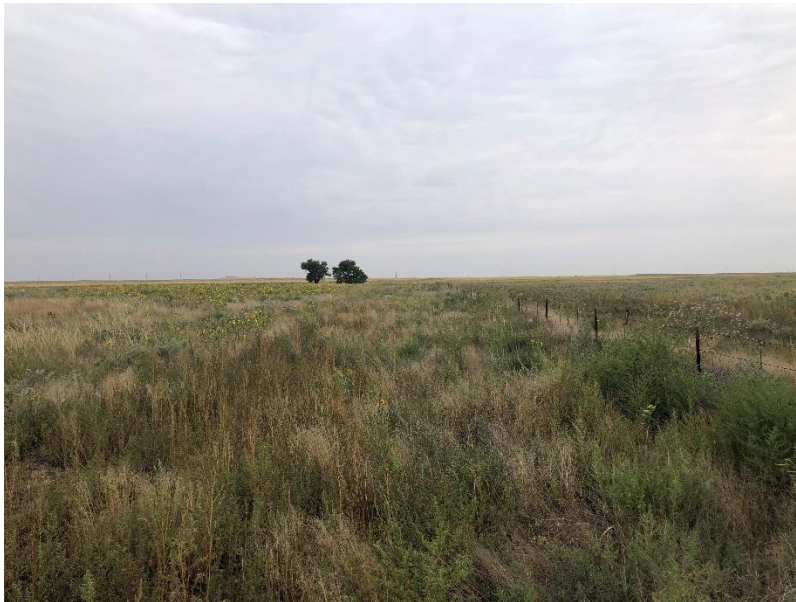
The entrance sign was in place and contained the necessary information. Boundary markers were observed on all sides of the site.

**Northern boundary, looking east**

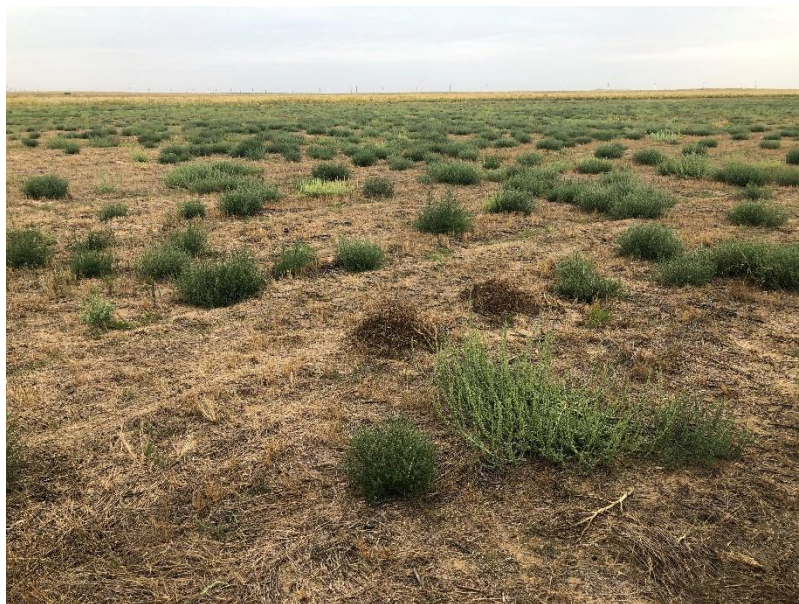
Other than cheat grass, no listed noxious weeds were identified. However, in some areas, non-desirable species such as Russian thistle (aka, tumbleweed) were prevalent.

**Russian thistle in Area 42 (west of Area 26)**

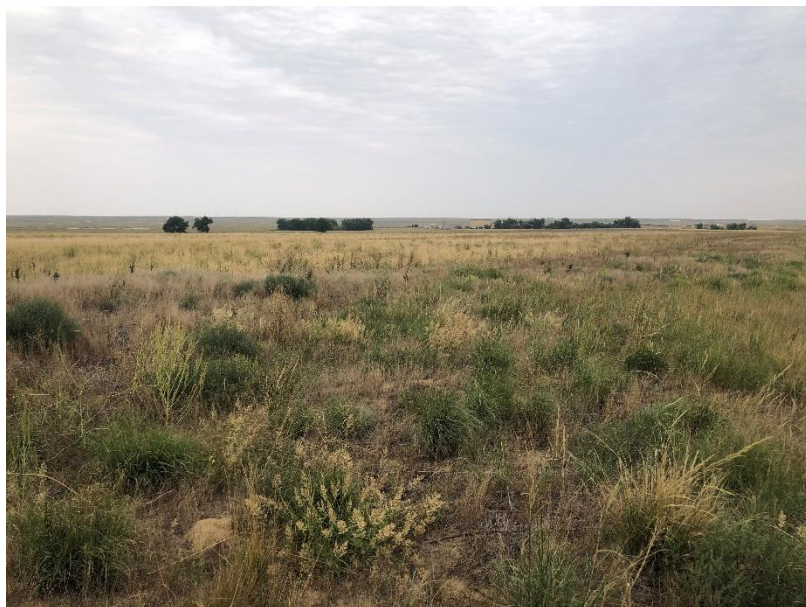
**Reclaimed Long Term Spoil Area, looking east**
