MINERALS PROGRAM INSPECTION REPORT
PHONE: (303) 866-3567

MINE NAME: Wagner Rock Pit	MINE/PROSPECTING ID#: M-1999-018	MINERAL: Gravel	COUNTY: Moffat
INSPECTION TYPE: Surety-Related Inspection	WEATHER: Clear	INSP. DATE: September 11, 2025	INSP. TIME: 08:00
OPERATOR: Wagner Construction Inc.	OPERATOR REPRESENTATIVE: Jay Wagner	TYPE OF OPERATION: 112c - Construction Regular Operation	
REASON FOR INSPECTION: Surety Related	BOND CALCULATION TYPE: Complete Bond	BOND AMOUNT: \$71,428.00	
DATE OF COMPLAINT: NA	POST INSP. CONTACTS: None	JOINT INSP. AGENCY: None	
INSPECTOR(S): Hunter Ridley	INSPECTOR'S SIGNATURE:

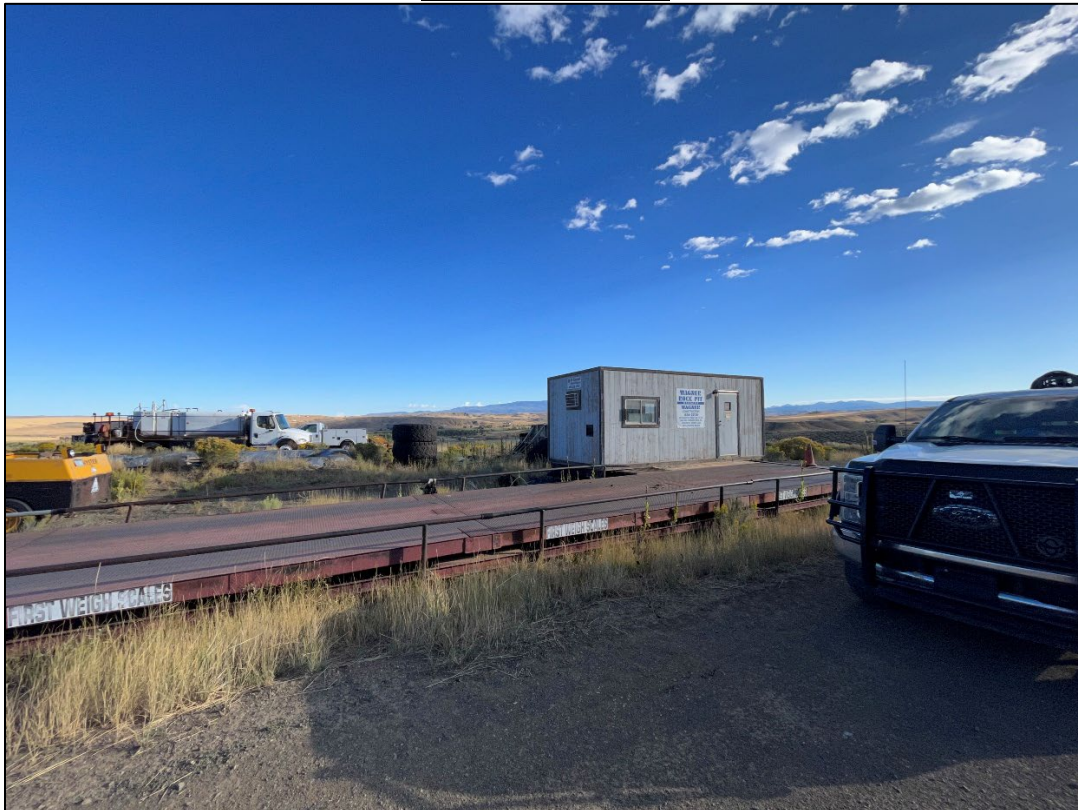
Photo 1: Scale house and permit sign.

Signs and Markers: The identification sign and affected area boundary markers are in place and in compliance with Rule 3. 1. 12. The sign is posted on the scale house (Photo 1) and includes all information necessary for compliance. Fence lines and T-posts (e.g. Photo 7) mark the permit boundary. Only ~17 acres of the 27.91 total acres are affected at this time.

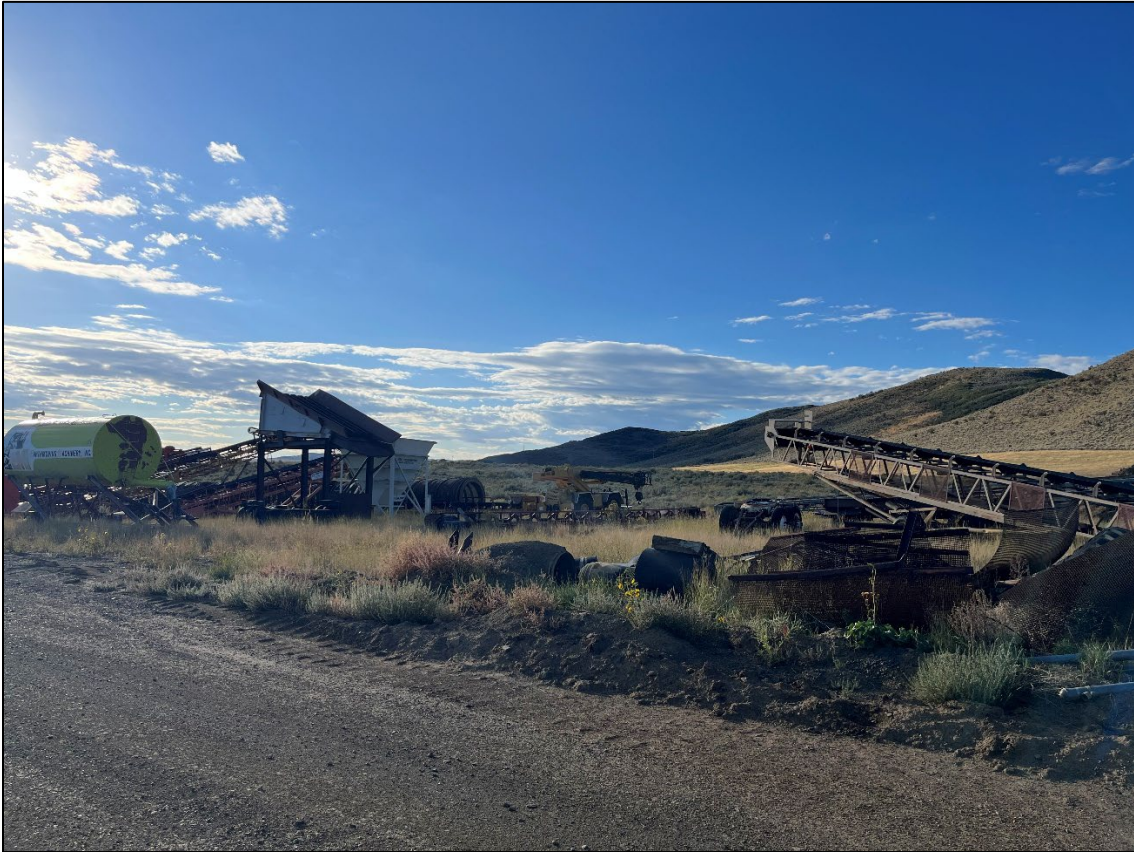
Photo 2: Equipment storage in the eastern half of the permit.

Revegetation: Areas not currently being mined are used for equipment storage (Photo 2) or storage of stockpiles (Photo 6) which vary in size of material. Overburden is stored on site around the pit area. Some weed species such as houndstongue and thistle are present, but limited populations and visual evidence suggest that the Operator is vigilant with hand spraying and treating weed species on site.

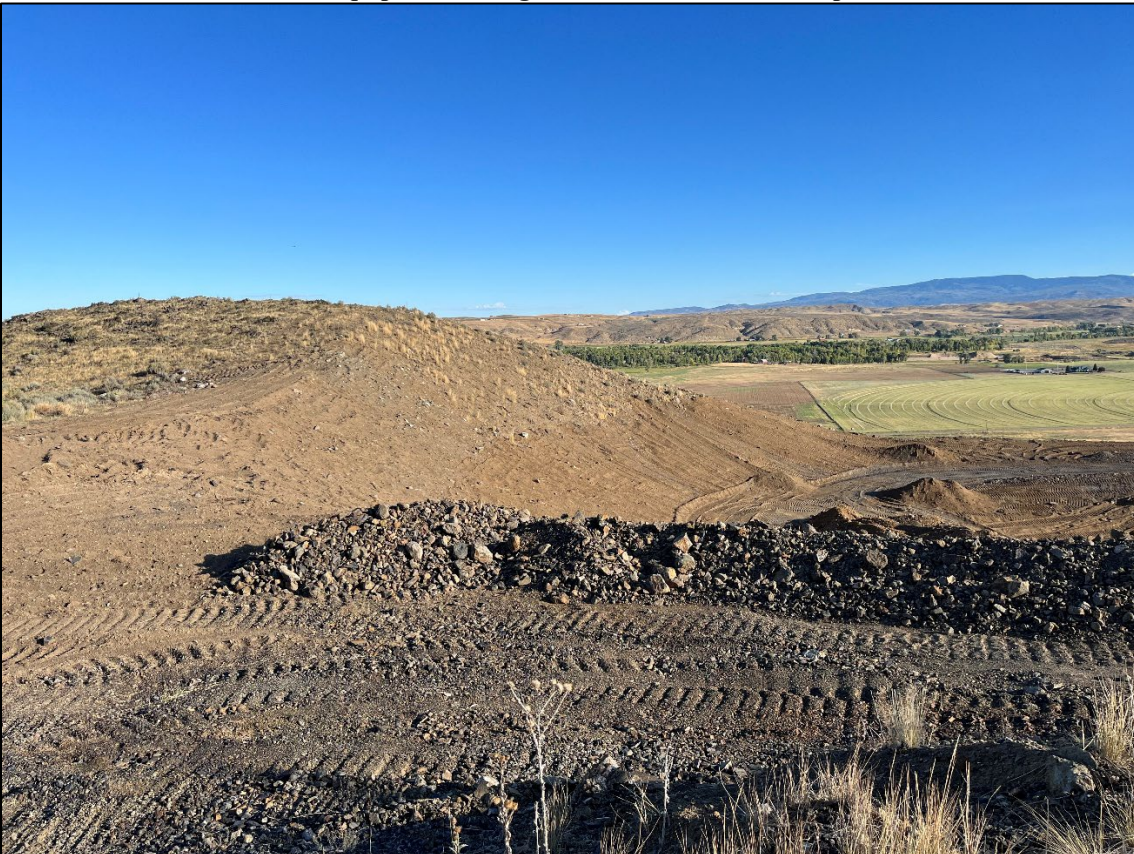
Backfilling and Grading: Some backfill and grading work, about 40%, for final reclamation has occurred onsite (Photos 3 and 4). Several vertical highwalls, in the north and southwestern end of the permit, remain in place and are broken up into two pits. The deeper pit is furthest west (Photos 4 and 5) and the shallower pit is to the east (Photo 8). Other slopes are made up of stockpiled topsoil and overburden, which will be distributed across the site in final reclamation. The highwalls and multiple stockpiles all appeared stable with no signs of instability, tension cracks or erosion.

Photo 3: View north of the recently graded, topsoiled and seeded western end of the affected area.

Reclamation Success: Partial reclamation has been initiated at this site. Several mined slopes have been backfilled, graded and seeded this year (Photos 3 and 4). No vegetation was noted to be growing yet on seeded slopes. This reclamation is the focal point of the Operator's request for a Surety Reduction (SR-1). Reclamation has been limited to areas in the western half of the permit. The Division has taken these completed reclamation activities into account during the recalculation of the required bond amount. This is further discussed in the 'Financial Warranty' section above.

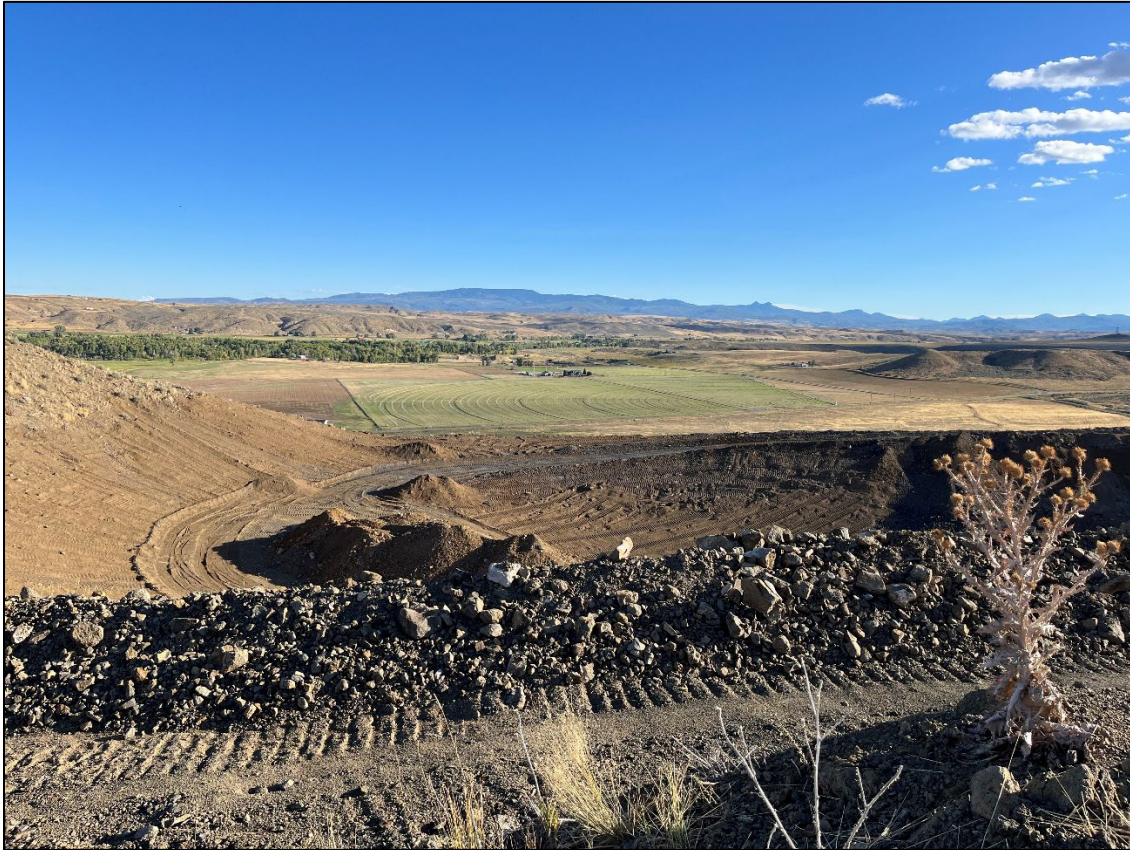
Photo 4: Continued view north into the pit area where several highwalls have been leveled to final grade.

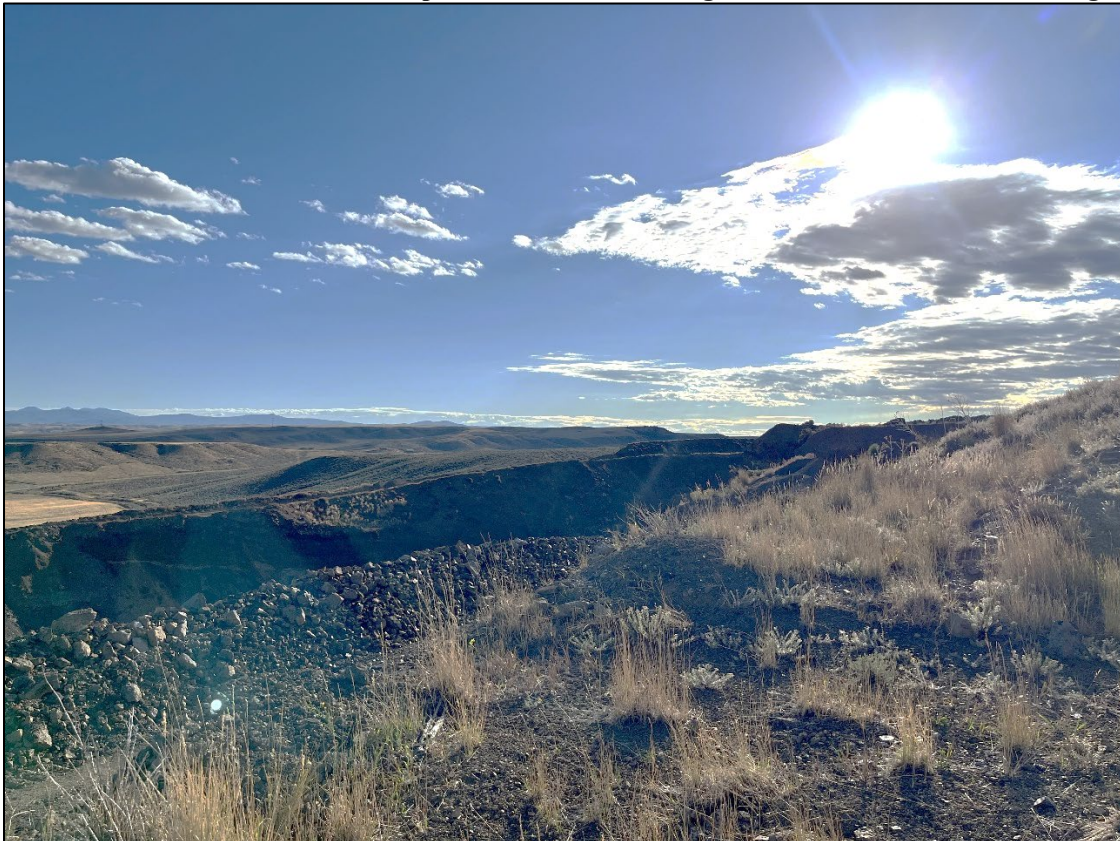
Photo 5: View northeast towards the current highwall and active mining area, a topsoil pile is in the foreground.

Topsoil: Topsoil berms line the sides of the pit highwalls and along the southern permit boundary. These are well vegetated with sagebrush and bunch grasses (Photo 5). Piles are marked in accordance with Rule 3.1.9.

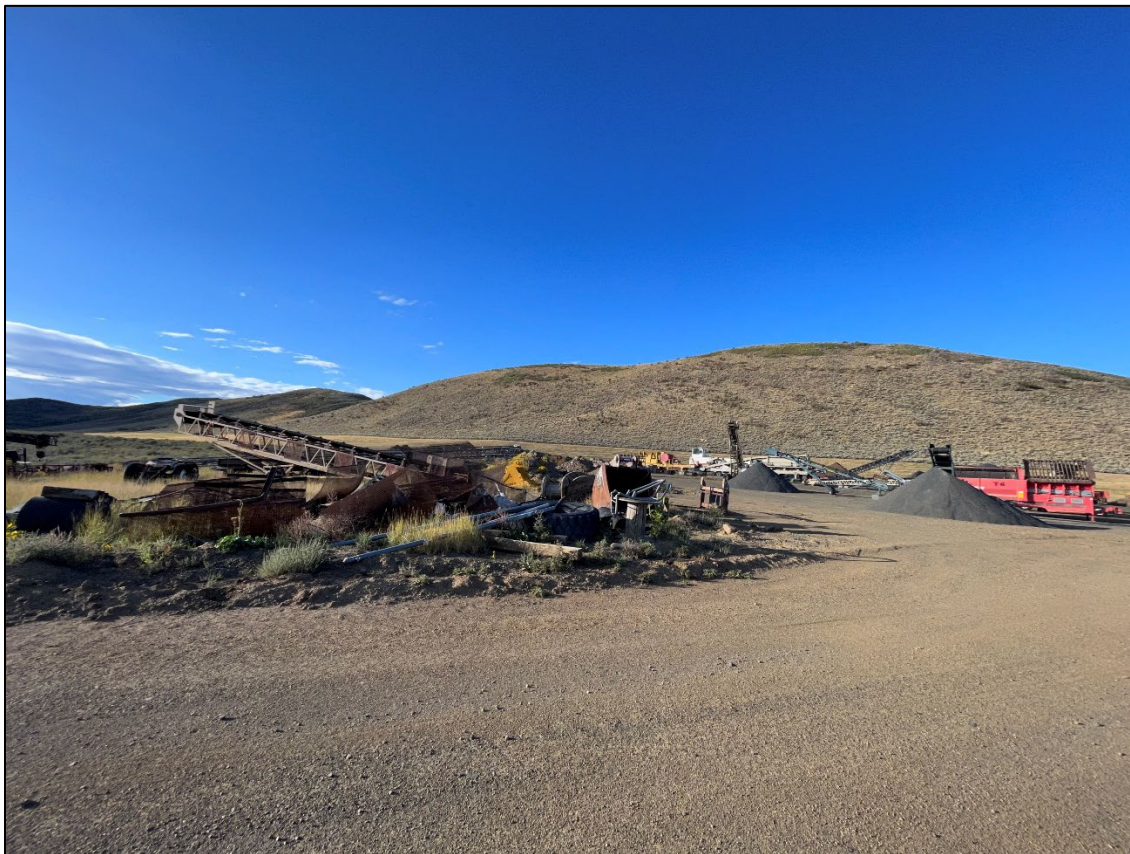
General Mine Plan Compliance: The site is active and operates on an as needed basis as material orders are placed. Multiple stockpiles of varying product size are located within the pit area (Photo 6).

Photo 6: Equipment storage and material stockpiles on the southeastern portion of the permit.

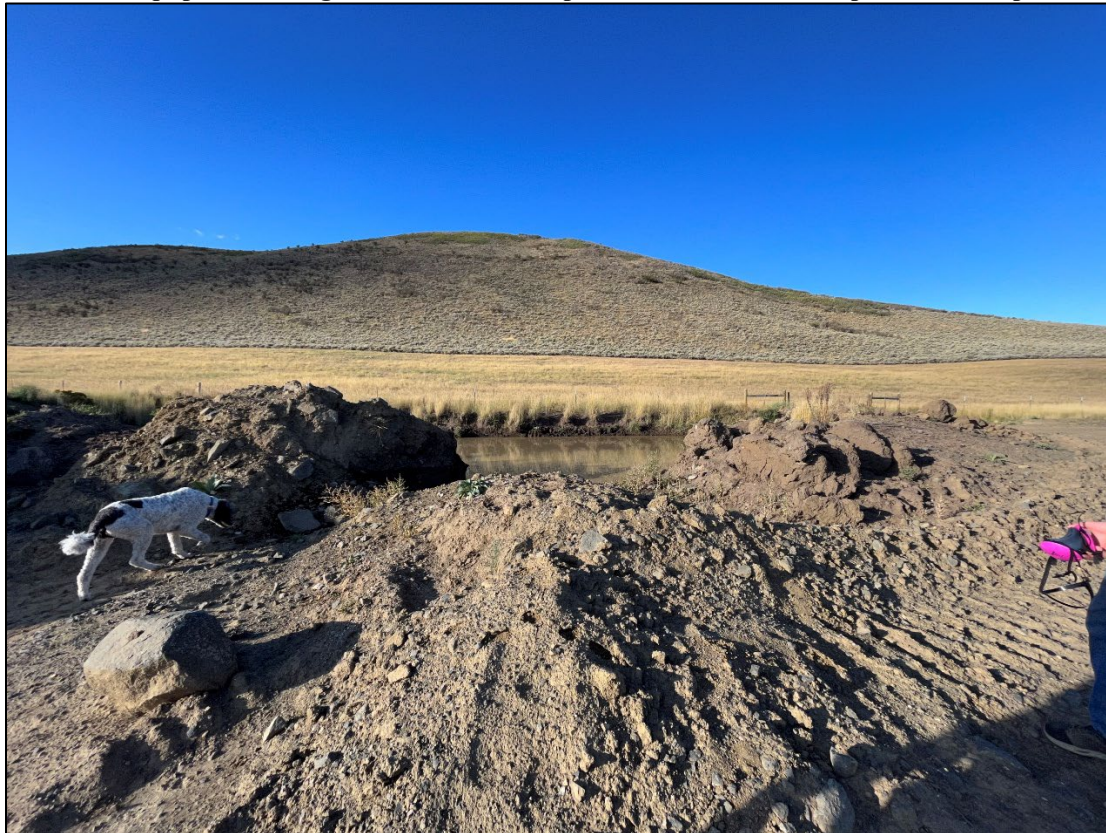
Sediment Control: No erosion problems were observed and no BMPs were needed at the time of the inspection. Three sediment control ponds are located around the southern and western edges of the affected area (e.g. Photo 7). These capture stormwater and filter any excess sediment.

Photo 7: One of three small sediment sumps used to contain stormwater onsite.

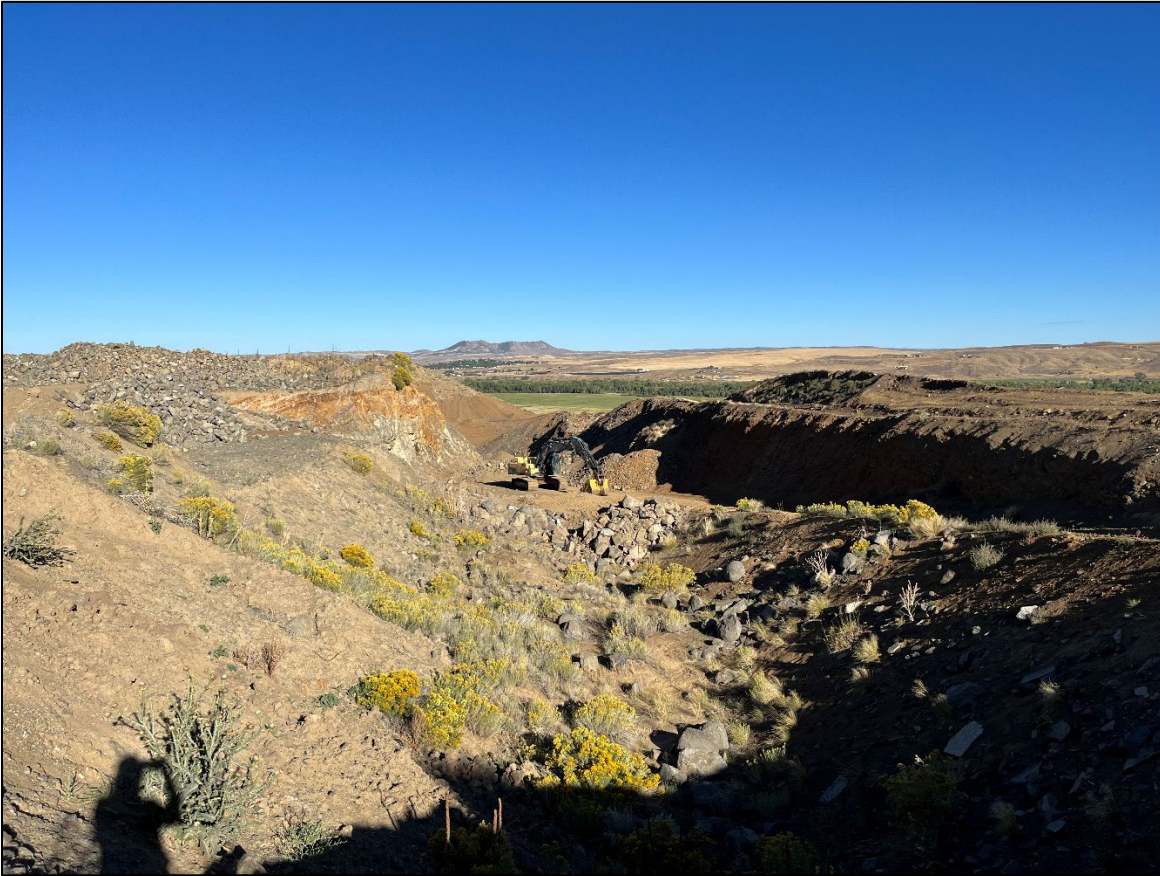
Photo 8: View northwest into the smaller pit / highwall area.
