**COLORADO DIVISION OF RECLAMATION, MINING AND SAFETY**  
**MINERALS PROGRAM INSPECTION REPORT**  
**PHONE: (303) 866-3567**

<b>MINE NAME:</b> Weimer One Gravel	<b>MINE/PROSPECTING ID#:</b> M-2001-002	<b>MINERAL:</b> Sand and gravel	<b>COUNTY:</b> Montrose
<b>INSPECTION TYPE:</b> Surety Release Inspection	<b>INSPECTOR(S):</b> G. Russell Means	<b>INSP. DATE:</b> April 24, 2012	<b>INSP. TIME:</b> 08:00
<b>OPERATOR:</b> West End Gravel Company	<b>OPERATOR REPRESENTATIVE:</b>	<b>TYPE OF OPERATION:</b> 112c - Construction Regular Operation	
<b>REASON FOR INSPECTION:</b> Surety Related	<b>BOND CALCULATION TYPE:</b> IT.Bondcalculationtype.CD.Desc	<b>BOND AMOUNT:</b> \$51,615.00	
<b>DATE OF COMPLAINT:</b> NA	<b>POST INSP. CONTACTS:</b> None	<b>JOINT INSP. AGENCY:</b> None	
<b>WEATHER:</b> Clear	<b>INSPECTOR'S SIGNATURE:</b>

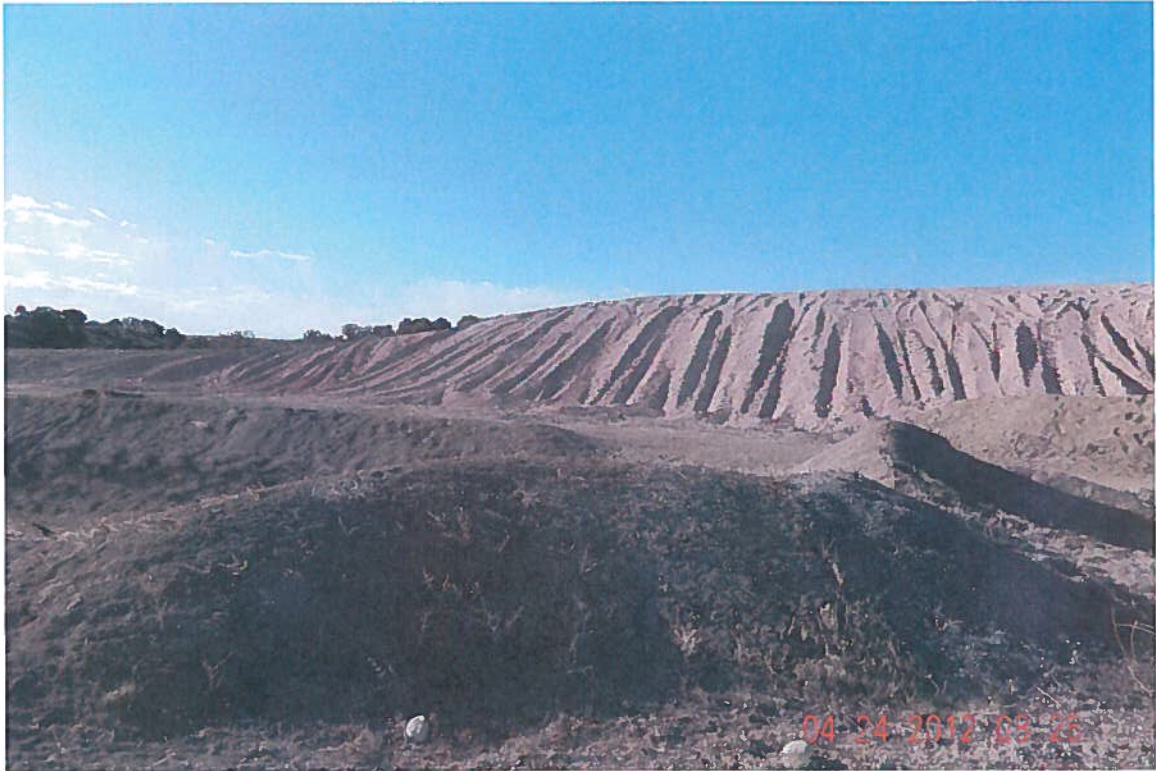
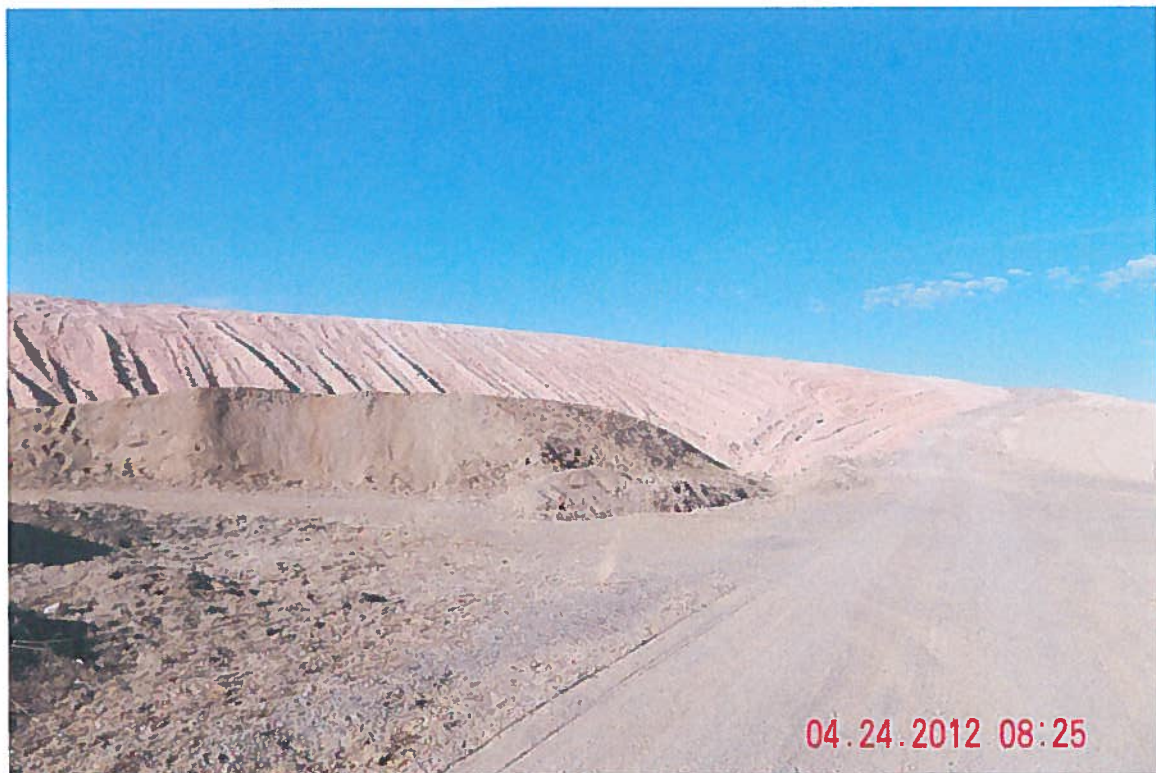
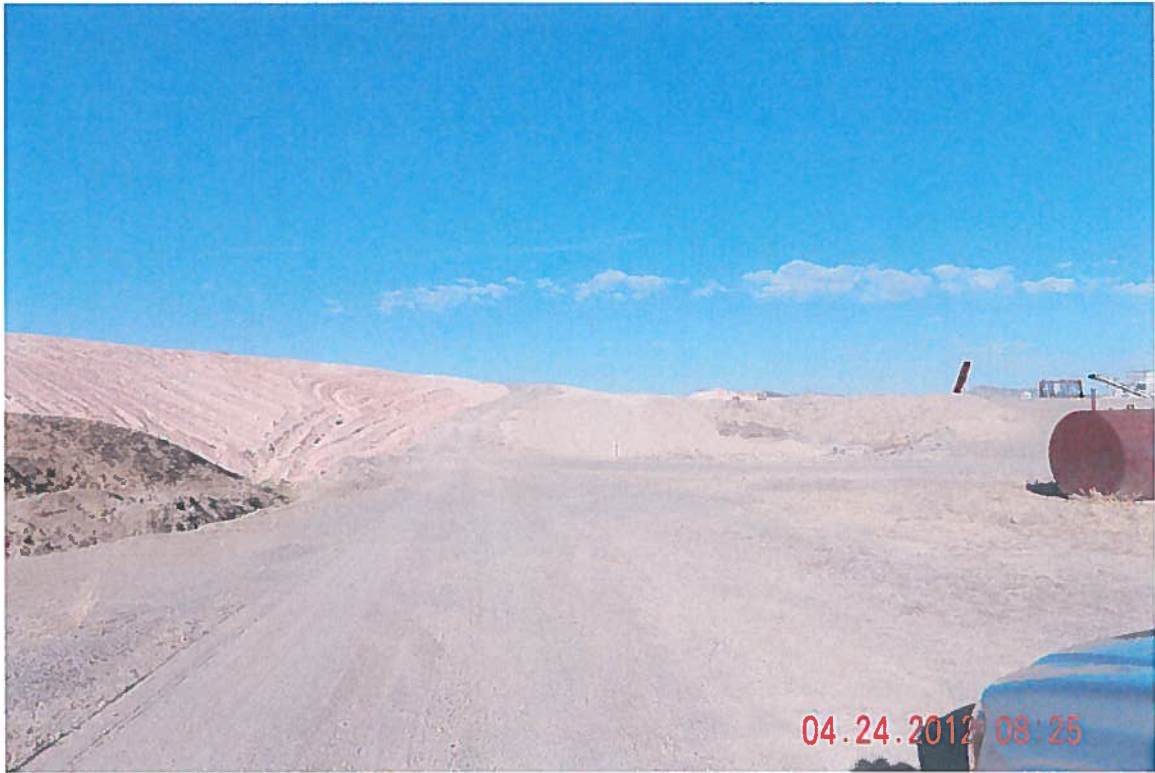
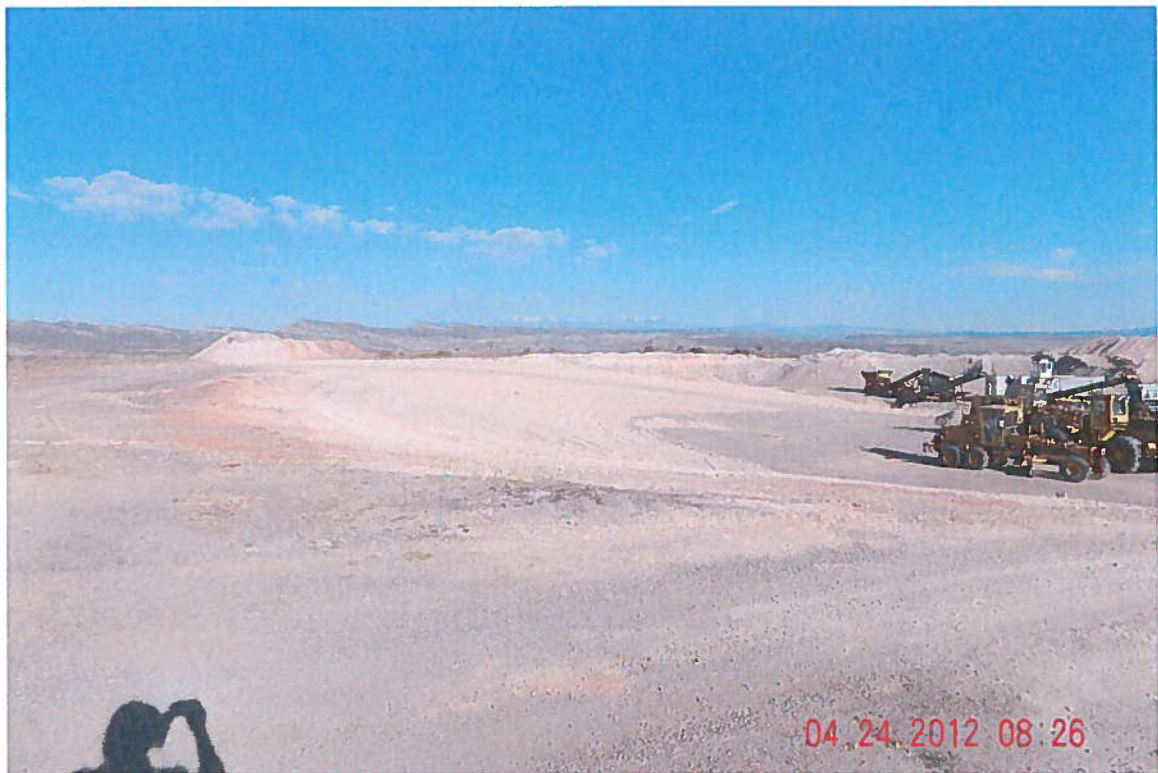
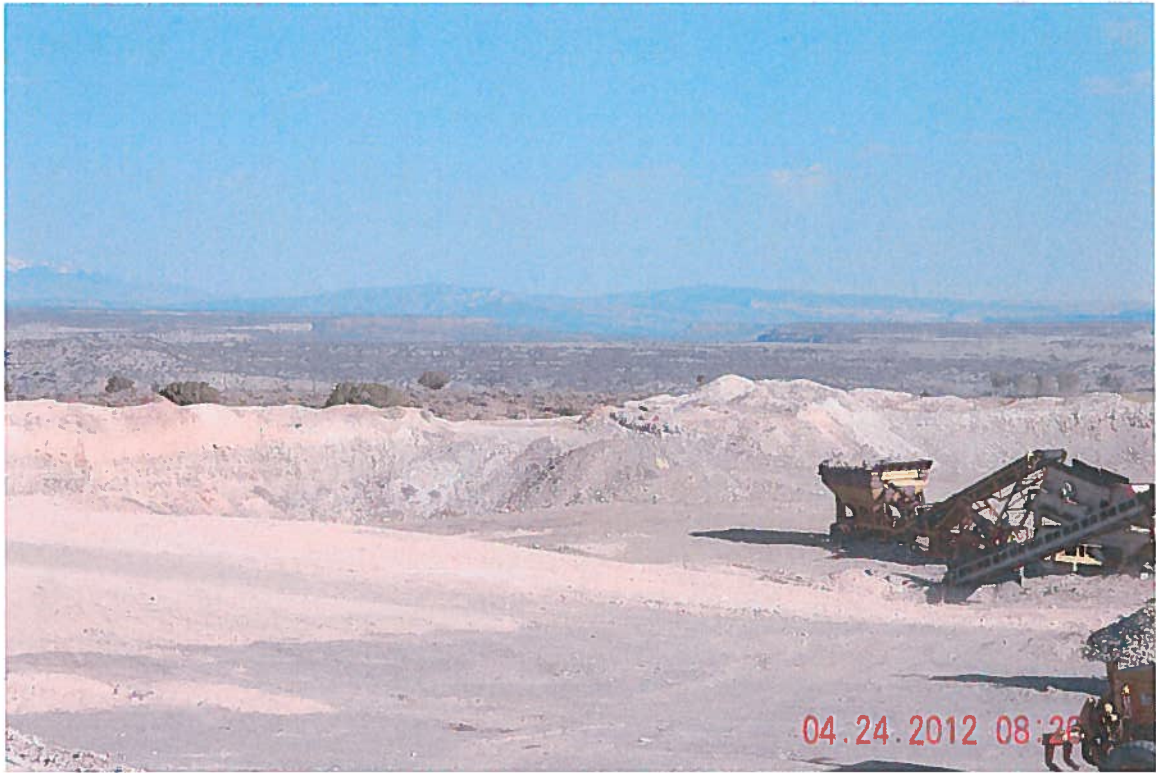
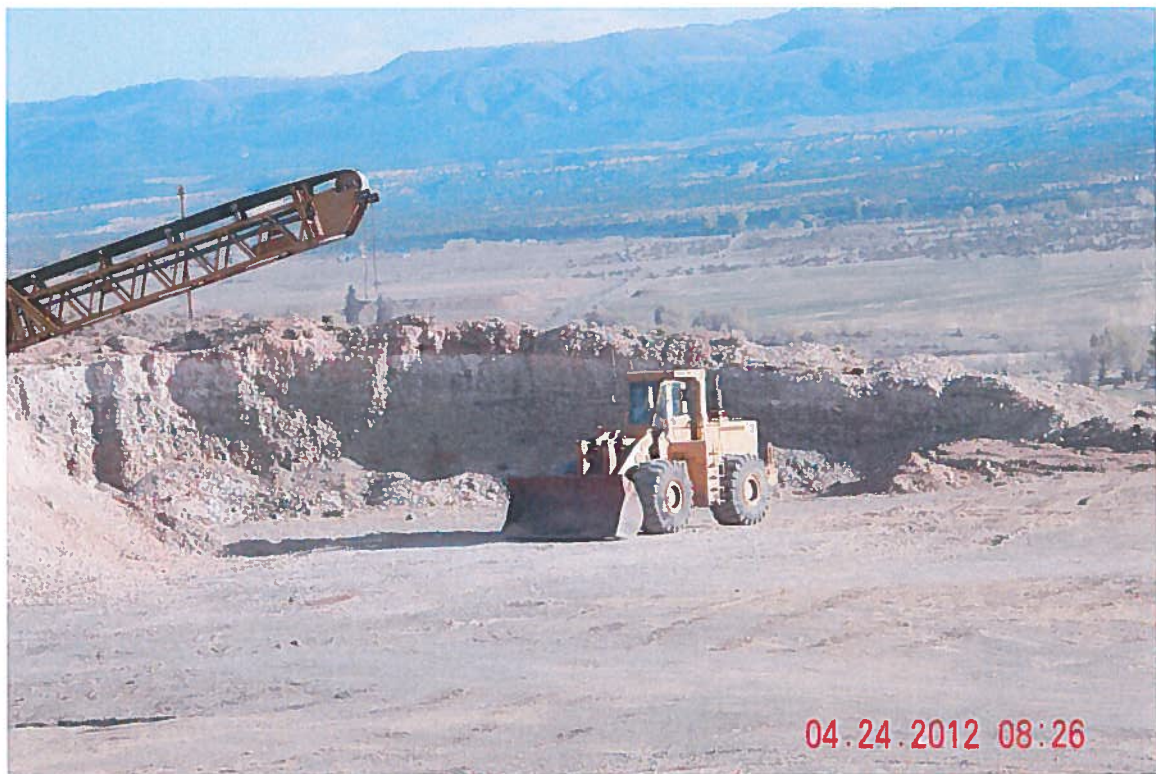
The slopes are now 2.5:1 or better and acceptable. Material is what may be considered topsoil like for this area.

The site has not been reseeded. This should be done right before monsoon season or in the fall. Seeding must be done by this fall to protect topsoil otherwise reclamation could be hampered significantly.

The operator has had discussions with the local weed control. The inspector has previously noted some knapweed which should be sprayed in a few weeks otherwise reclamation will be compromised.
