**RIO GRANDE
SILVER, INC.**

RE: Prospector Application for Release of Warranties: DRMS NOI P-2008-037
NOI P-2010-007, P-2010-007 MD-1

Prospector Application for Release of Warranties

Summary of Reclamation Performed:

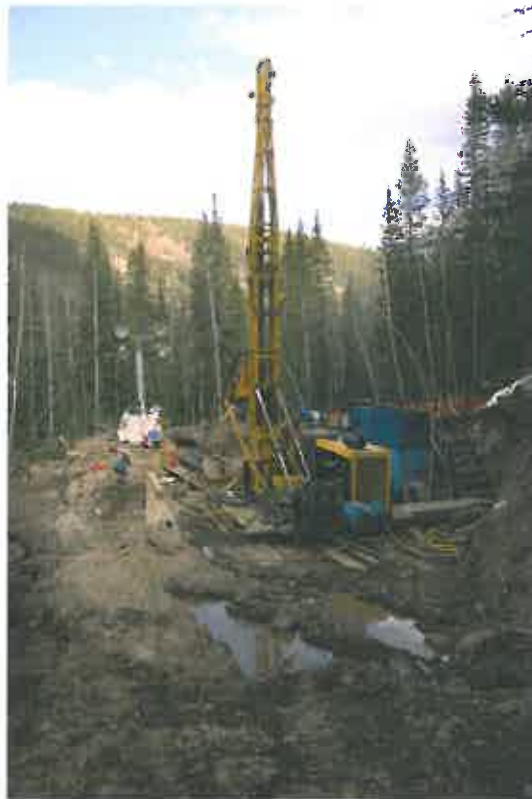
CIS Pad-4 in 2010

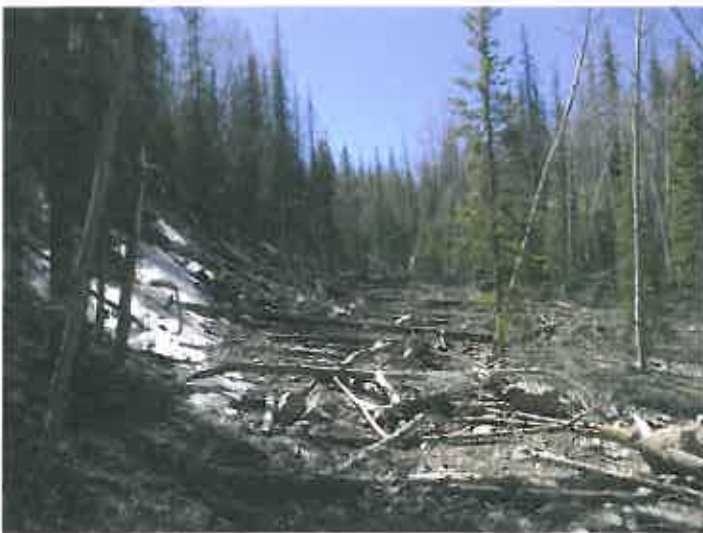
Reclaimed CIS Pad-4

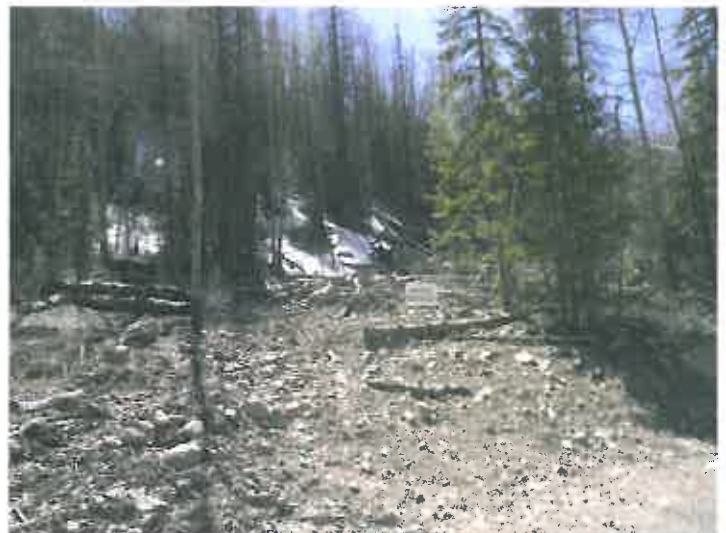
Reclaimed road to CIS Pad-4

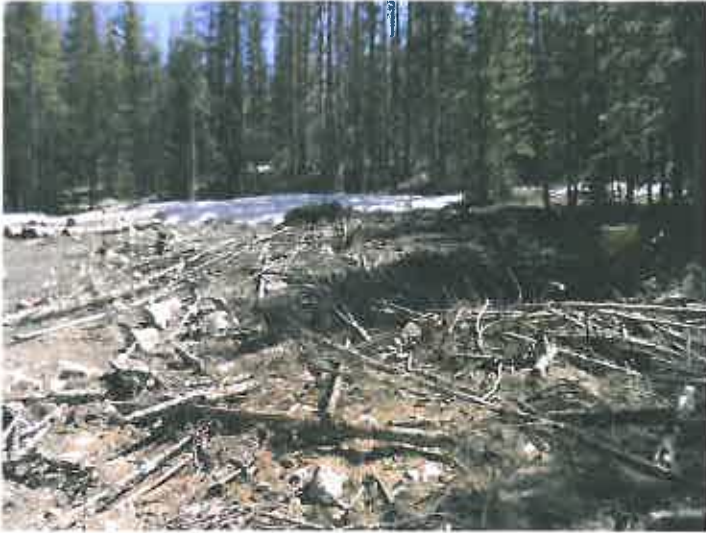
Reclaimed CIS-3 PAD

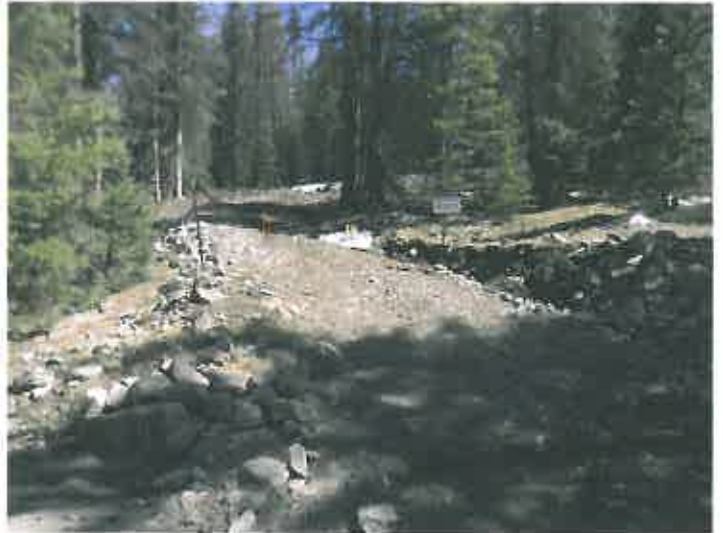
Private Access to CIS Pad-3. Big Dan Pat. Claim

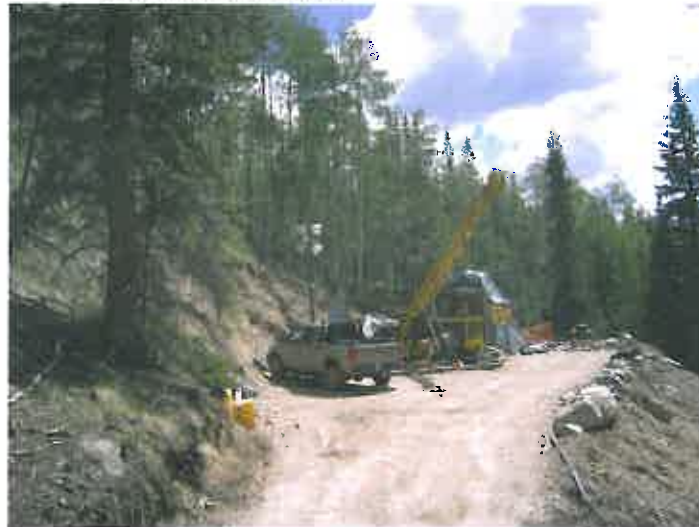
CIS Pad-2 in 2010

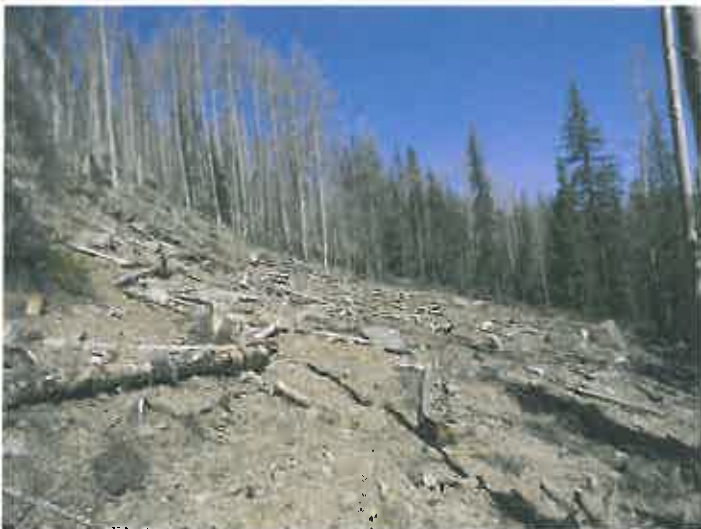
Reclaimed CIS Pad-2

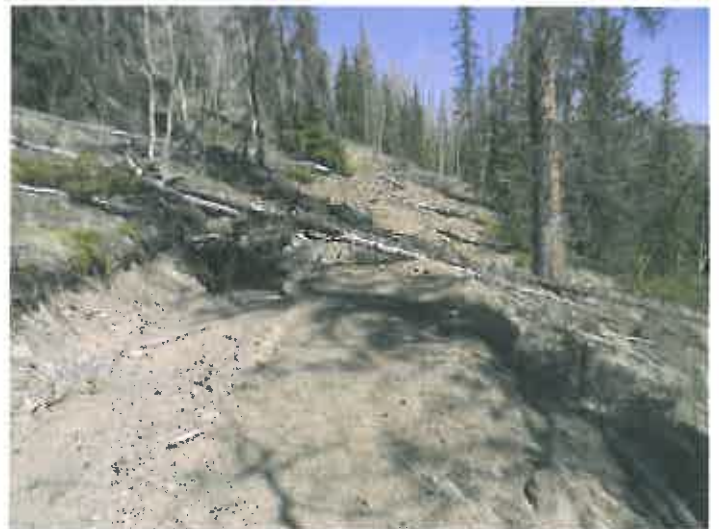
Reclaimed road to CIS Pad-2

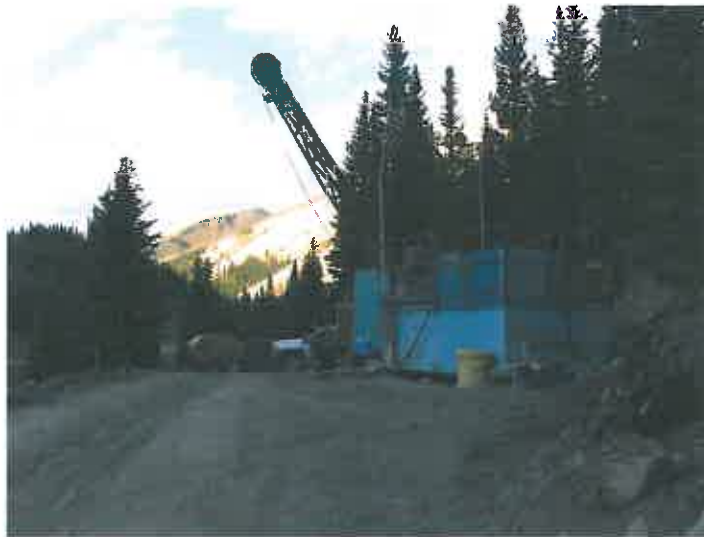
NA Pad-1 in 2010

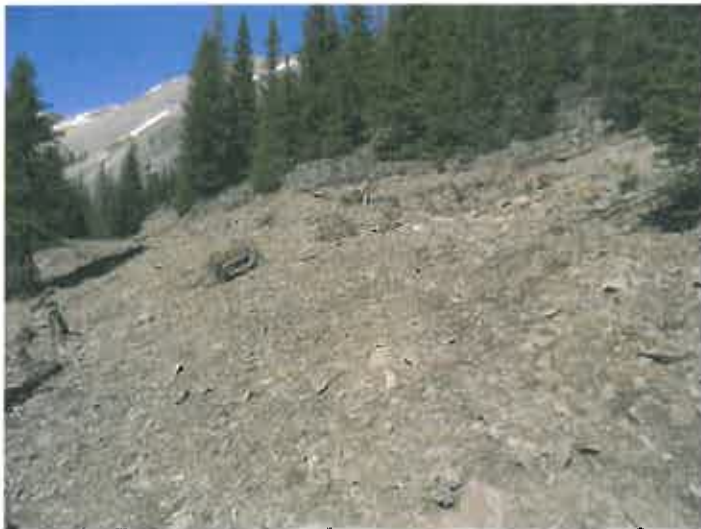
Reclaimed NA Pad-1

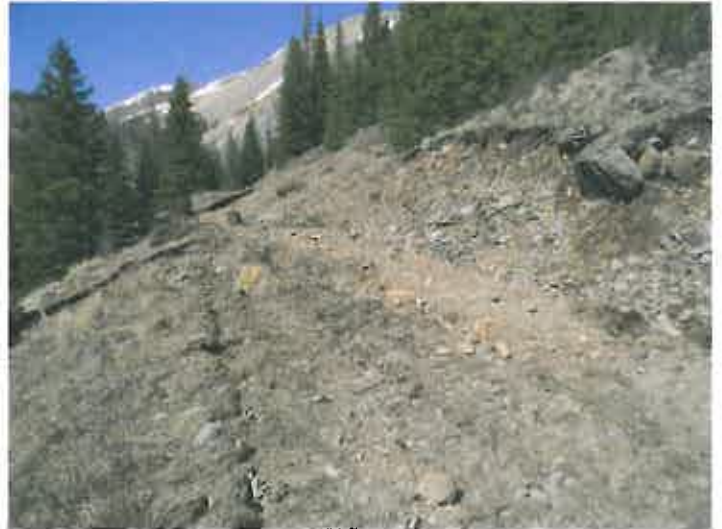
Pre-existing abandoned county road to NA Pad-1
