**COLORADO DIVISION OF RECLAMATION, MINING AND SAFETY  
COAL PROGRAM INSPECTION REPORT**

<b>Permit Number:</b> C-1992-081 <b>Mine Name:</b> Hayden Gulch Loadout <b>Operator:</b> Hayden Gulch Terminal, LLC <b>Operator Address:</b> Mr. Roy Karo 37796 Routt County Road 53 P.O. Box 670 Hayden, CO 81639	<b>County:</b> Routt <b>Operation Type:</b> Loadout <b>Permit Status:</b> Permanent Cessation <b>Ownership:</b> Private
	<b>Operator Representative Present:</b>  Roy Karo
<b>Operator Representative Signature:</b> (Field Issuance Only)

<b>Inspection Start Date:</b> October 1, 2012 <b>Inspection Start Time:</b> 14:50 <b>Inspection End Date:</b> October 1, 2012 <b>Inspection End Time:</b> 17:00	<b>Inspection Type:</b> Coal Complete Inspection <b>Inspection Reason:</b> Normal I&E Program <b>Weather:</b> Clear
<b>Joint Inspection Agency:</b>  None	<b>Joint Inspection Contacts:</b>
<b>Post Inspection Agency:</b>  None	<b>Post Inspection Contacts:</b>
<b>Inspector(s):</b>  Jared L. Ebert	<b>Inspector's Signature:</b>

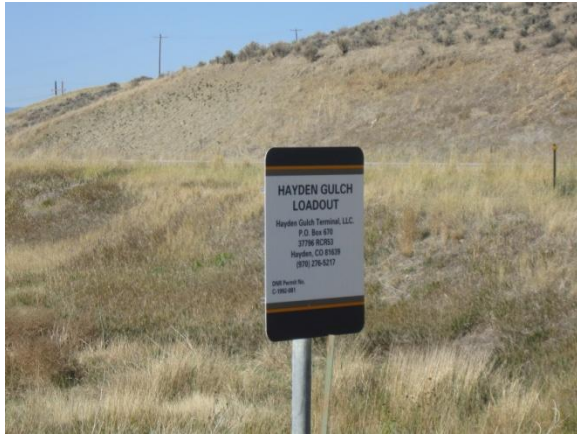
New mine entrance signs have been installed to comply with Rule 4.02.2. These signs have been placed at each public road that enters the permit area.

Mine entrance sign

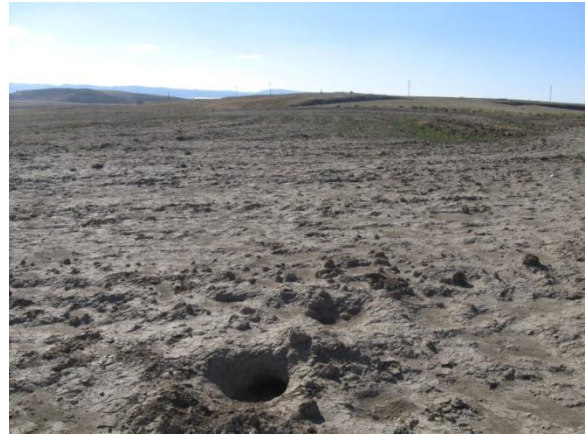
Topsoil stockpile #2 has been graded to a gentle slope. Very little vegetation has established on this pile during the growing season. The Operator will need to monitor this pile to insure adequate measures are taken to protect the remaining topsoil in this stockpile from wind and water erosion.

Topsoil Stockpile 2

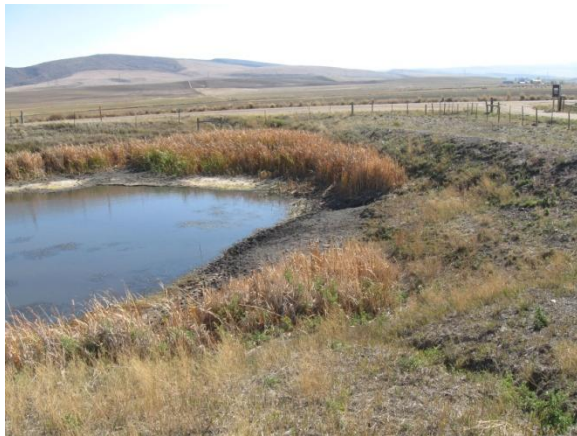
The truck loop pond was holding a small amount of water but was not discharging. The slopes were stable and well vegetated. The spillway was clear and functional.

Truck Loop Pond

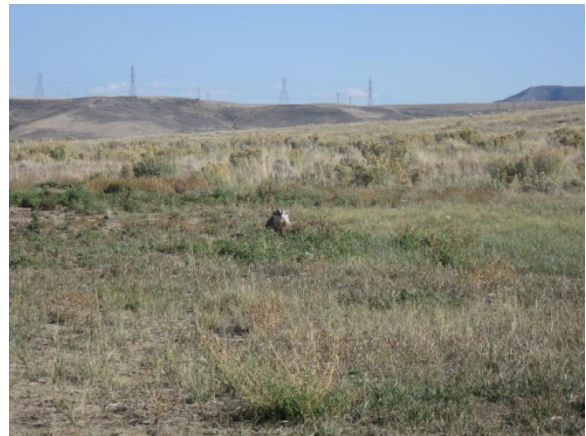
Topsoil stockpile #3 is delineated with metal posts; however the labeled signs have been knocked off the metal posts and will need to be replaced. This pile has been graded to blend into the surrounding topography. Several badgers holes were observed in the topsoil stockpile area. Likely the offending badger was observed in the pile area.

Topsoil Stockpile 3

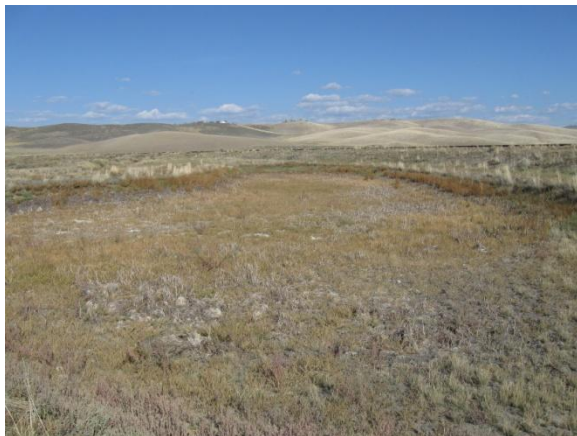
The rail loop pond was dry and not discharging. The spillway appeared stable and functional.

Rail Loop Pond

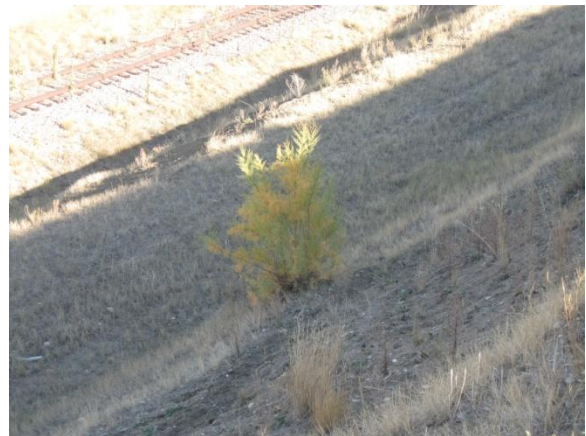
A tamarisk tree was observed on the south side of the rail line on the southwest portion of the loop inside the steep embankment. This is a state listed noxious weed and will need to be treated.

Tamarisk tree
