COLORADO DIVISION OF RECLAMATION, MINING AND SAFETY COAL PROGRAM INSPECTION REPORT

Permit Number: C-1980-007 Mine Name: West Elk Mine Operator: Mountain Coal Company, LLC Operator Address: Ms Kathleen G Welt P.O. Box 591 Somerset, CO 81434	County: Delta, Gunnison Operation Type: Underground Permit Status: Active Ownership: Federal
	Operator Representative Present: Kathy Welt
Operator Representative Signature: (Field Issuance Only) NA – Issued from Denver Office

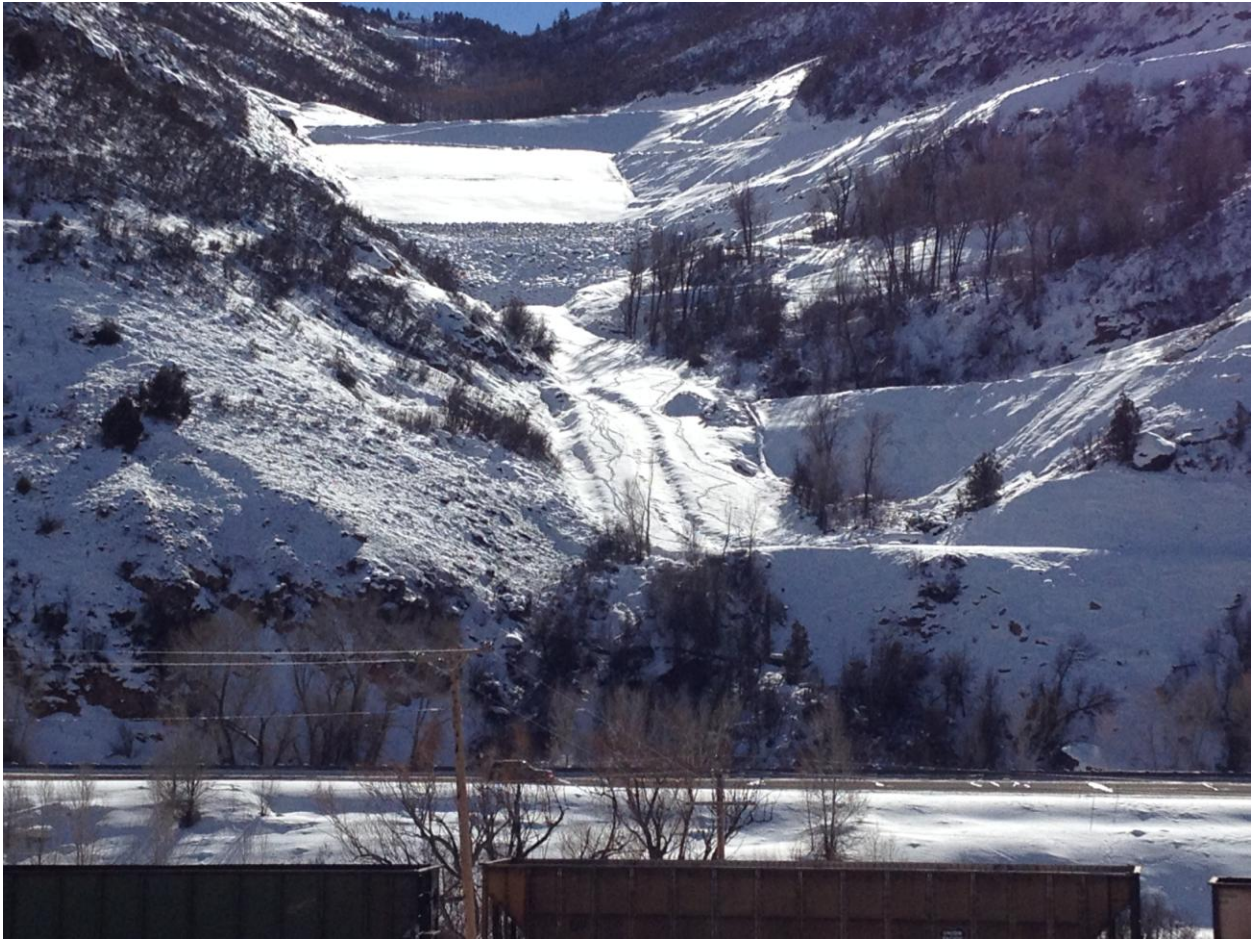
- The road to the RPEE was closed due to weather. It is anticipated that the RPEE and the haul road to the RPEE will remain closed until late spring, when conditions improve. During the summer and early fall West Elk removed the temporary coal that was stockpiled at the RPE and hauled it to the RPEE. They also excavated additional refuse and hauled that to the RPEE. This provided additional room for a refuse stockpile at the RPE. This stockpiled refuse will then be transported to the RPEE next summer.

RPEE and ditches – taken from old Highway 133

- As with every winter at the West Elk Mine, the ditches are all covered with snow at this point. The Division understands that, although the ditches are covered with snow, water can still flow in the ditch and the snow acts as an insulator. However, West Elk needs to continue to monitor the ditches to ensure that they do not become frozen and/or blocked and no water is flowing out of the ditches and onto the roads.

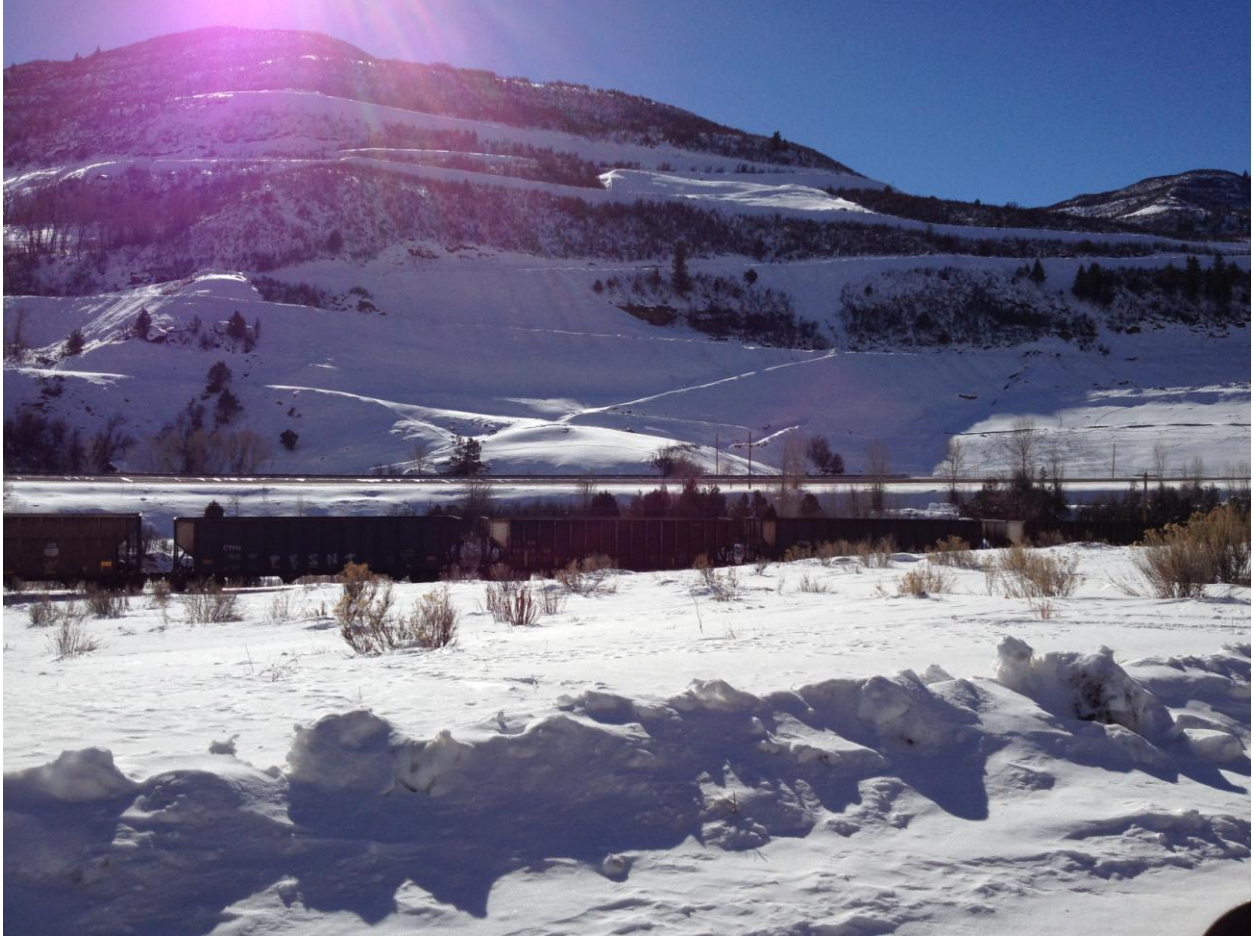
- The HR-1 slide area was covered with snow but appeared to be stable at the time of the inspection. There did not appear to be any movement in the slide remediation area.

HR-1 slide area – taken from old Highway 133
