COLORADO DIVISION OF RECLAMATION, MINING AND SAFETY COAL PROGRAM INSPECTION REPORT

Permit Number: C-1981-038 Mine Name: Bowie No. 1 Mine Operator: Bowie Resources, LLC Operator Address: Mr Basil Bear P.O. Box 1488 Paonia, CO 81428	County: Delta Operation Type: Underground Permit Status: Permanent Cessation Ownership: Federal
	Operator Representative Present: None Present
Operator Representative Signature: (Field Issuance Only)

Inspection Start Date: March 20, 2013 Inspection Start Time: 10:30 Inspection End Date: March 20, 2013 Inspection End Time: 12:00	Inspection Type: Coal Complete Inspection Inspection Reason: Normal I&E Program Weather: Clear
Joint Inspection Agency: None	Joint Inspection Contacts:
Post Inspection Agency: None	Post Inspection Contacts:
Inspector(s): Susan L. Burgmaier	Inspector's Signature: <i>Susan Burgmaier</i> Signature Date: 03/21/2013

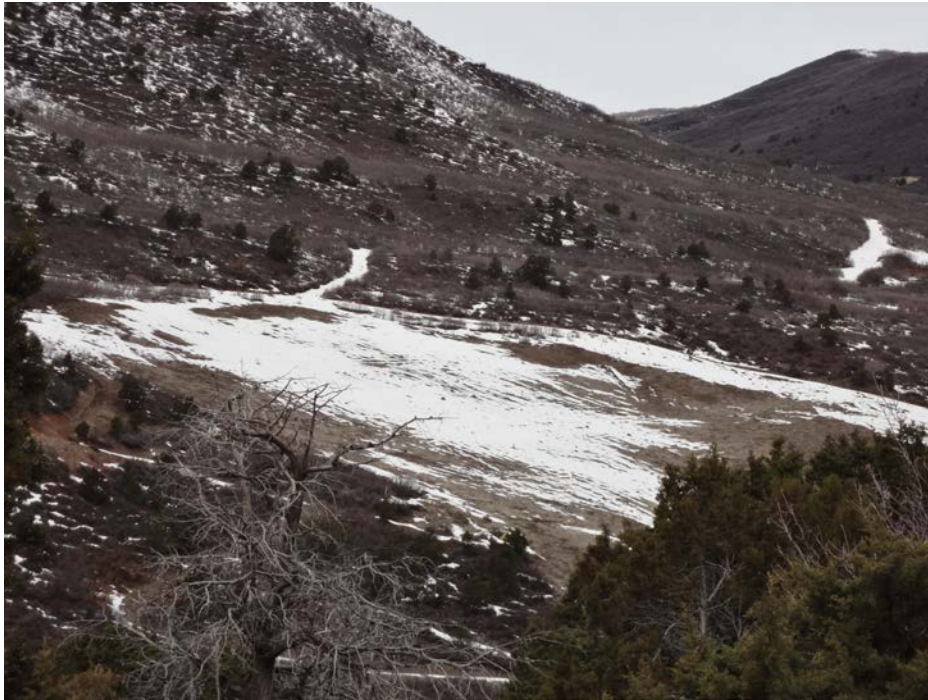
The road into the West Mine area was not plowed and was covered by about 6" of snow. The East Mine road was clear of snow but very muddy and not drivable.

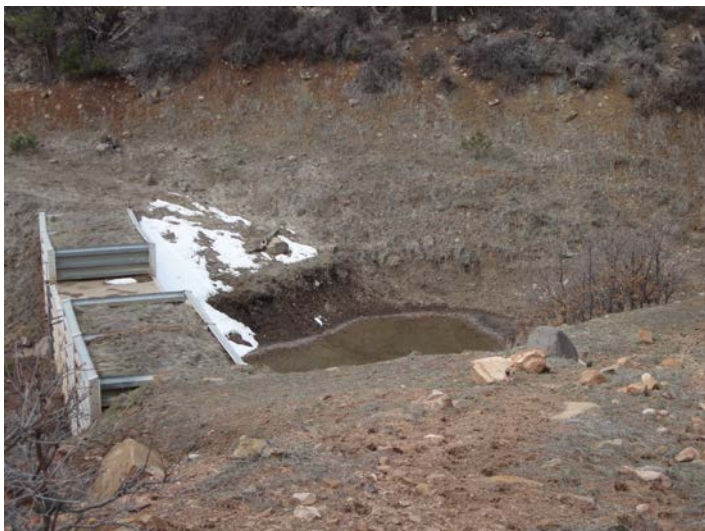
The ROM area pond and Pond 2 at the East Mine and the west loadout pond held water, but none were discharging. Ponds 1, 2, and 3 at the East Mine and the east loadout area pond were dry. The West Mine and

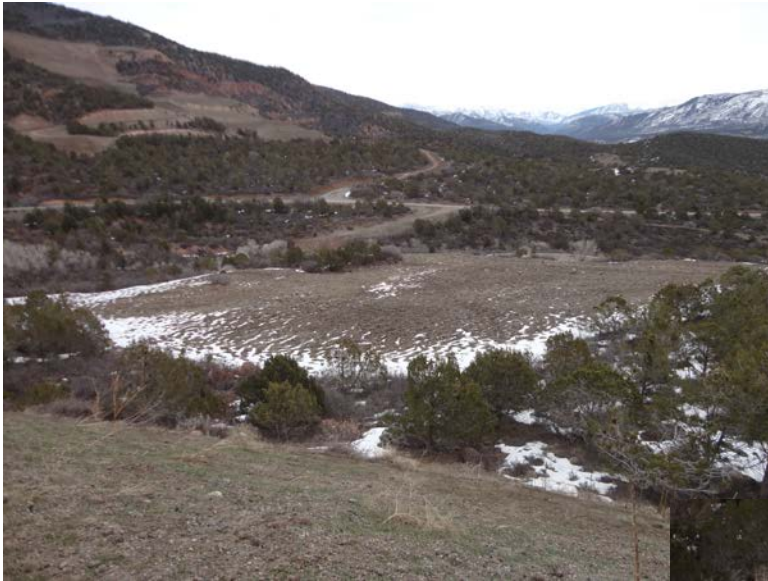
ROM area

The silt fence at the ROM pond, around Steven's Gulch needs to be maintained this Spring. Ditch 7, reconstructed last Fall, appeared to be stable and in good condition.

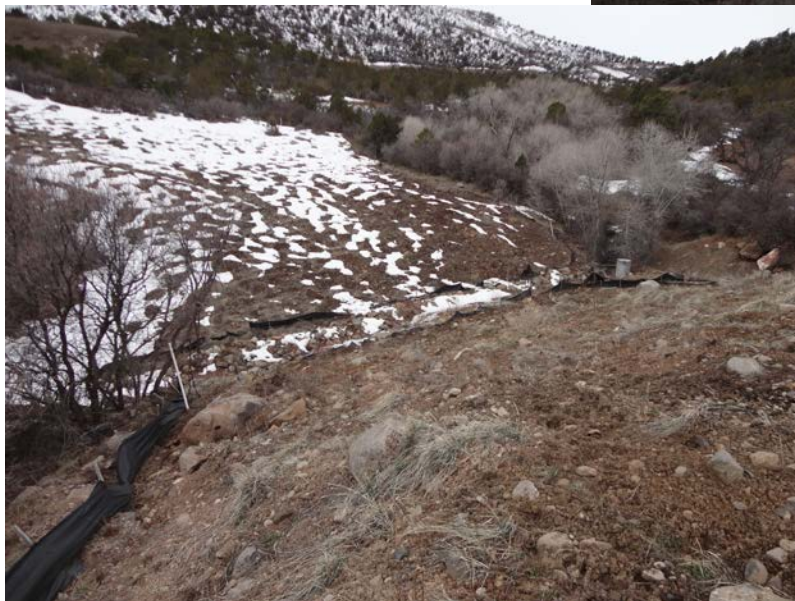
ROM area silt fence around Stevens Gulch

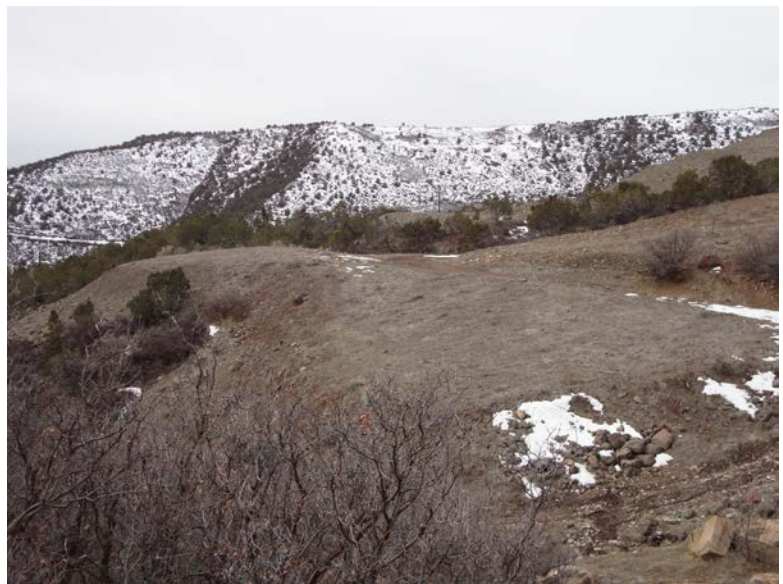
Old Refuse Pile

The old refuse disposal area appeared to be stable; the west pile was not accessible.
