COLORADO DIVISION OF RECLAMATION, MINING AND SAFETY COAL PROGRAM INSPECTION REPORT

Permit Number: C-1980-006 Mine Name: Marr Mine Operator: Kerr Coal Company Operator Address:	County: Jackson Operation Type: Surface Permit Status: Permanent Cessation Ownership: Federal			
Mr. George Patterson	Ownersmp. Pederal			
C/O Energy Fuels Coal, Inc.	Operator Representative Present:			
P.O. Box 459				
Florence, CO 81226				
Operator Representative Signature: (Field Issuance Only)

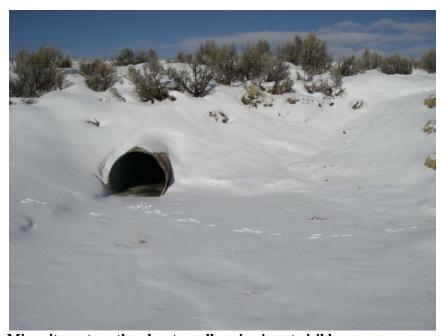
Both culverts at the mine site were inspected. One of the pipes at the north culvert was largely blocked with ice, but no problems were identified. The smaller pipe at the south culvert was not visible due to snow and sediment.

Mine site – at south culvert smaller pipe is not visible

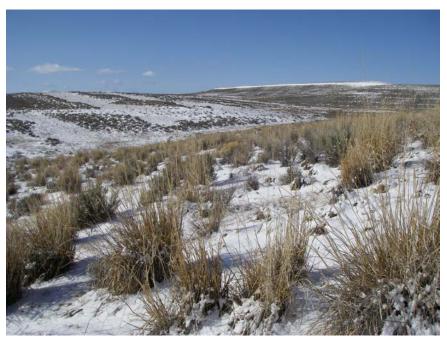
The two remaining parcels at the mine site contain no gullies, large weed patches, or other problems.

Mine site – vegetation at northern parcel

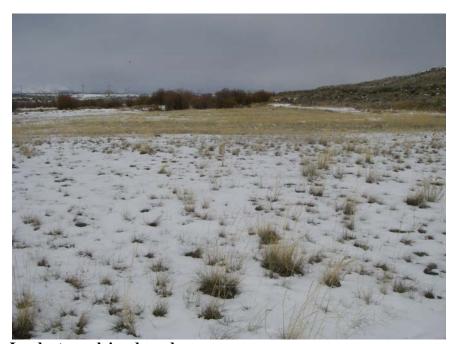
The Best Management Practices for sediment control from the reclaimed pond area at the loadout were in good shape.

Loadout – reclaimed pond
