COLORADO DIVISION OF RECLAMATION, MINING AND SAFETY COAL PROGRAM INSPECTION REPORT

Permit Number: C-1984-065 Mine Name: Coal Ridge No. 1 Mine Operator: C.B. Minerals Company, LLC Operator Address: Mr James Stover 2352 N 7th St, Ste B Grand Junction, CO 81501 County: Garfield Operation Type: Underground Permit Status: Inactive Ownership: Private

Inspection Start Date: March 28, 2013 Inspection Start Time: 12:00 Inspection End Date: March 28, 2013 Inspection End Time: 14:30			Inspection Type: Coal Complete Inspection Inspection Reason: Normal I&E Program Weather: Clear	
Joint Inspection Agency:		Joint Inspection Contacts:		
None		None		
Post Inspection Agency:		Post Inspection Contacts:		
None		None		
Inspector(s):	Inspecto	r's Sig	nature: Signature Date:	
Zach T. Trujillo	36	T	<i>4/1/13</i>

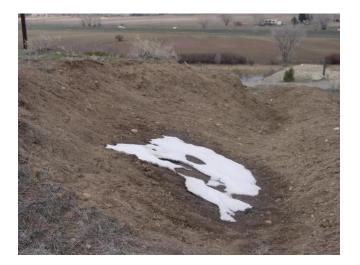
Topsoil Stockpile #2 was disturbed along the eastern edge and used for the reclamation of the unapproved sediment control ditch. This disturbed section remains bare and has yet to be reseeded.

Eastern edge of Topsoil Stockpile #2.
