**COLORADO DIVISION OF RECLAMATION, MINING AND SAFETY**  
**MINERALS PROGRAM INSPECTION REPORT**  
**PHONE: (303) 866-3567**

<b>MINE NAME:</b> Alamosa Pit No. 2	<b>MINE/PROSPECTING ID#:</b> M-1983-175	<b>MINERAL:</b> Sand and gravel	<b>COUNTY:</b> Alamosa
<b>INSPECTION TYPE:</b> Surety-Related Inspection	<b>INSPECTOR(S):</b> Wallace H. Erickson	<b>INSP. DATE:</b> April 22, 2013	<b>INSP. TIME:</b> 15:45
<b>OPERATOR:</b> Southwest Ready-Mix Inc	<b>OPERATOR REPRESENTATIVE:</b> Roy Burtraw	<b>TYPE OF OPERATION:</b> 112c - Construction Regular Operation

Alamosa Pit No. 2  
M-1983-175  
April 22, 2013

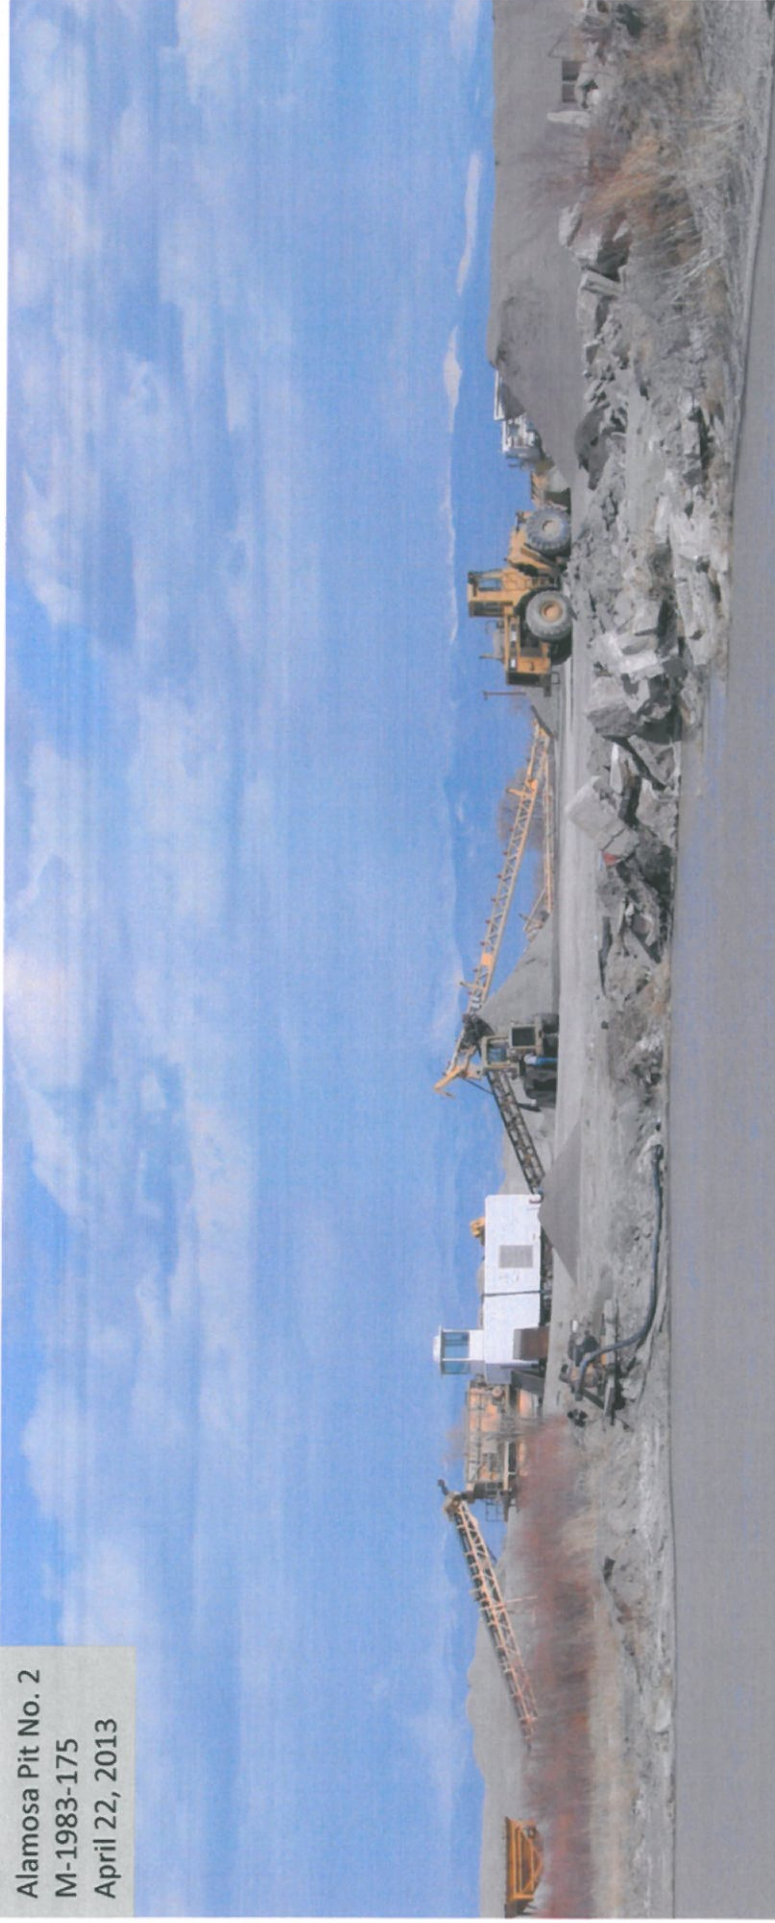
Alamosa Pit No. 2  
M-1983-175  
April 22, 2013

Processing yard appeared active, trucks were being loaded and departing the site during the time of this inspection. Operator indicated mine materials from other permitted sites are processed here with the fines and reject materials being utilized to backfill the ponds. Rubbilized concrete is also imported and utilized as backfill materials. The Operator indicated the area of exposed ground water had been reduced 3.55 acres, from approximately 14.55 acres to 11 acres, by employing such methods.
