**COLORADO DIVISION OF RECLAMATION, MINING AND SAFETY**  
**MINERALS PROGRAM INSPECTION REPORT**  
**PHONE: (303) 866-3567**

<b>MINE NAME:</b> Hay Camp Pit	<b>MINE/PROSPECTING ID#:</b> M-1990-025	<b>MINERAL:</b> Gravel	<b>COUNTY:</b> Montezuma
<b>INSPECTION TYPE:</b> Surety Release Inspection	<b>INSPECTOR(S):</b> Kate A. Pickford	<b>INSP. DATE:</b> July 5, 2013	<b>INSP. TIME:</b> 11:00
<b>OPERATOR:</b> Four States Aggregates - McStone Aggregate	<b>OPERATOR REPRESENTATIVE:</b> Casey McClellan	<b>TYPE OF OPERATION:</b> 112c - Construction Regular Operation

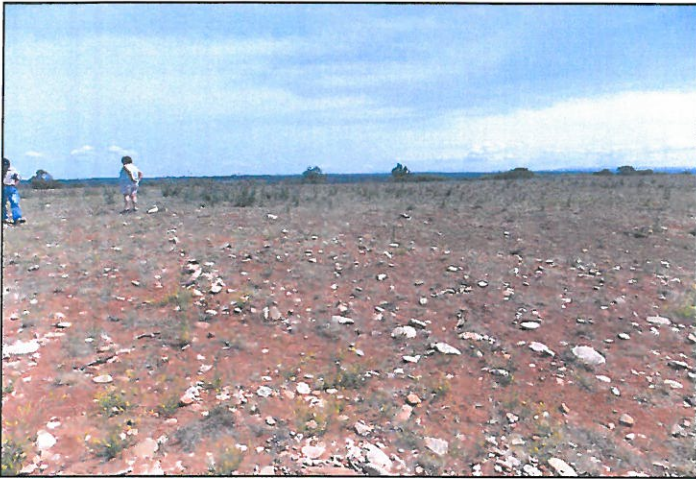
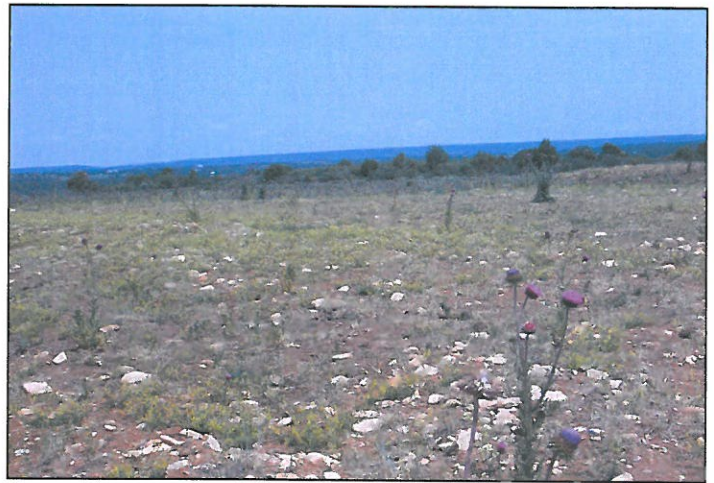
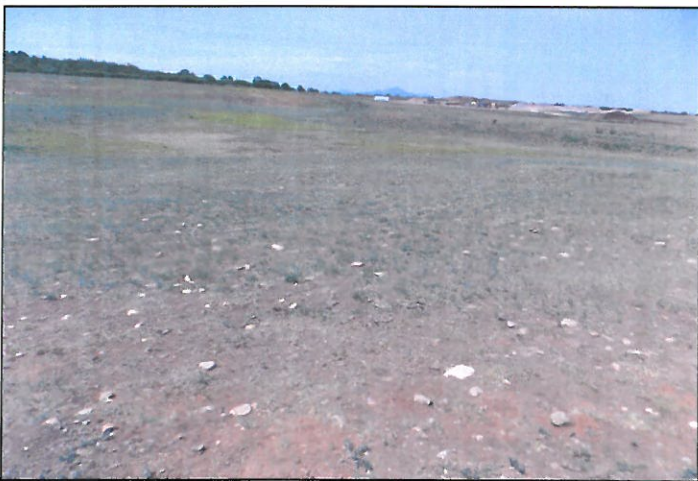
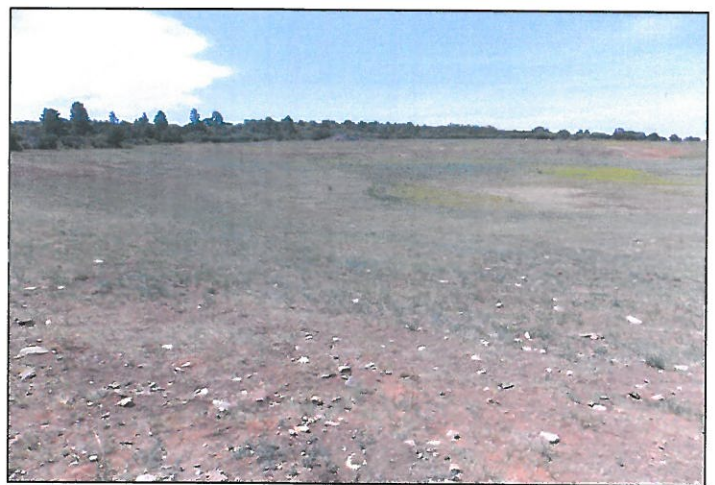
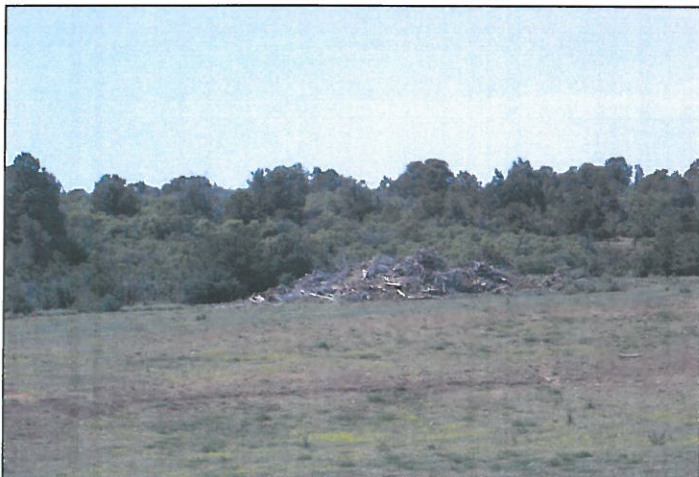
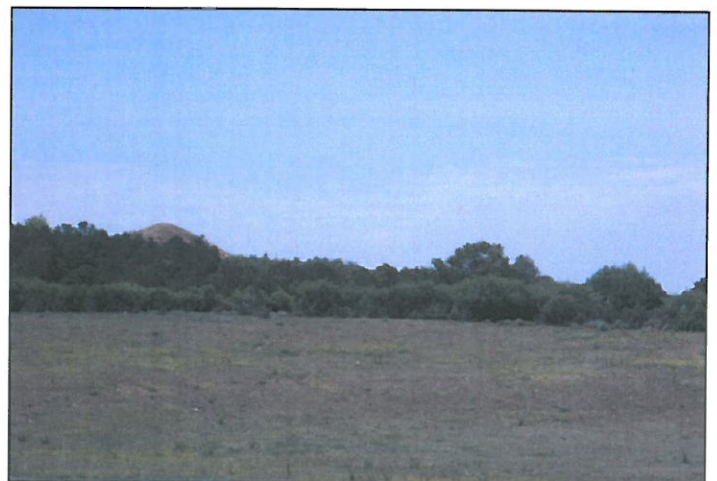
PHOTOGRAPHS

The two areas first observed, furthest from the entrance to the site, are not adequate for release. These areas are essentially devoid of grasses and contain a fairly dense growth of Canada thistle.

The other two areas, proposed for release, are adequate for release from the permit. These include an undisturbed area consisting of pinion and junipers, and an area that has been graded and seeded with adequate grasses for reclamation.

1. Submit notice that the two areas proposed for release that are not adequately reclaimed are being removed from the release request.
2. Submit a new map to the Division that depicts the proposed permit boundary after release of the areas adequately reclaimed. This map should clearly depict the resulting permit boundary that will remain at the site.
