**COLORADO DIVISION OF RECLAMATION, MINING AND SAFETY  
COAL PROGRAM INSPECTION REPORT**

| <b>Permit Number:</b> X-2006-214-01<br><b>Mine Name:</b> BTU Empire 2006 Project<br><b>Operator:</b> Moffat County Mining, LLC<br><b>Operator Address:</b><br>Mr Scott Cowman<br>36600 Routt County Road 27<br>Hayden, CO 81639 | <b>County:</b> Moffat<br><b>Operation Type:</b> Coal exploration<br><b>Permit Status:</b> Active<br><b>Ownership:</b> Private<br><br><b>Operator Representative Present:</b><br><br>Scott Cowman |

| <b>Inspection Start Date:</b> August 27, 2013<br><b>Inspection Start Time:</b> 08:00<br><b>Inspection End Date:</b> August 27, 2013<br><b>Inspection End Time:</b> 14:00 | | <b>Inspection Type:</b> Coal Exploration Inspection<br><b>Inspection Reason:</b> Surety Release Requested<br><b>Weather:</b> Clear | |

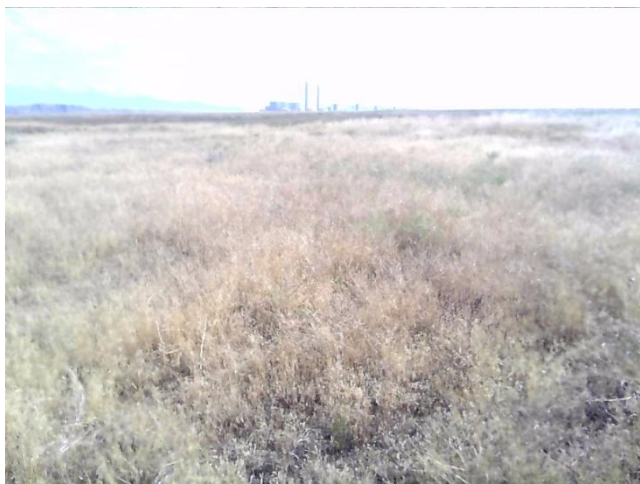
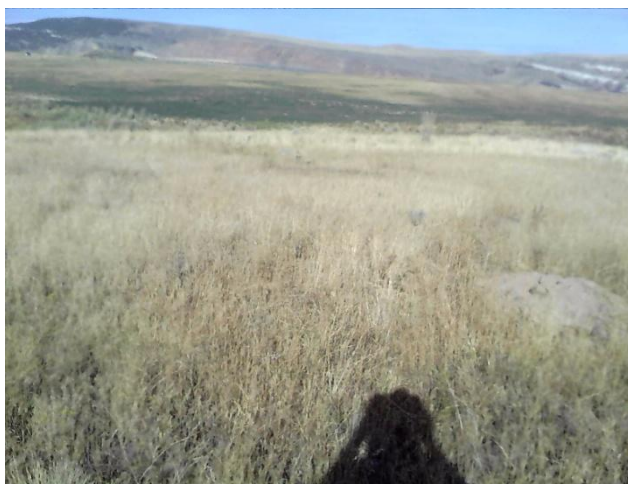
Site WF-006 was found to have inadequate vegetation growth during the initial inspection. The site was interseeded and found to have adequate vegetation throughout. Noticeable cheatgrass was observed. However, this is representative of the area and the cheatgrass throughout the site made up less cover than the surrounding undisturbed area.

Based on this inspection the Division can release the reclamation liability for all sites approved but not disturbed and for Site 006. Liability will remain for vegetation costs associated with Site WF-003.

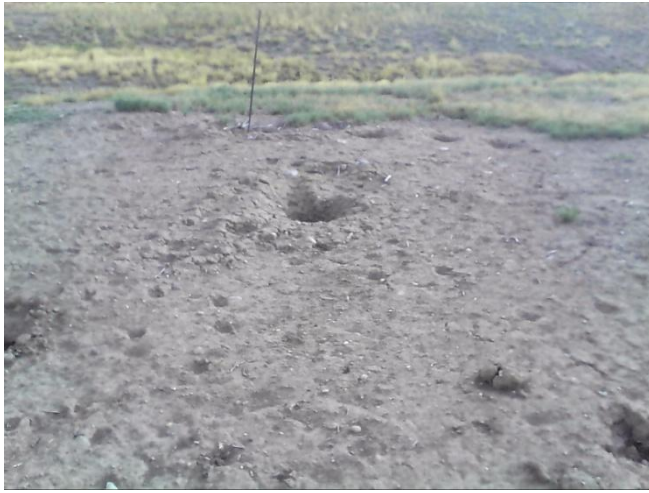
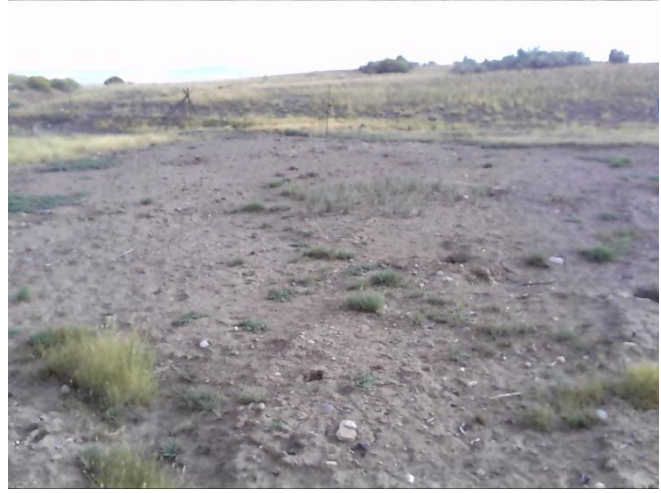
Site WF-003 was found to be unreclaimed during the initial inspection. The site is reclaimed as of this inspection. However, the site shows little to no vegetation growth with a heavy houndstounge presence throughout.
