Permit M-1977-196 Buena Vista Pit- Response to Inspection

From: Brian Sack [mailto:bsack51@yahoo.com]**Sent:** Friday, August 23, 2013 4:55 PM**To:** Denise Gonzales**Cc:** John Paul Ary**Subject:** BV Pit

Here are the updated BV Pit pictures.

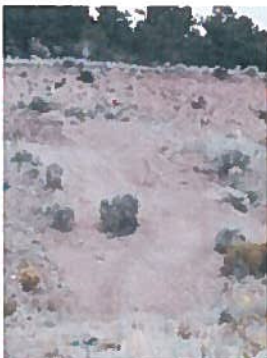
Figure 1.JPG
4076K

-Figure 1 is the far west gully that has been filled, graded and re-seeded.

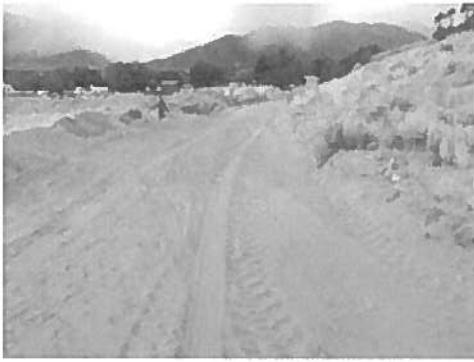
Figure 1-1.JPG
4105K

-Figure 1-1 is the access road that goes through the north end of the property, we slopped the road to the adjacent slope so flow would continue down the road and not cross it. We also replaced the safety berm bordering the pit and re-seeded it.

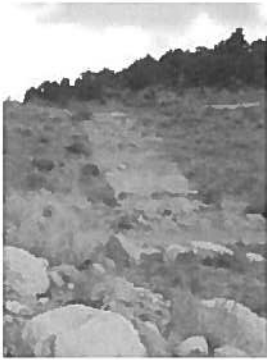
Figure 2.JPG
4185K

-Figure 2 is the center gully which is fed by a culvert at the top end that crosses underneath the access road; the culvert is not on our property. We decided to keep the drainage and address the flow and sediment control. We placed check dams and a 10' long rip rap flare at the top and bottom of the slope.

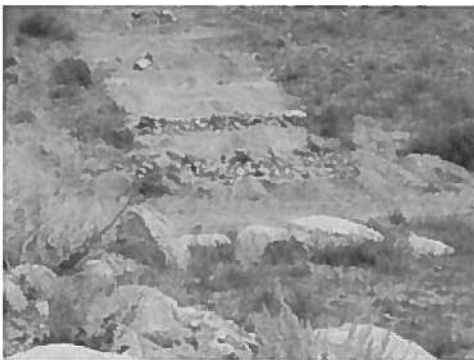
Figure 2-1.JPG
4112K

-Figure 2-1 is showing the rip rap flare at the bottom of the slope
