# Introduction & 2014 Administration

Division of Water Resources

David Nettles, P.E.  
Division Engineer, Water Division 1

**State and Division Engineer's Forum - April 15, 2014**

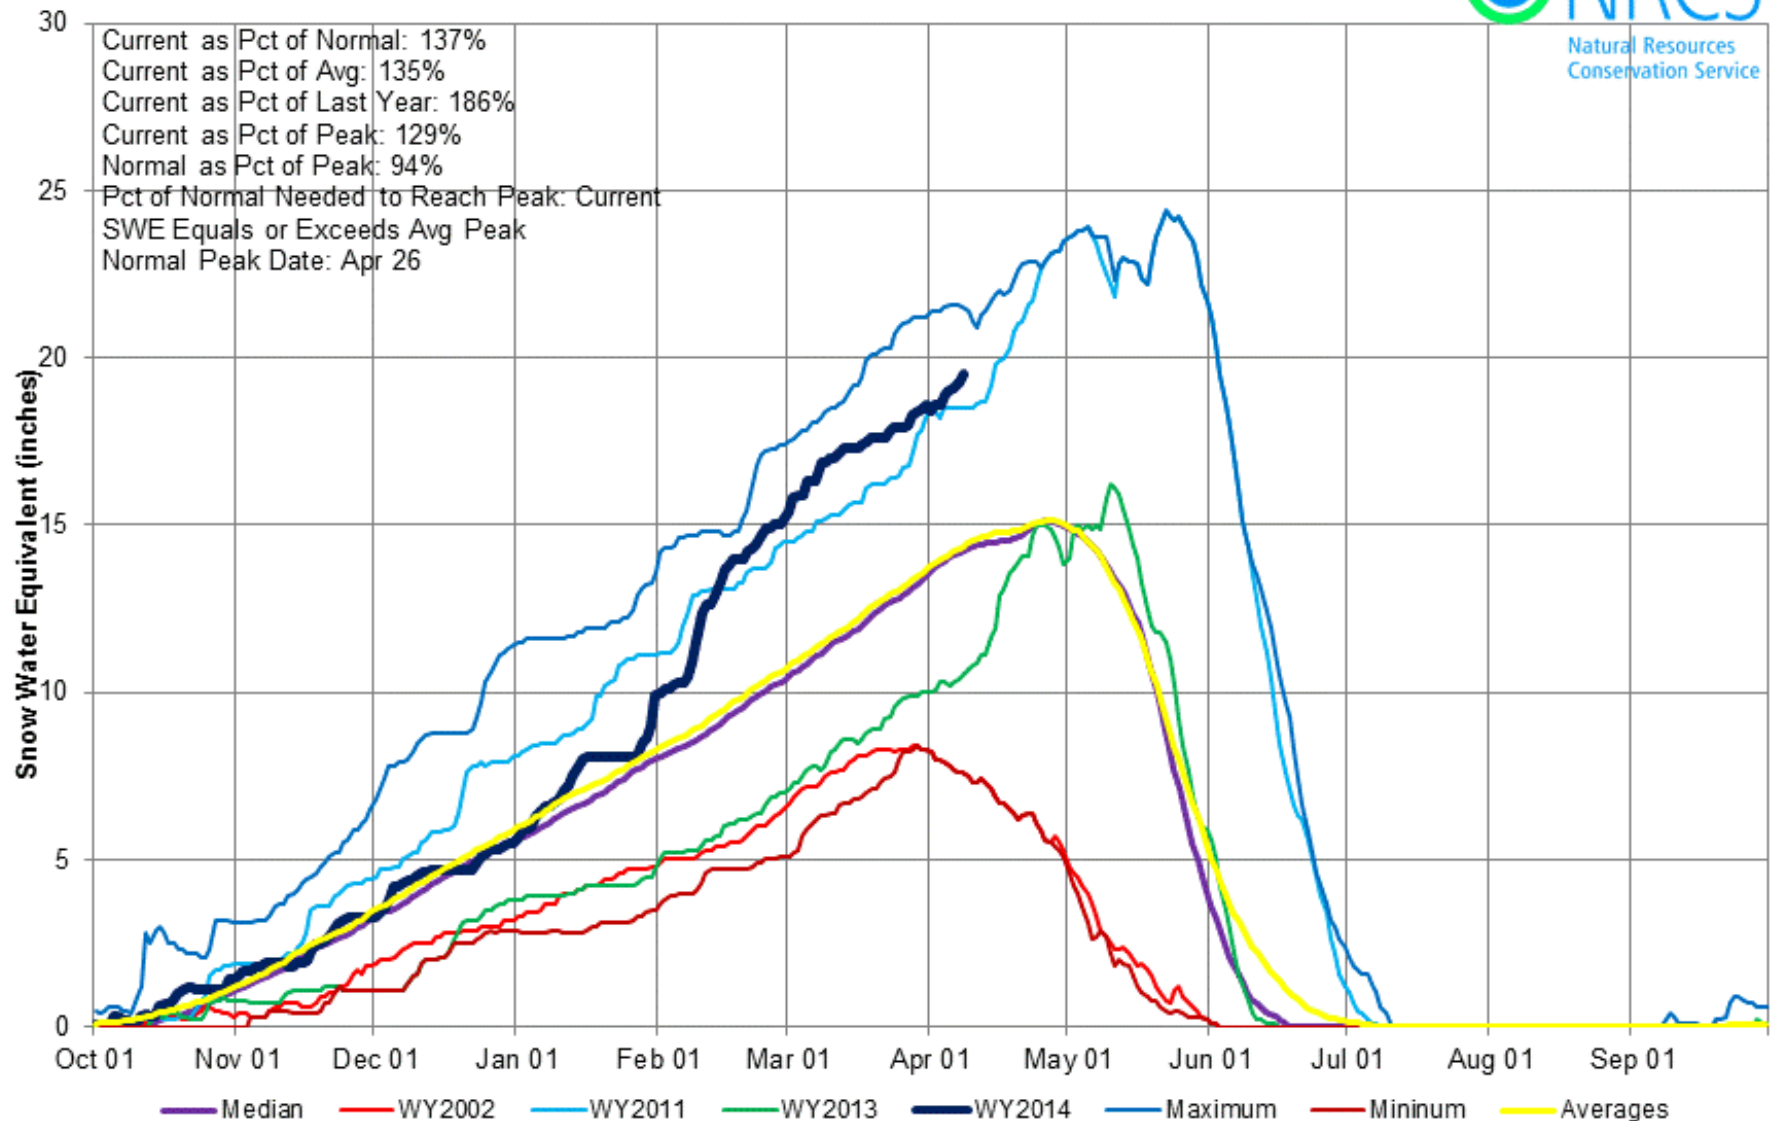
## South Platte River Basin High/Low Snowpack Summary

*Based on Provisional SNOTEL data as of Apr 08, 2014*

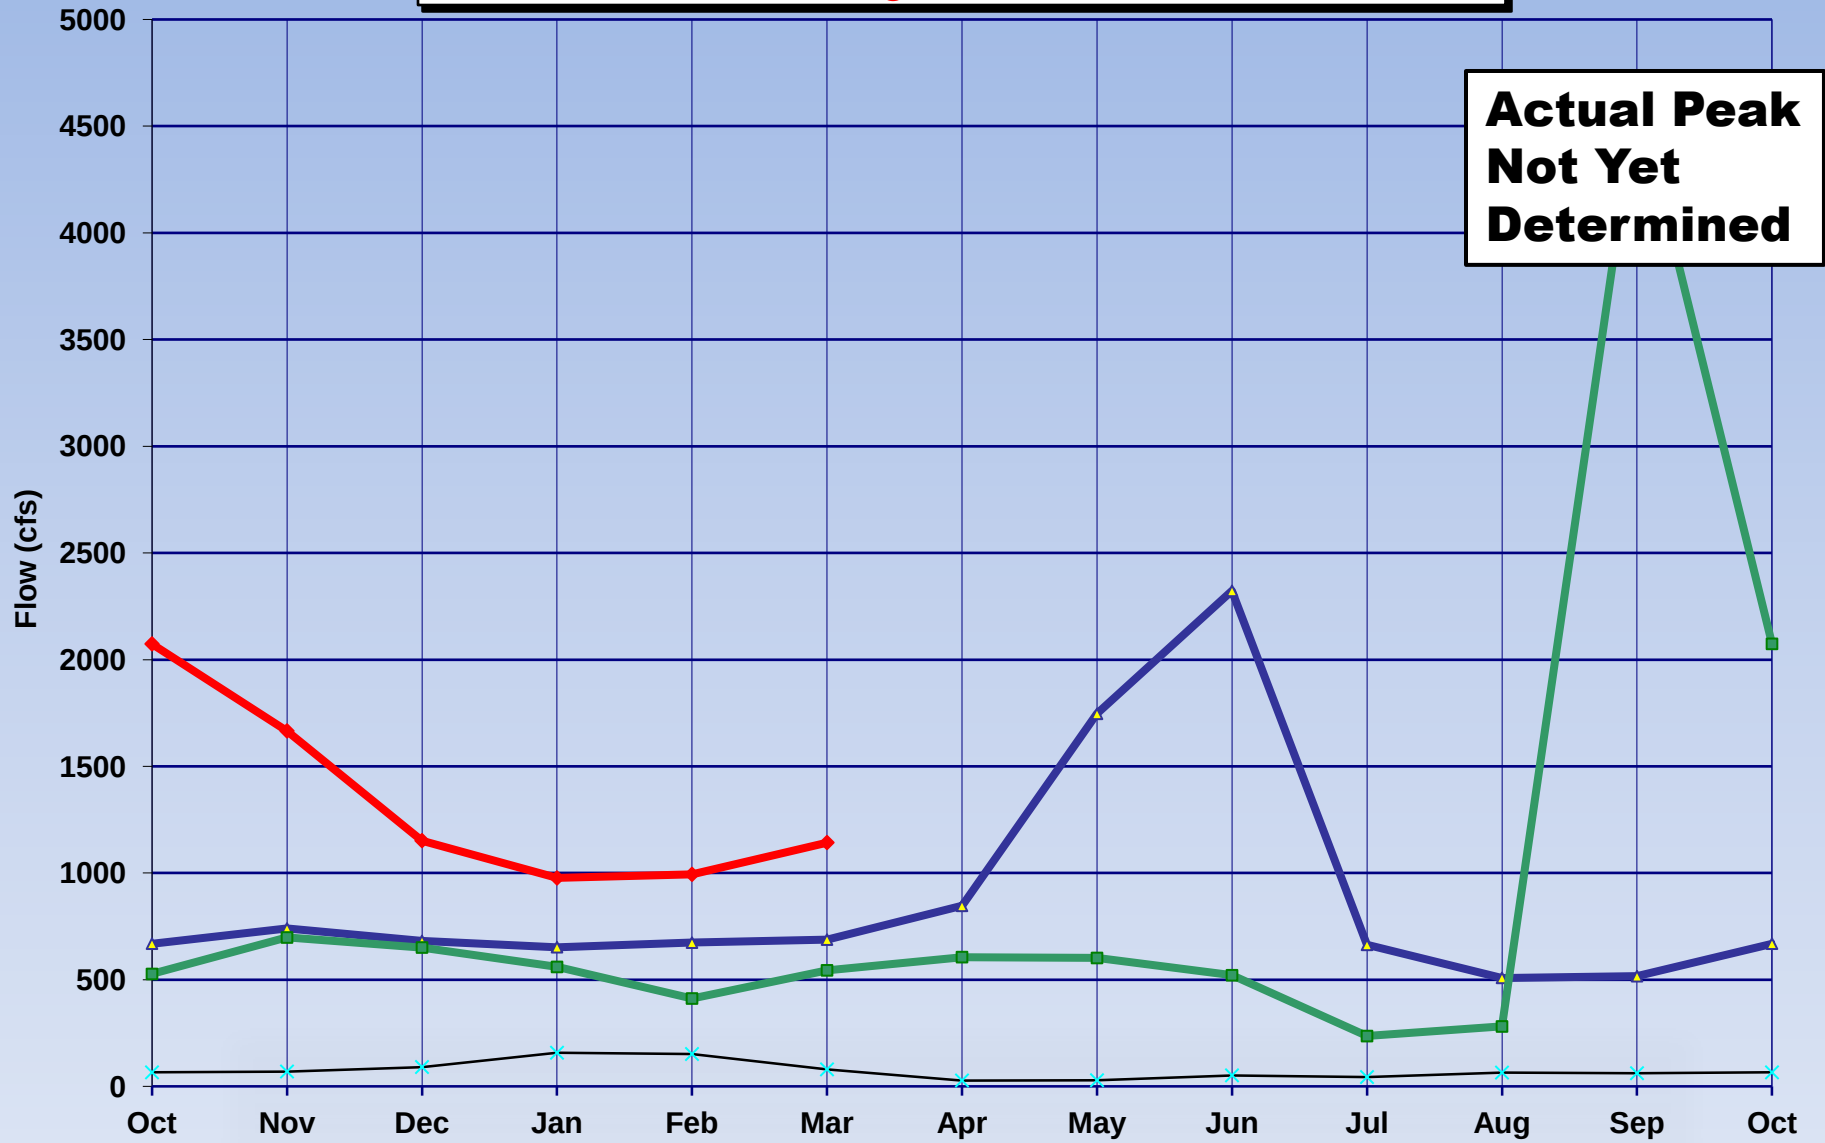
# South Platte River at Kersey

Historic\* Mean Flow    Historic\* Min Flow    2013-2014 Mean Flow    2012-2013 Mean Flow

\*1901-2012

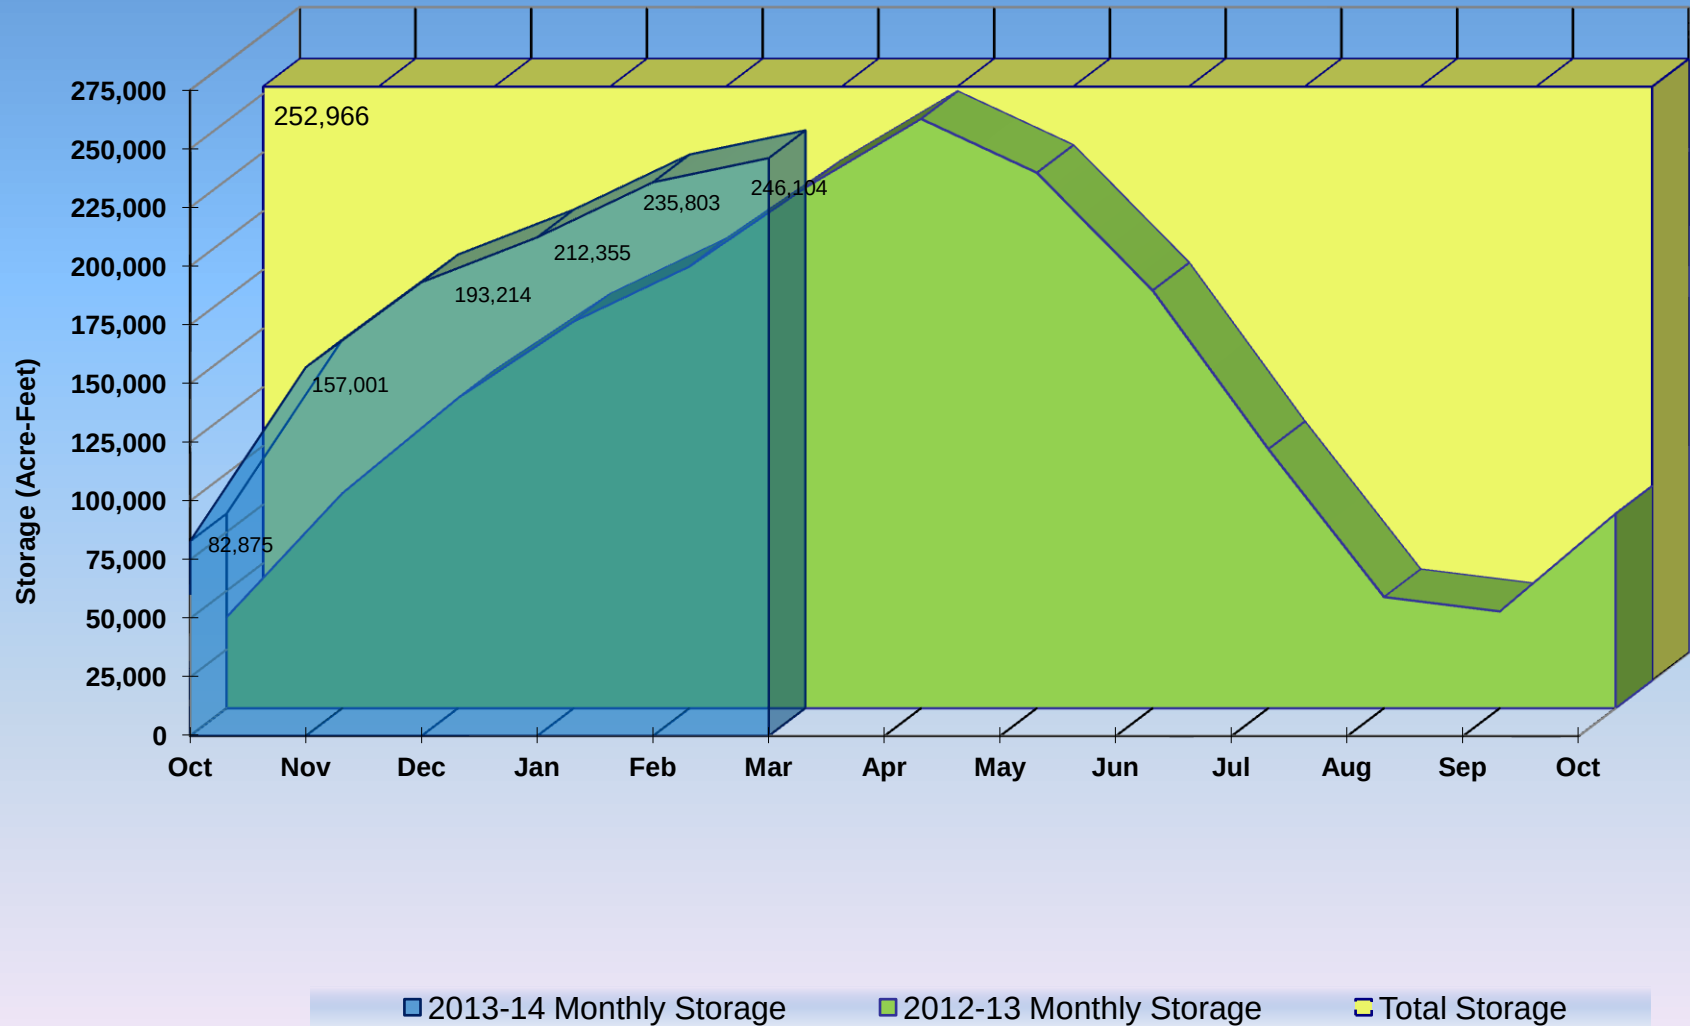
# South Platte Reservoir Storage below Kersey\*

\*Empire, Riverside, Jackson, Prewitt, North Sterling, & Julesburg

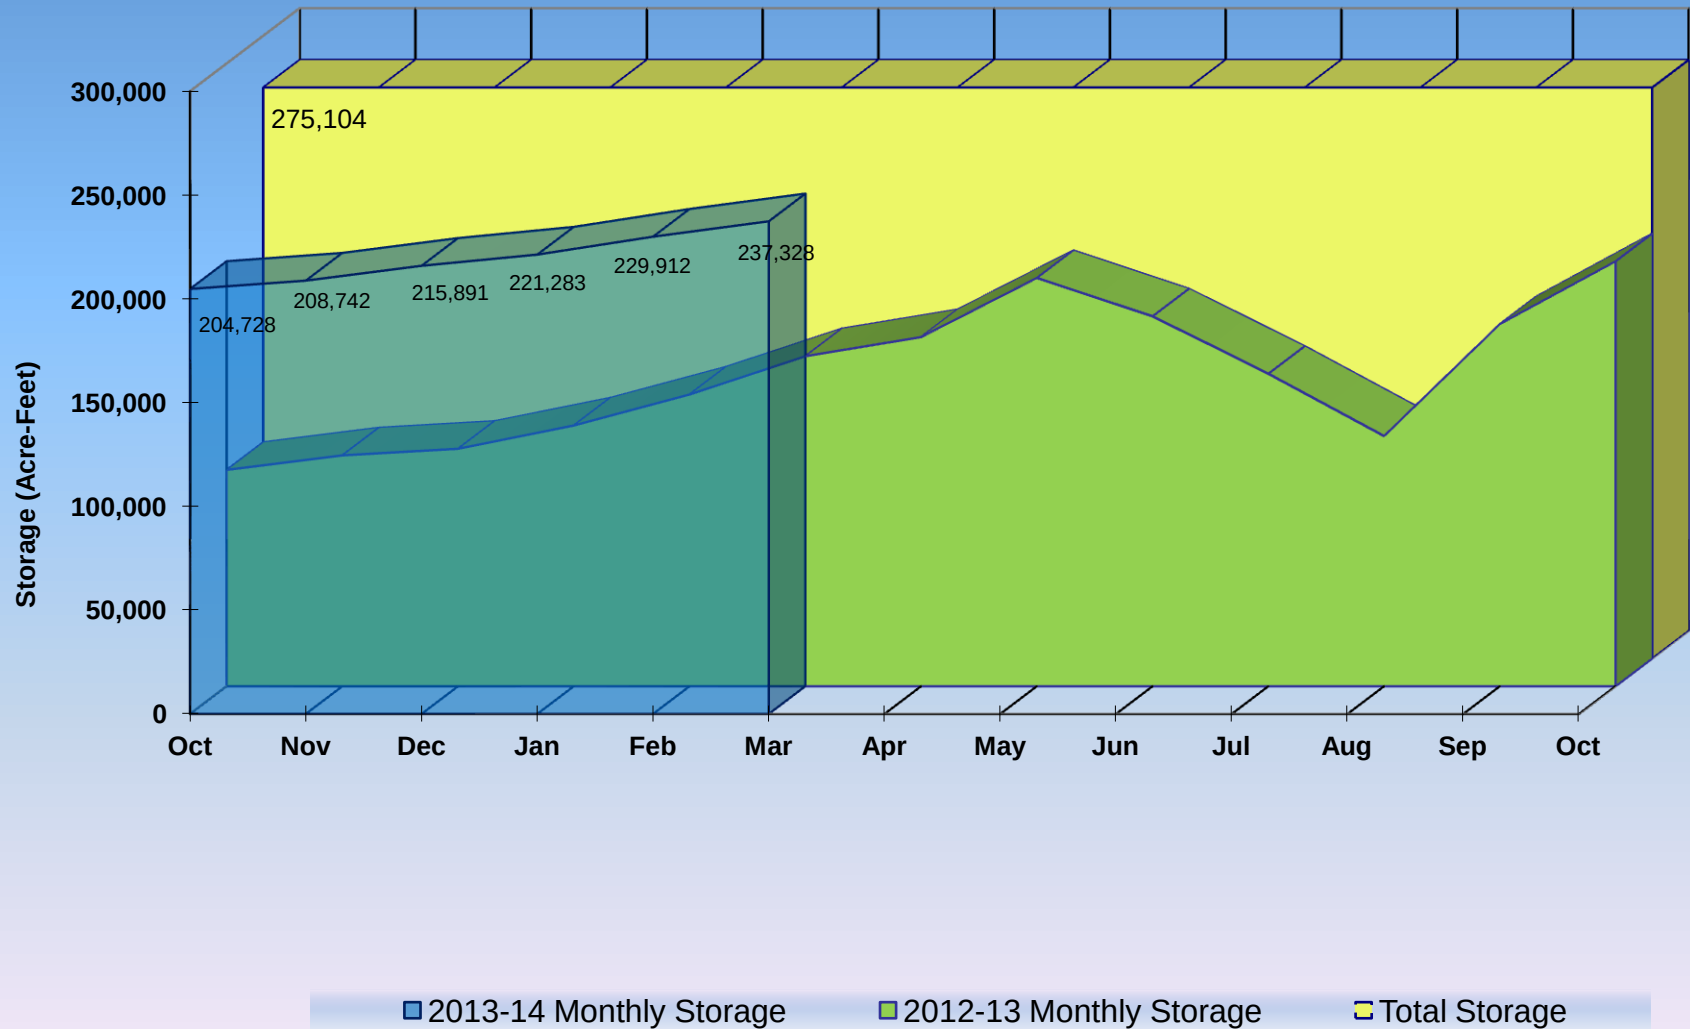
# South Platte Reservoir Storage above Kersey\*

\*Barr, Cobb, Fossil Crk, Halligan, Marshall, Milton, Union, Standley, Lower Latham, Boyd, Loveland, Windsor, Horse Crk, & Prospect

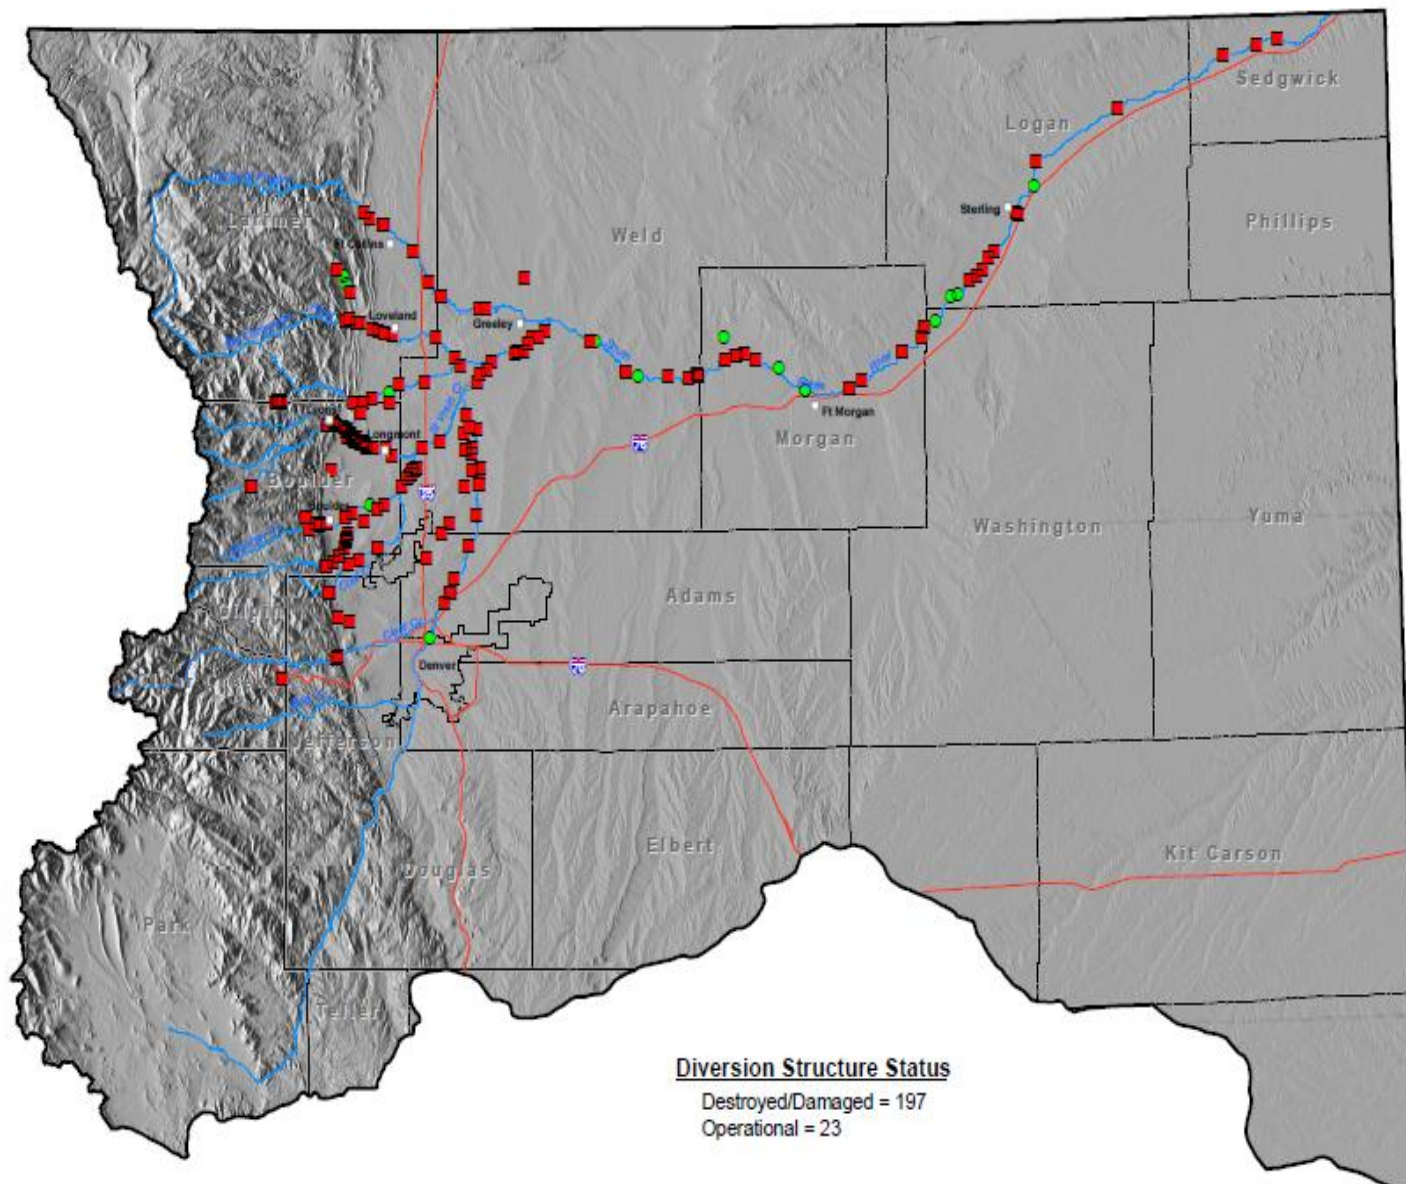
## Flood Affected Diversion Structures in the South Platte Basin

- Operational
- Destroyed/Damaged

## Diversion Structure Projected Recovery

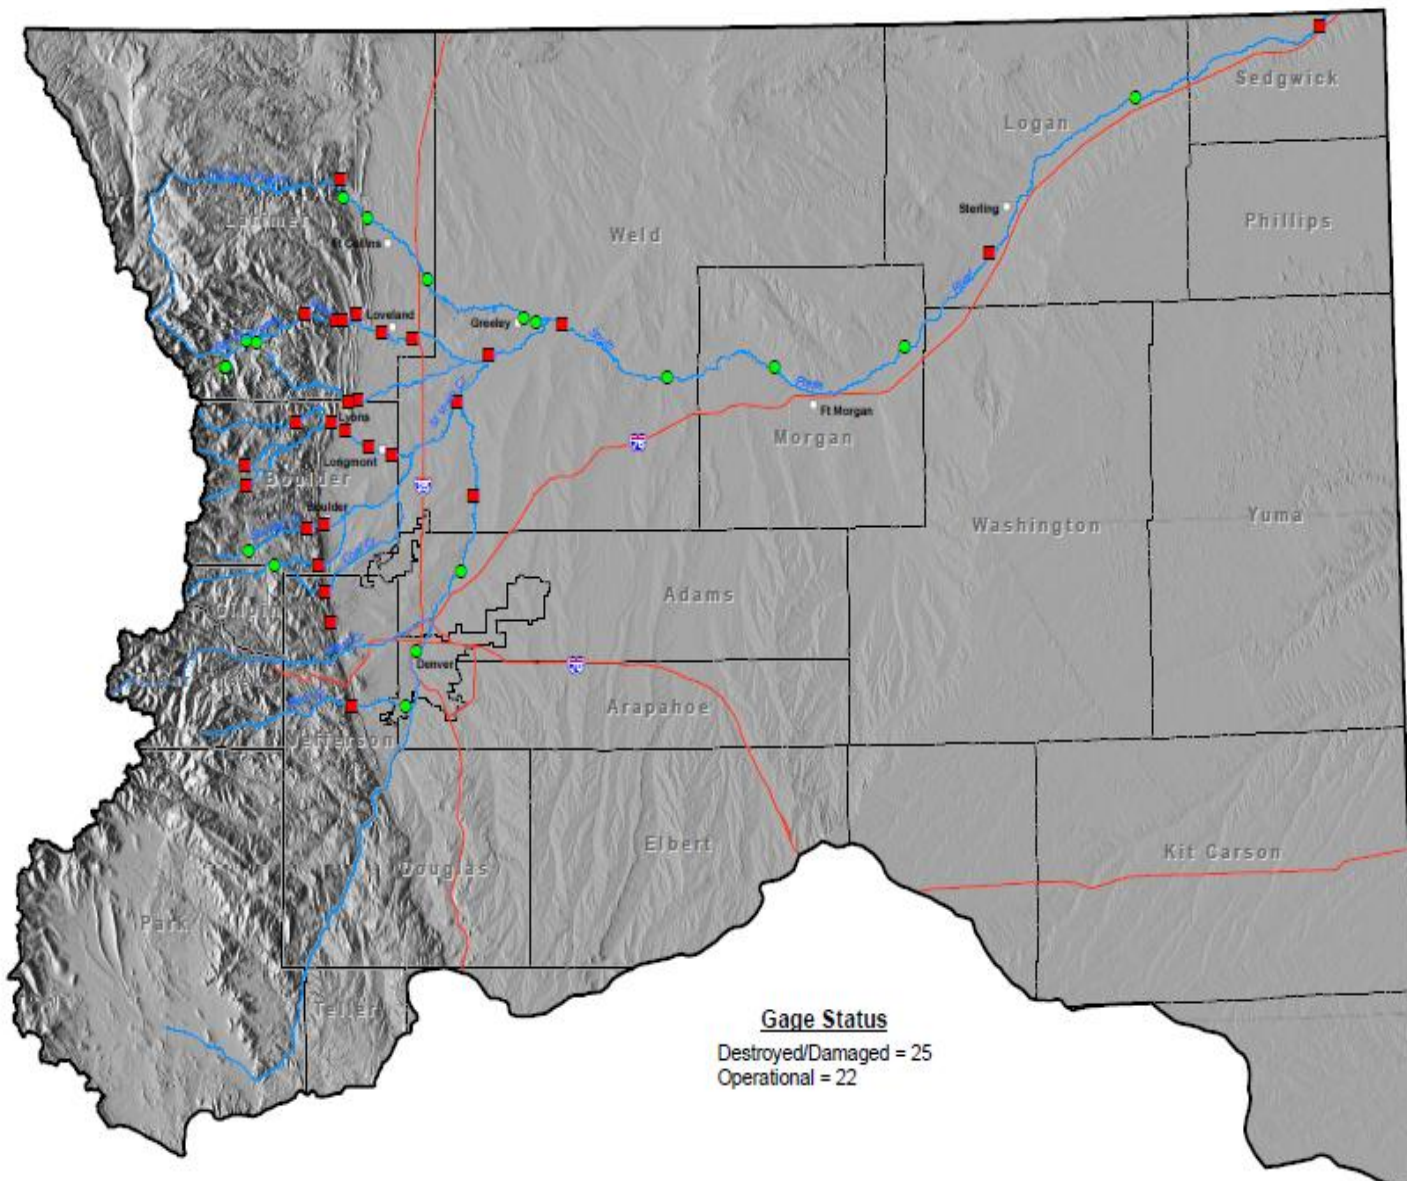
## Flood Affected Stream Gages in the South Platte Basin

- Operational
- Destroyed/Damaged

- **14 Gages permanently repaired**
- **3 Gages temporarily repaired**
- **2 Surrogate gages installed**
- **2 Gages currently under construction (pre-runoff finish projected)**
- **4 Gages unrepaired until after runoff**
