Water Plan Grant Application

Twelvemile Ranch:
A reconnaissance assessment of stream and riparian condition for the Riparian Reconnect project with recommendations for restoration and management

Tarryall Notch Ranch: Assessment for Riparian Reconnect

Elk Creek Highlands Property Owners Open Space Reach:
A reconnaissance assessment of stream and riparian condition for the Riparian Reconnect project with recommendations for restoration and management

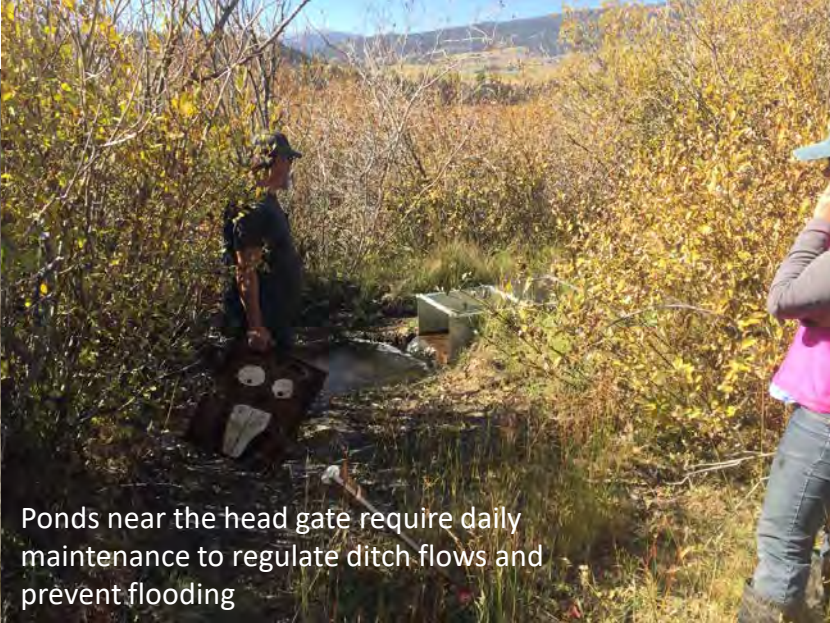
Ponds near the head gate require daily maintenance to regulate ditch flows and prevent flooding

- A series of flow devices on the ponds on the west branches of Sheep Creek (point A) and at the head gate (point B) may help alleviate the daily maintenance burden ranch managers currently expend to:
 - (1) manage ditch flows,
 - (2) prevent flows entering ditch via path 3, and
 - (3) maintain perennial flow through both branches of Sheep Creek.
- Additional flow devices at the stream culverts (points C and D) may alleviate the need for daily maintenance to:
 - (1) prevent road flooding and erosion, and
 - (2) maintain perennial flow on Sheep Creek.
- Continue maintaining the ditch culver (point E) manually while the ditch is flowing.

For the diversion to function, some portion of flow must follow path 1 to the head gate and ditch (path 2). A beaver dam that failed in 2018 greatly increases the risk of this path drying up, as flows preferentially direct towards path 3. Repairing this dam would mitigate this risk to the water right. Flow devices could also be considered if necessary.

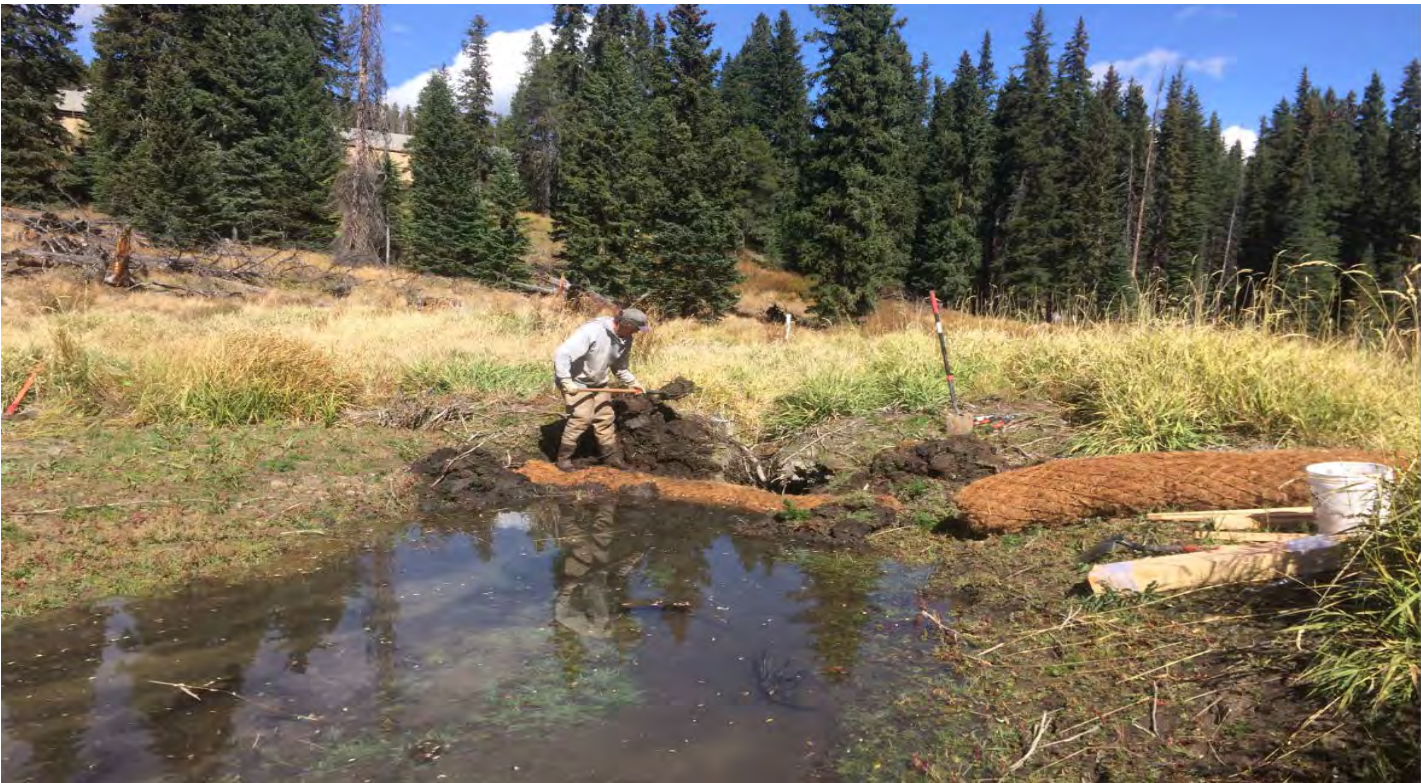
↑ Repairing breached beaver dams with coir logs and sod. ↓ Before and after.

Design specs
The diagrams above and left show specifications for repairing cross-channel dams. These structures are designed to persist through normal runoff events, but are not permanent. They are constructed of native materials that assimilate into the streamscape over time.

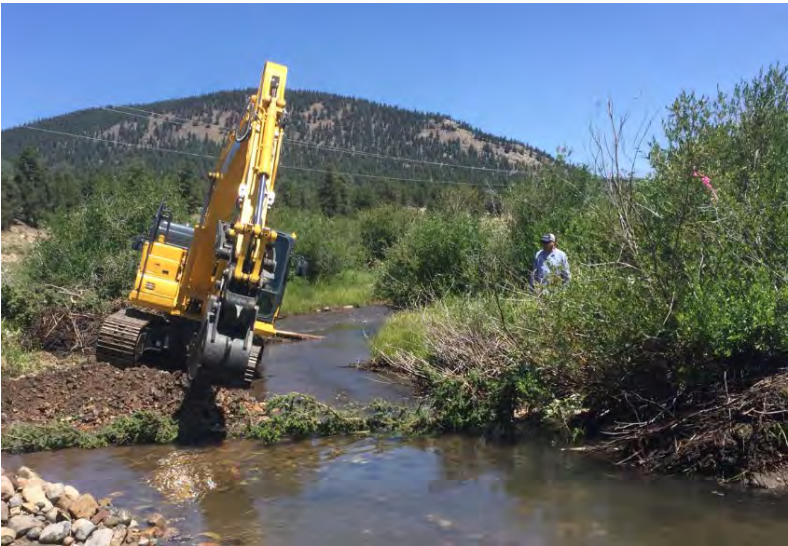
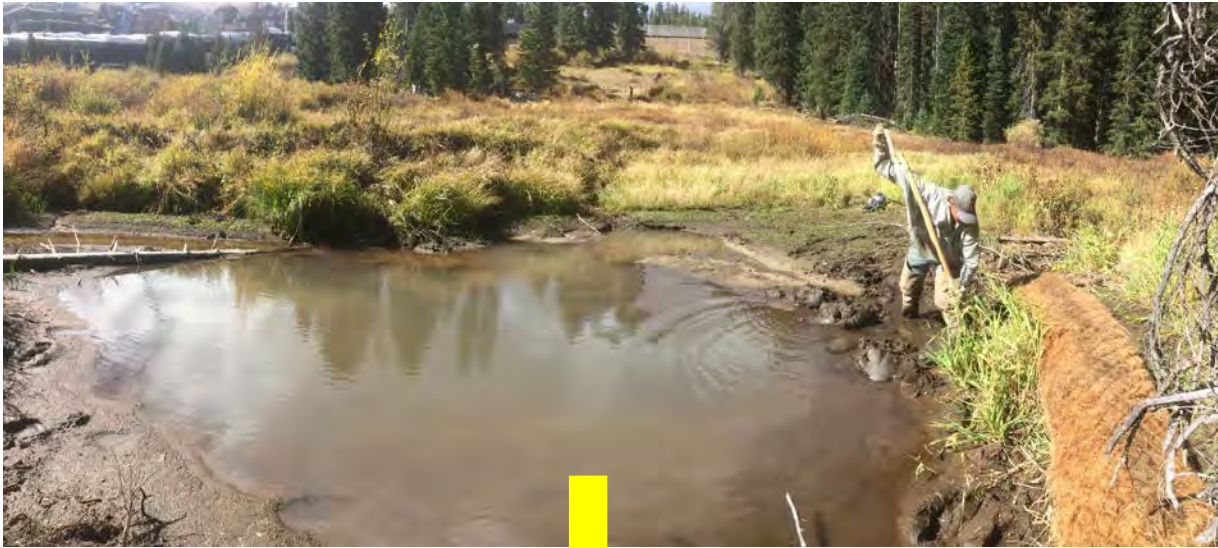
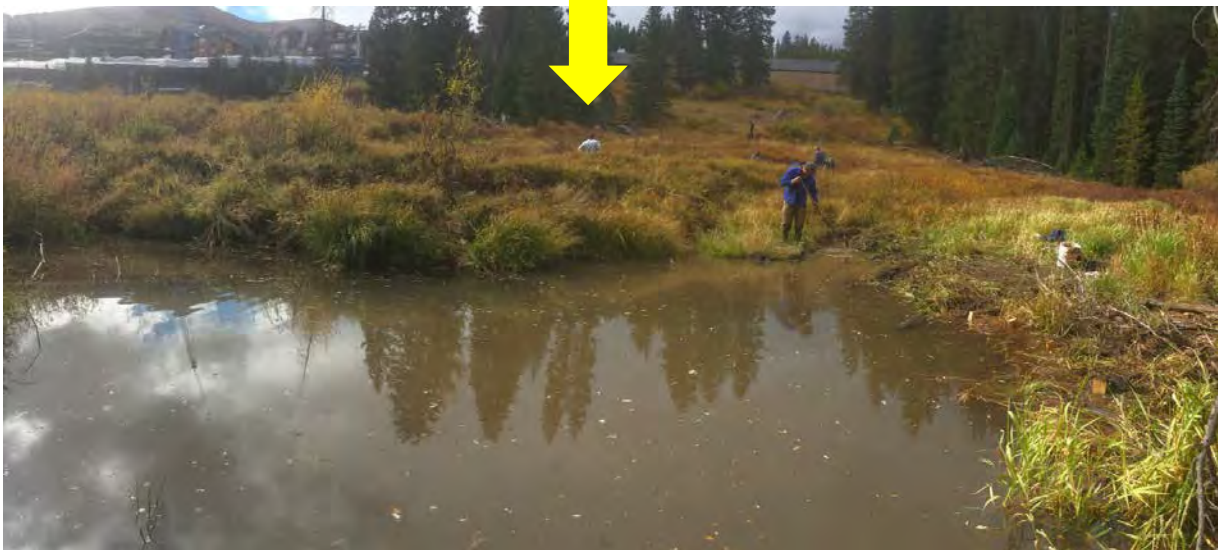
Heavy equipment can greatly improve the quality and efficiency of beaver dam repair and construction, especially on larger creeks

Repairing or reconstructing beaver dams in places where beavers have been inactive is a good way to ensure continued function and habitat benefits during periods of prolonged beaver absence. Repaired dams also create deep water and cover that attracts dispersing beavers and entices them to recolonize an area. These treatments are highly recommended on Cave Creek, and could also be employed a spot treatments along Sheep and Twelvemile Creeks.

The **stream and riparian restoration plan** would repair about 10 breached beaver dams, allowing them to continue functioning during prolonged absence of beaver. Dam repairs would be made using native materials (sod, willow stems, willow fascines) and soft biodegradable coir logs that will grow and assimilate into the landscape. Dam repairs aim to restore up to about 2.5 acres of pond area and about 5 acres of wetland, creating habitat ideal for recolonization by beaver.

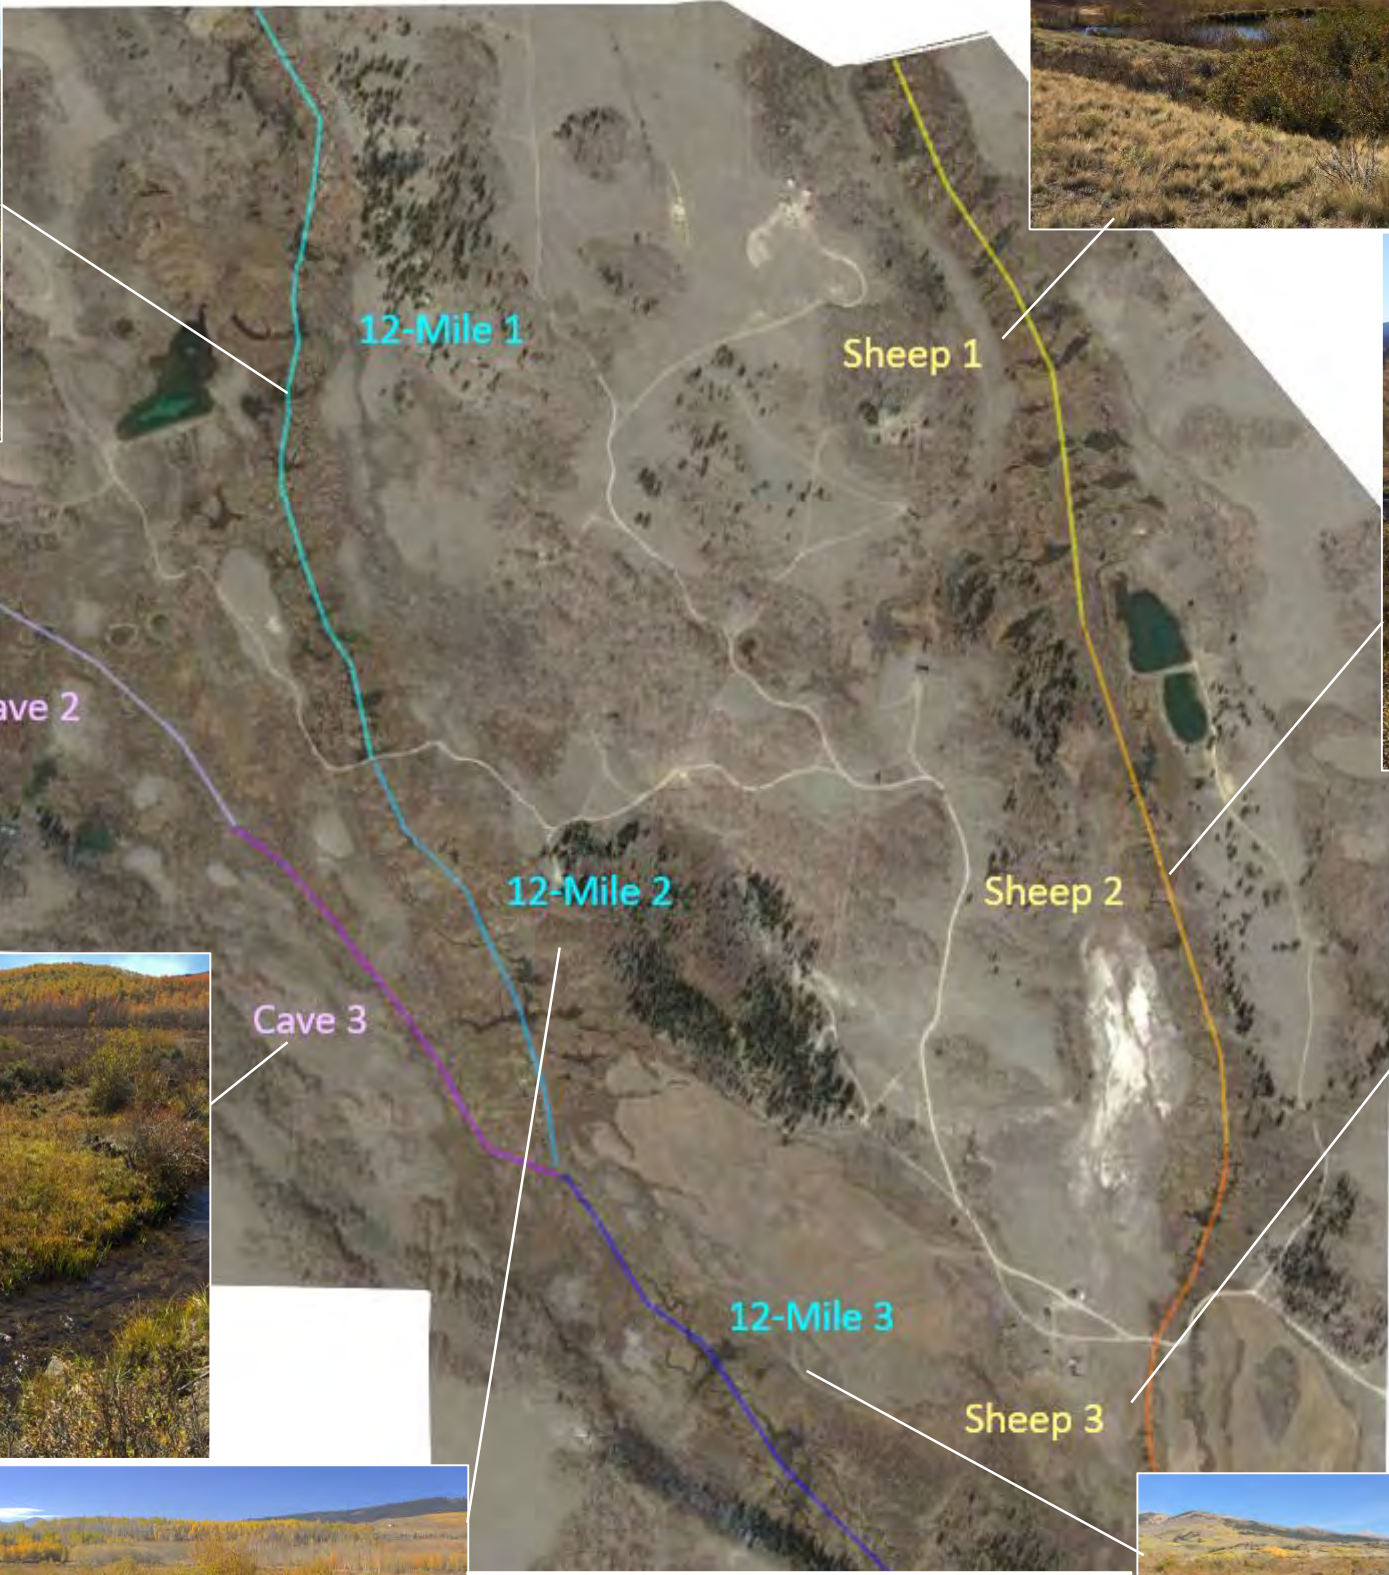
Stream functional assessment reaches

Assessment Reaches
Streams and riparian areas were divided into eight reaches, as shown here. Each reach is evaluated independently.

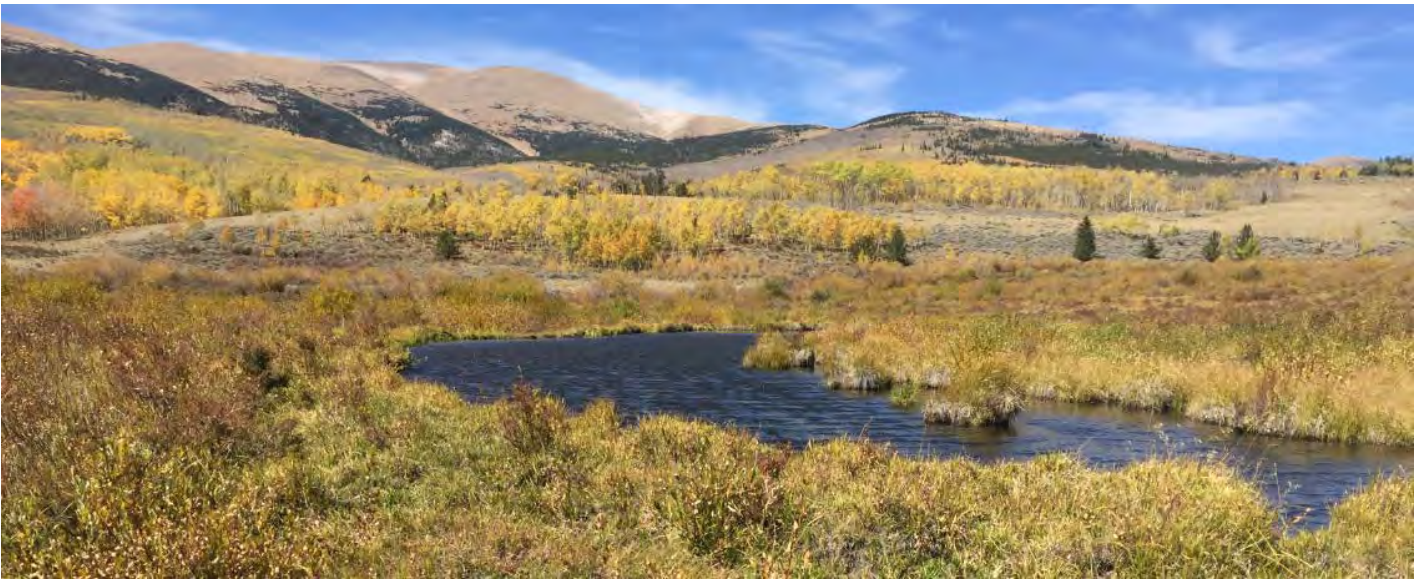
← Looking upstream on Twelvemile Creek. Most of the 9.5-square-mile contributing watershed is in the alpine and subalpine terrain in the background.

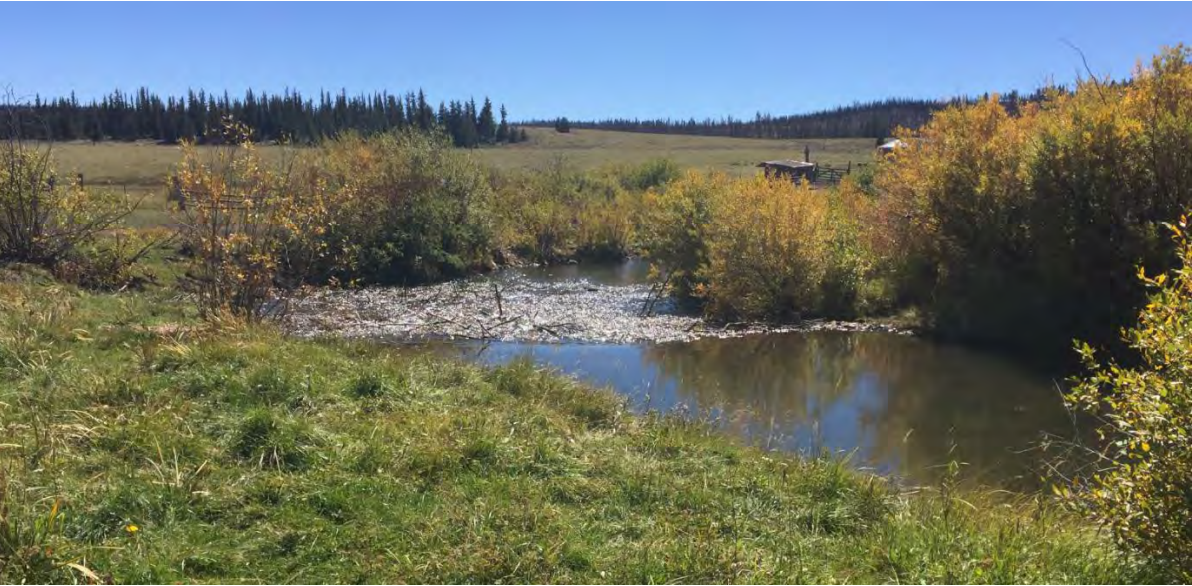
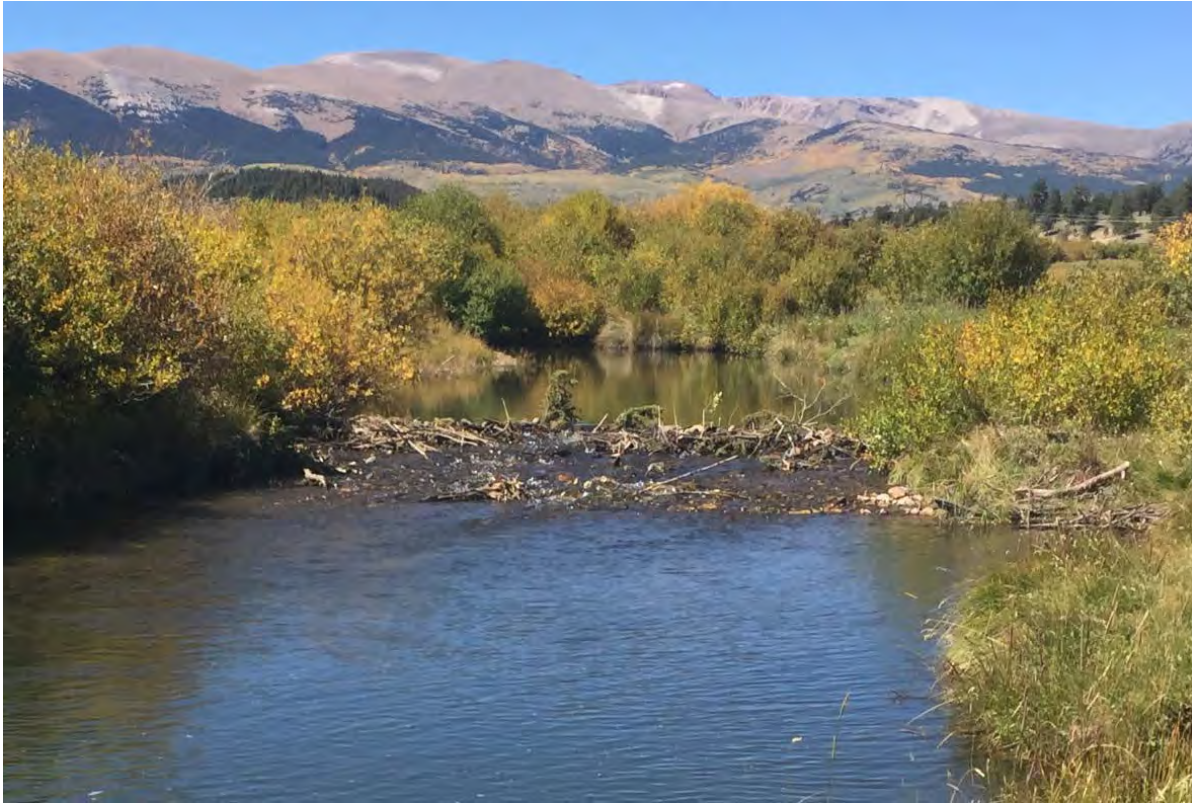
Mimicking beaver dams: Typical BDAs on DM Ranch viewed from upstream (upper right) and downstream (lower right) raise water stage and reconnect floodplain swales and off-channel wetland habitat (left). The BDAs on Tarryall Notch Ranch will be similar to these, but scaled to match the smaller size of Tarryall Creek.

BDA function
BDAs mimic natural channel-spanning beaver dams to create deep water habitat, raise the surrounding water table, and reactivate floodplain swales and side channels. Examples from the DM Ranch are shown in the photos to the right.

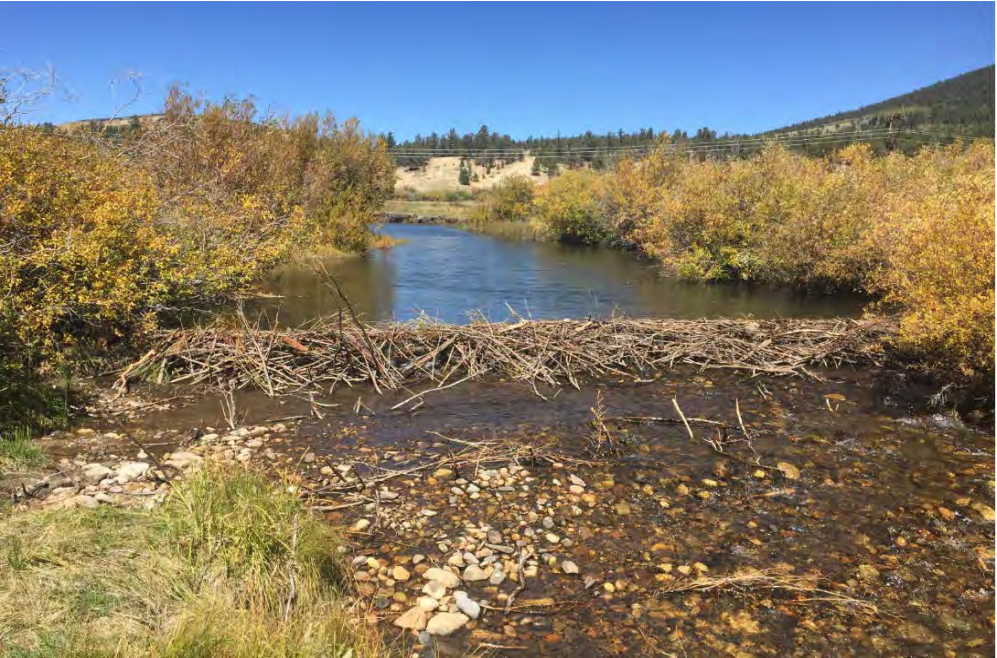
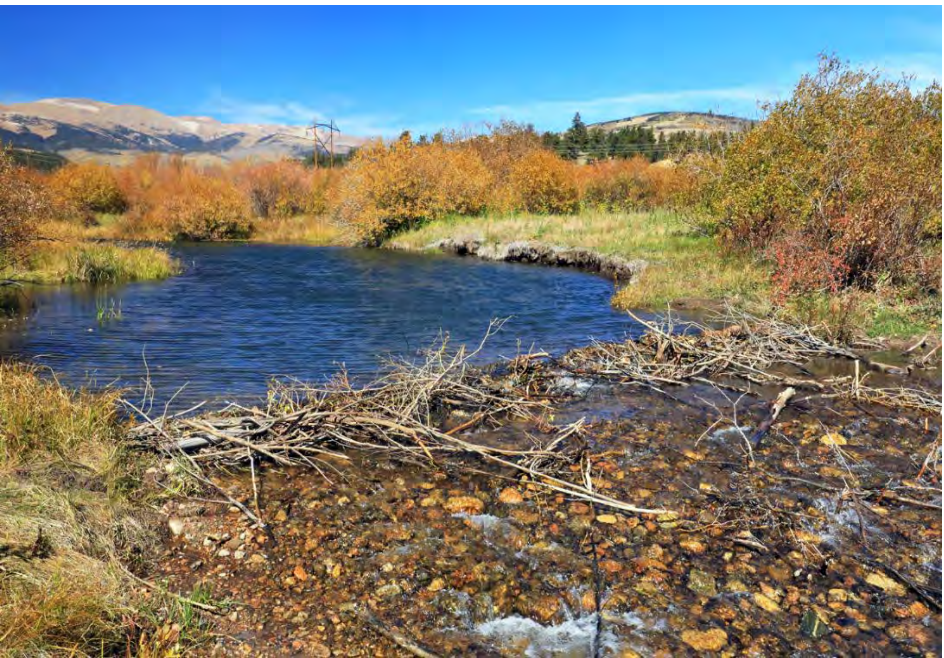
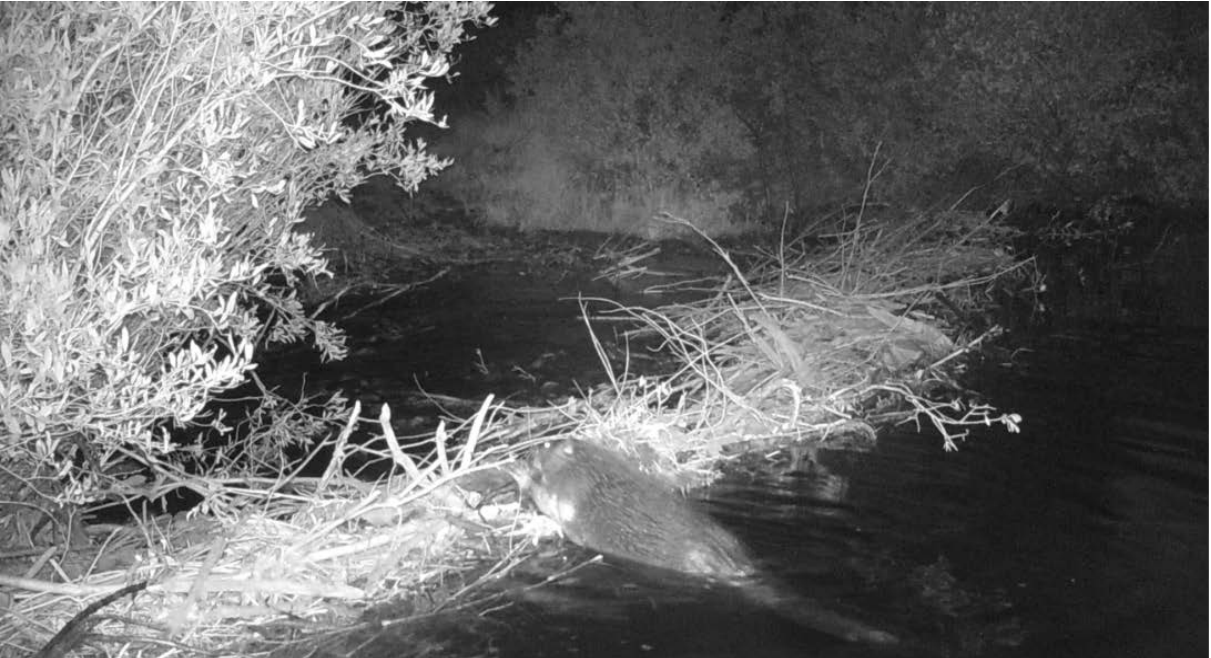
Enticing beaver: BDAs also provide deep water habitat and cover that entice migrating beavers to settle on the site. Several of the BDAs on DM Ranch were occupied by beavers in the first season. We suspect this would be the case at Tarryall Notch Ranch as well, given that there are active beaver colonies nearby both upstream and downstream.

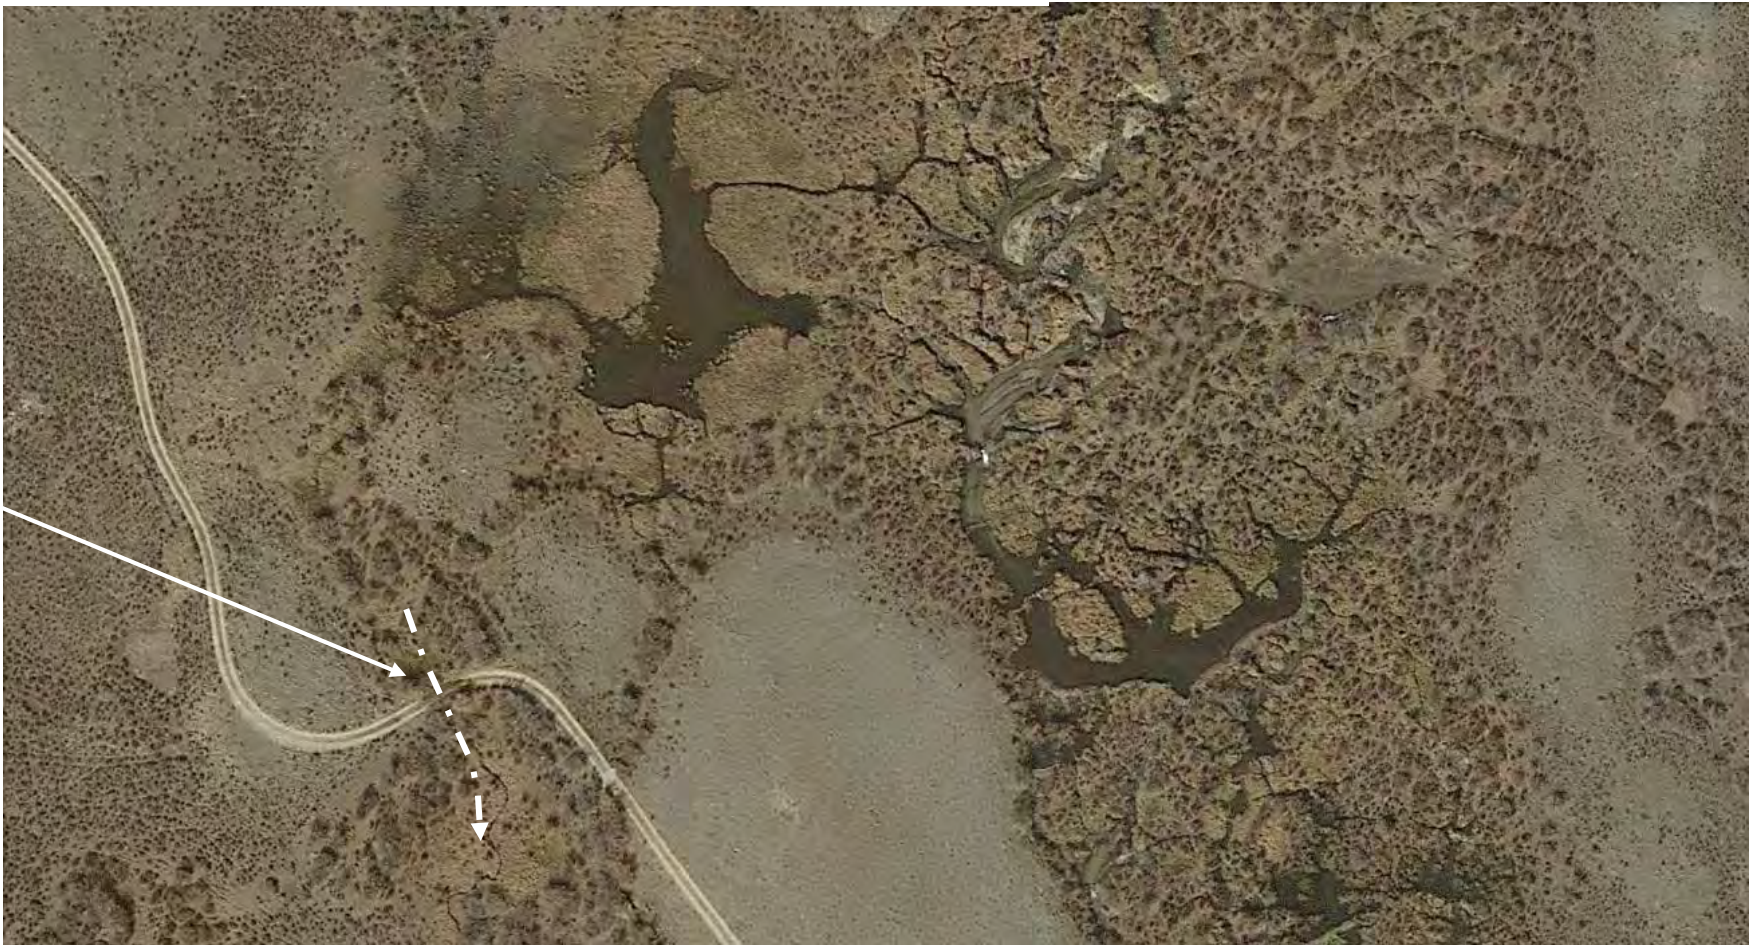
Management concepts: Upper ranch road crossing

Upper ranch road crossing

Depending on beaver activity upstream, a portion of Twelvemile Creek flows follow the flow path shown, flooding the road as it was in 2018. A culvert and possibly a flow device could help manage this situation.

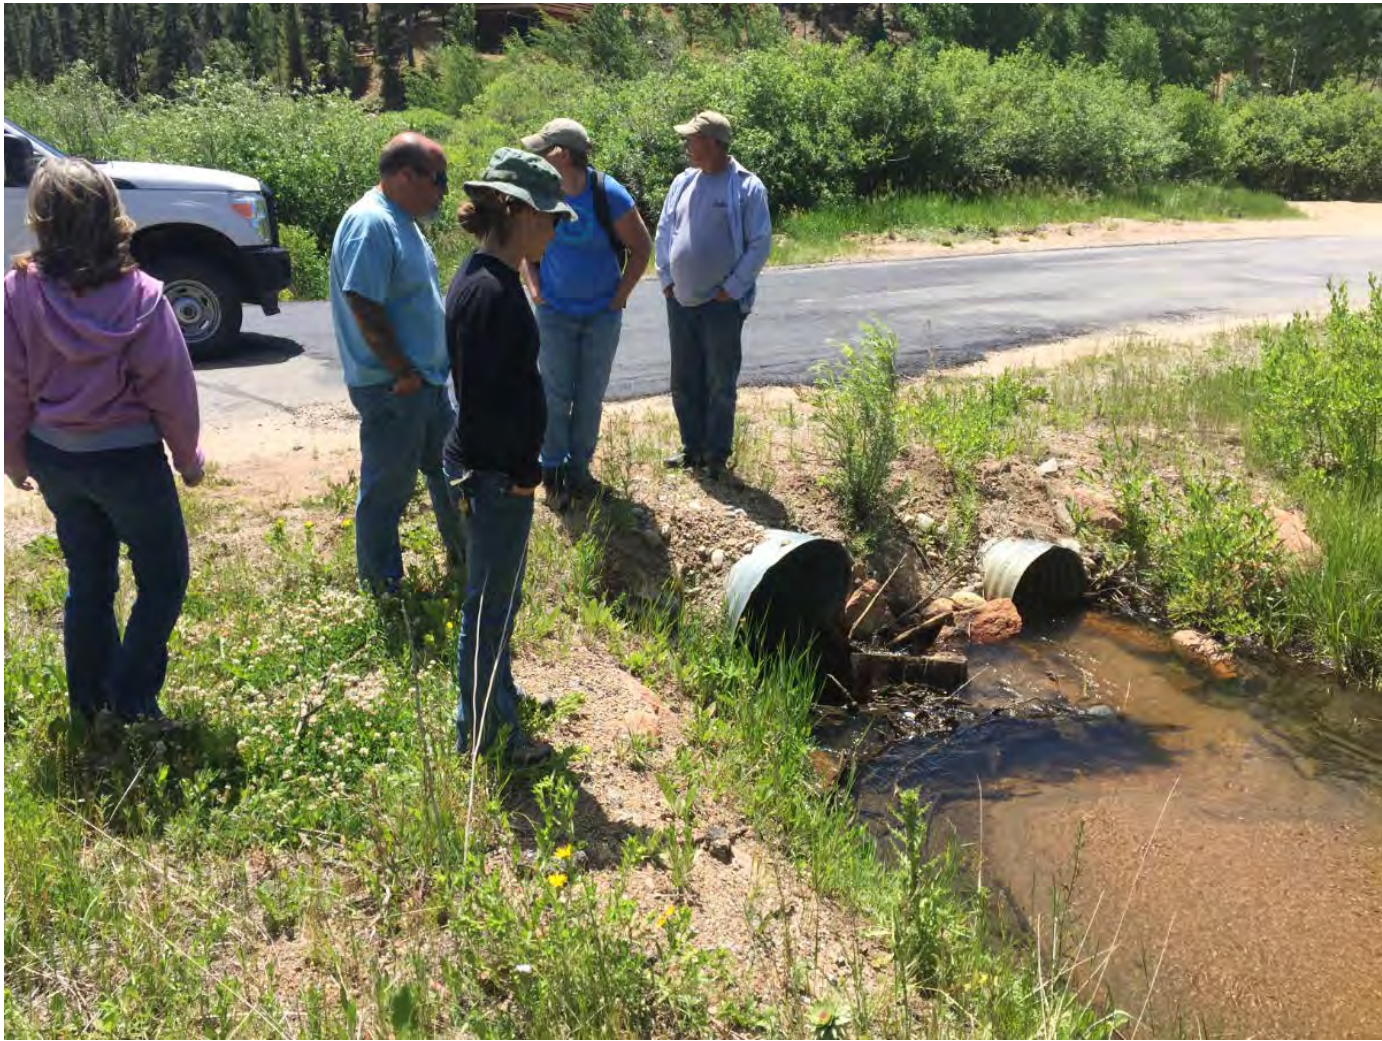
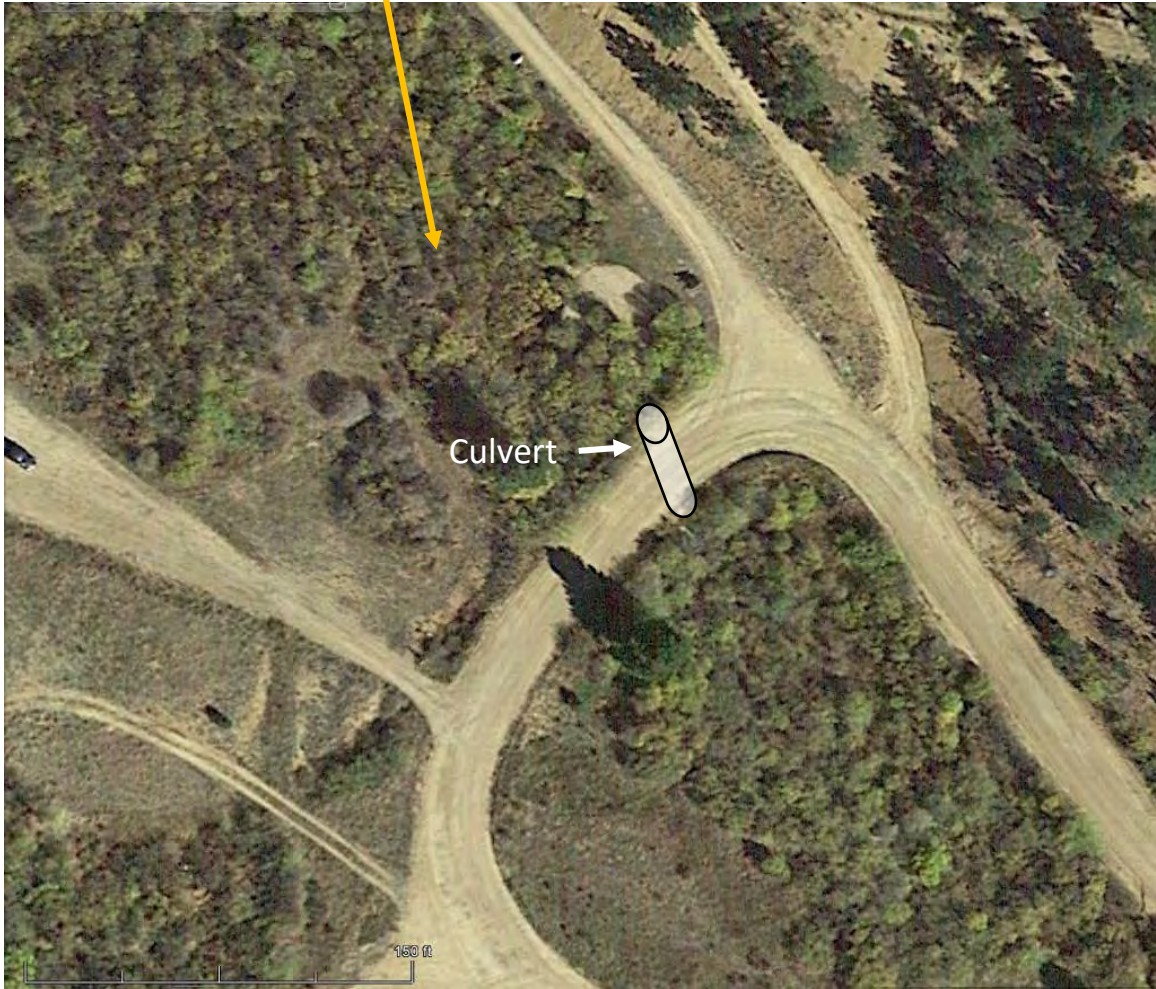
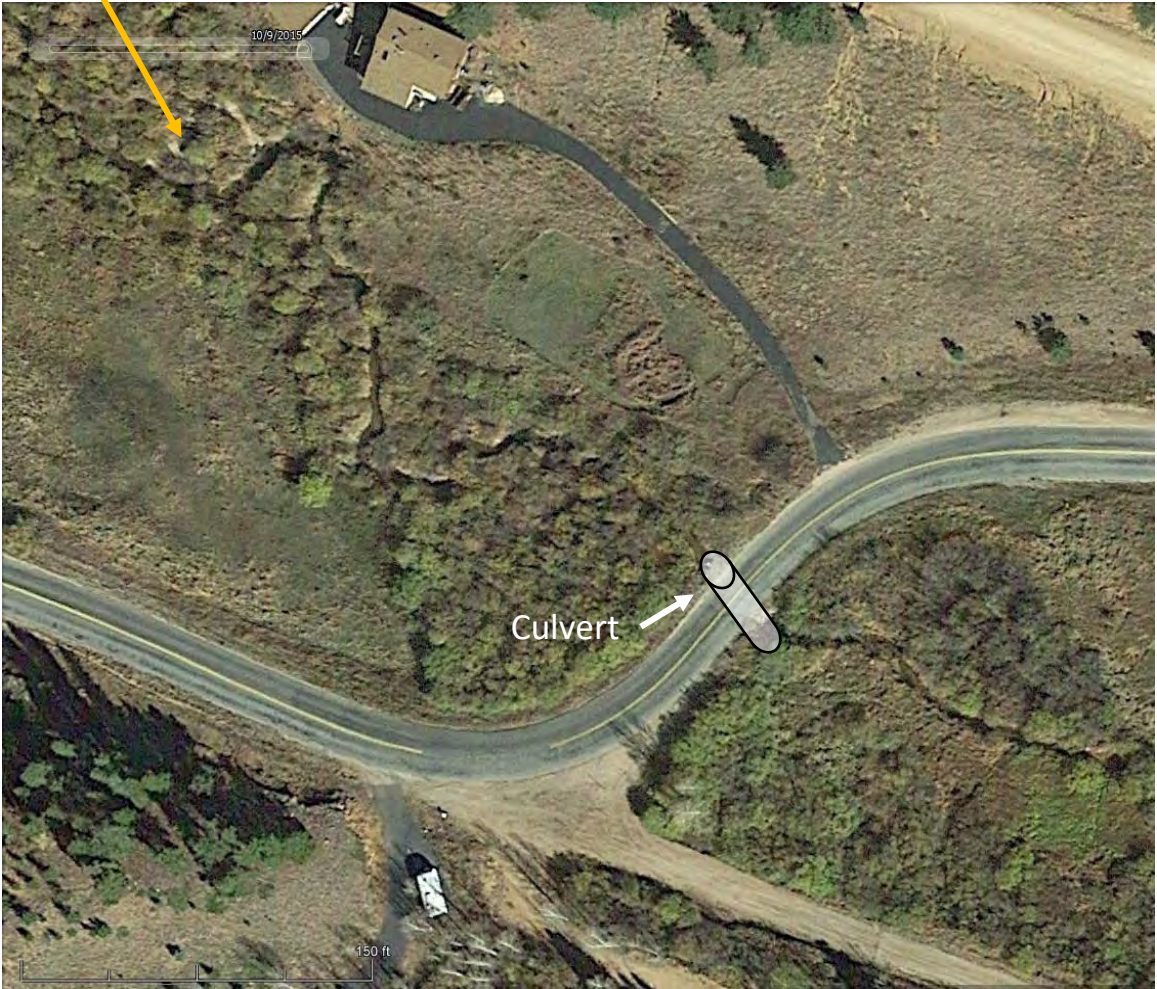
↓ Elk Creek culvert at the upper road crossing

Maintaining culverts in beaver habitat
Restoring beaver habitat on the ECHPOA reach could mean an increased risk that beavers will plug culverts. Identifying these potential conflict areas allows us to prepare for potential issues and prepare in advance to reduce the risk of damage or maintenance issues.

Flow devices and other emerging technologies have been used extensively in the Eastern US and Canada to allow coexistence of beaver habitat with human infrastructure, solving thousands of potential problems similar to the potential culvert issues on Elk Creek. Riparian Reconnect is bringing this technology to Colorado in collaboration with [Beaver Solutions™](#) and the [Beaver Institute](#). Please see their websites for examples of Beaver conflict management using flow devices.

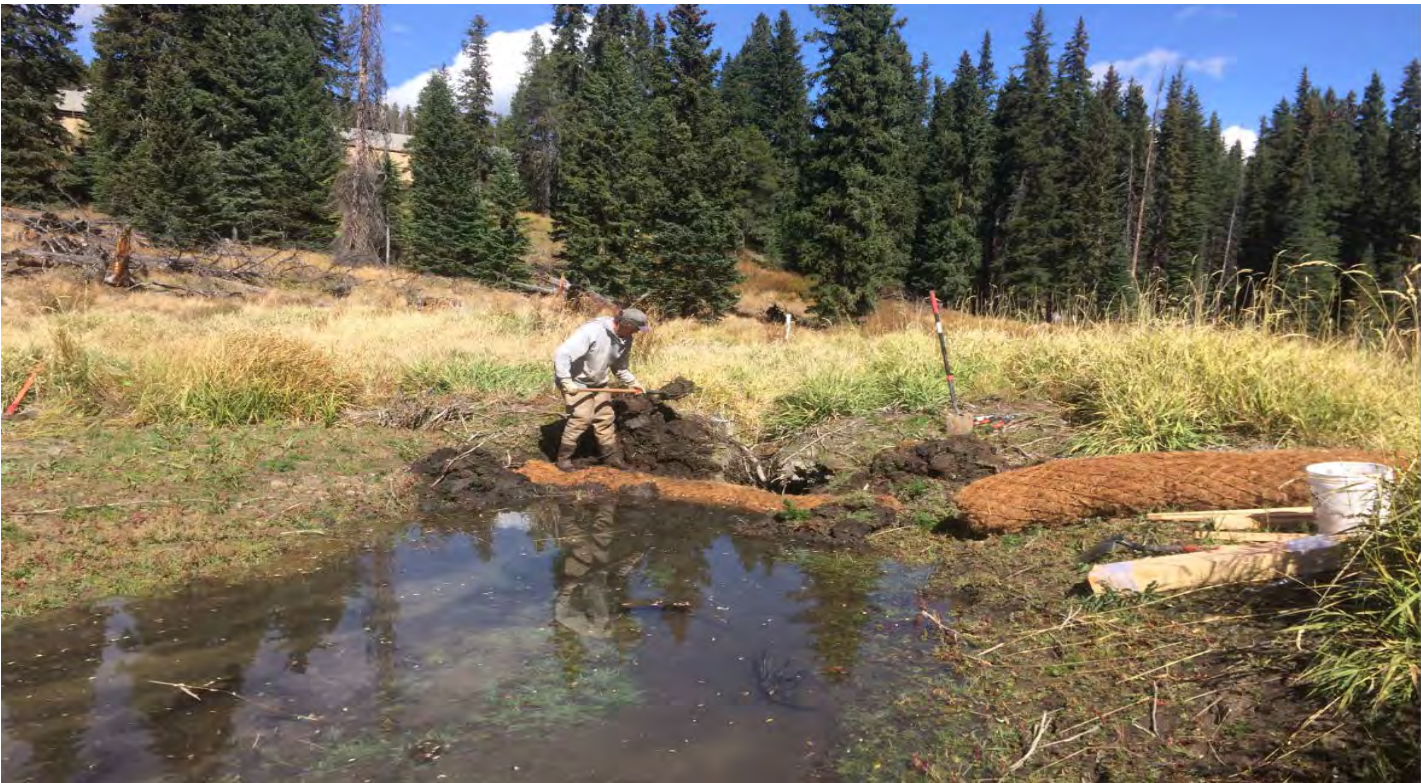
↑Repairing breached beaver dams with coir logs and sod.

The diagrams above and left show specifications for repairing cross-channel dams. These structures are designed to persist through normal runoff events, but are not permanent. They are constructed of native materials that assimilate into the streamscape over time.

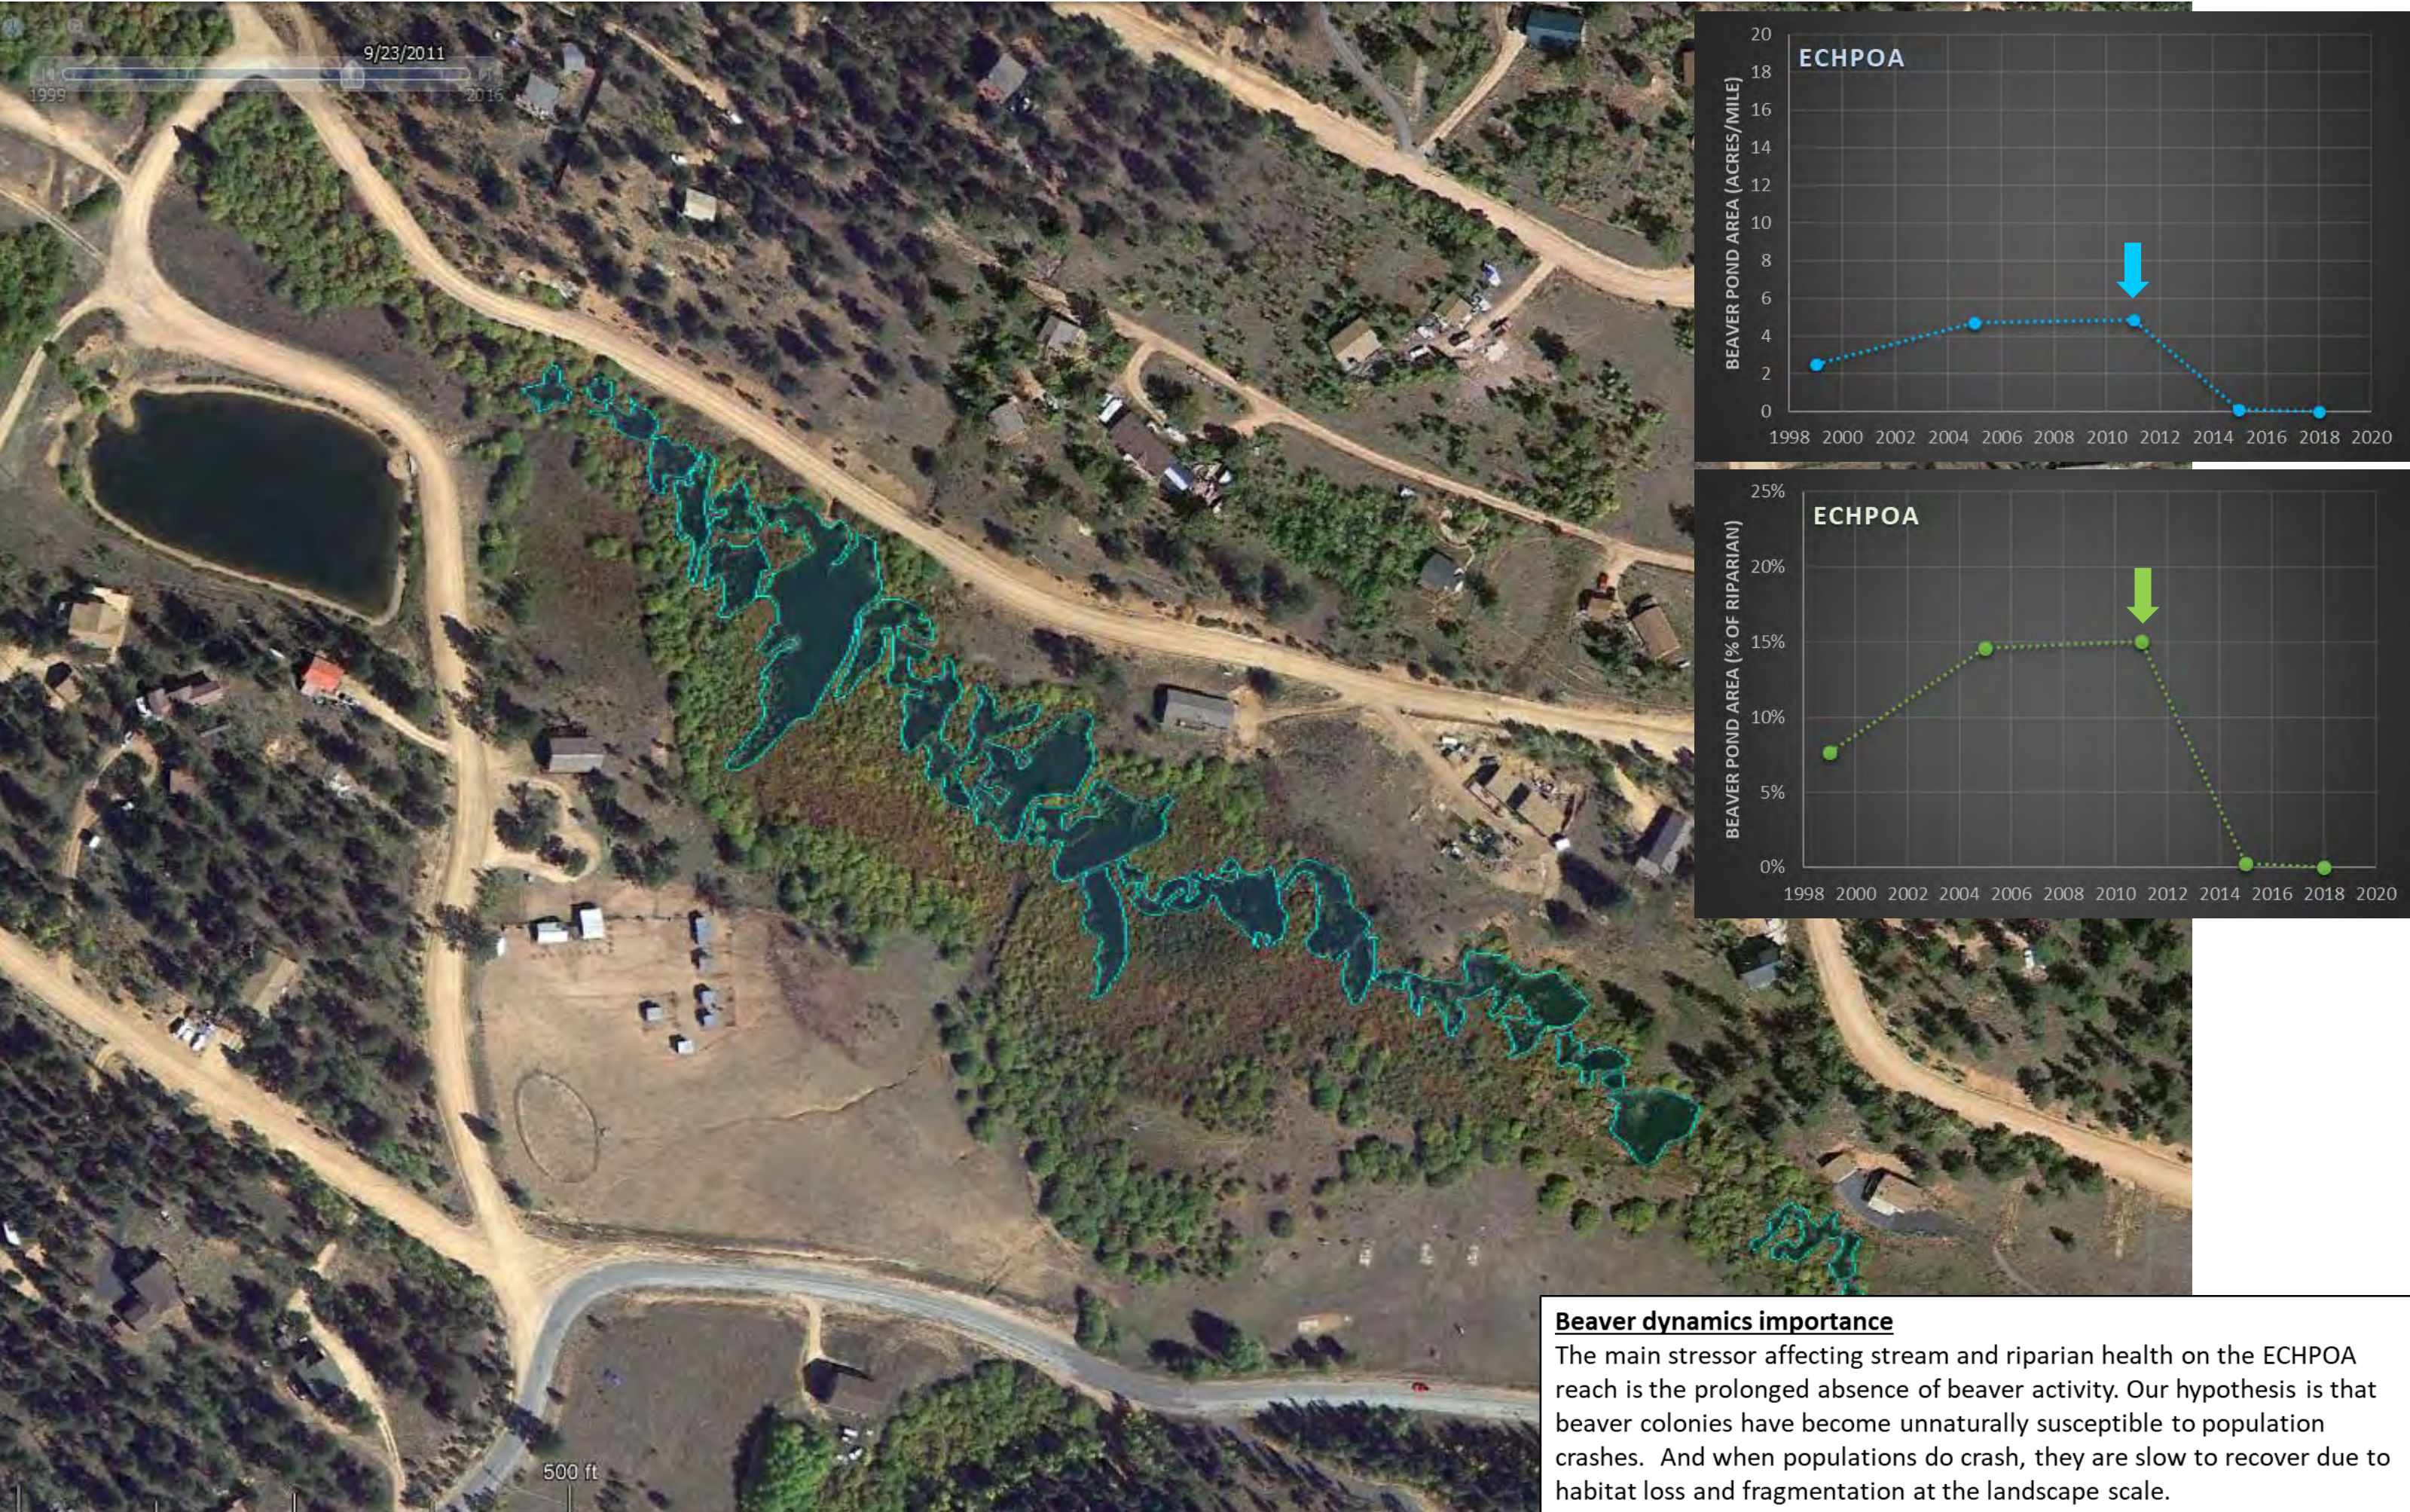
Beaver activity — 2011

The main stressor affecting stream and riparian health on the ECHPOA reach is the prolonged absence of beaver activity. Our hypothesis is that beaver colonies have become unnaturally susceptible to population crashes. And when populations do crash, they are slow to recover due to habitat loss and fragmentation at the landscape scale.
