Water Plan Grant Application

Twelvemile Ranch:
A reconnaissance assessment of stream and riparian condition for the Riparian Reconnect project with recommendations for restoration and management

Tarryall Notch Ranch: Assessment for Riparian Reconnect

Elk Creek Highlands Property Owners Open Space Reach:
A reconnaissance assessment of stream and riparian condition for the Riparian Reconnect project with recommendations for restoration and management

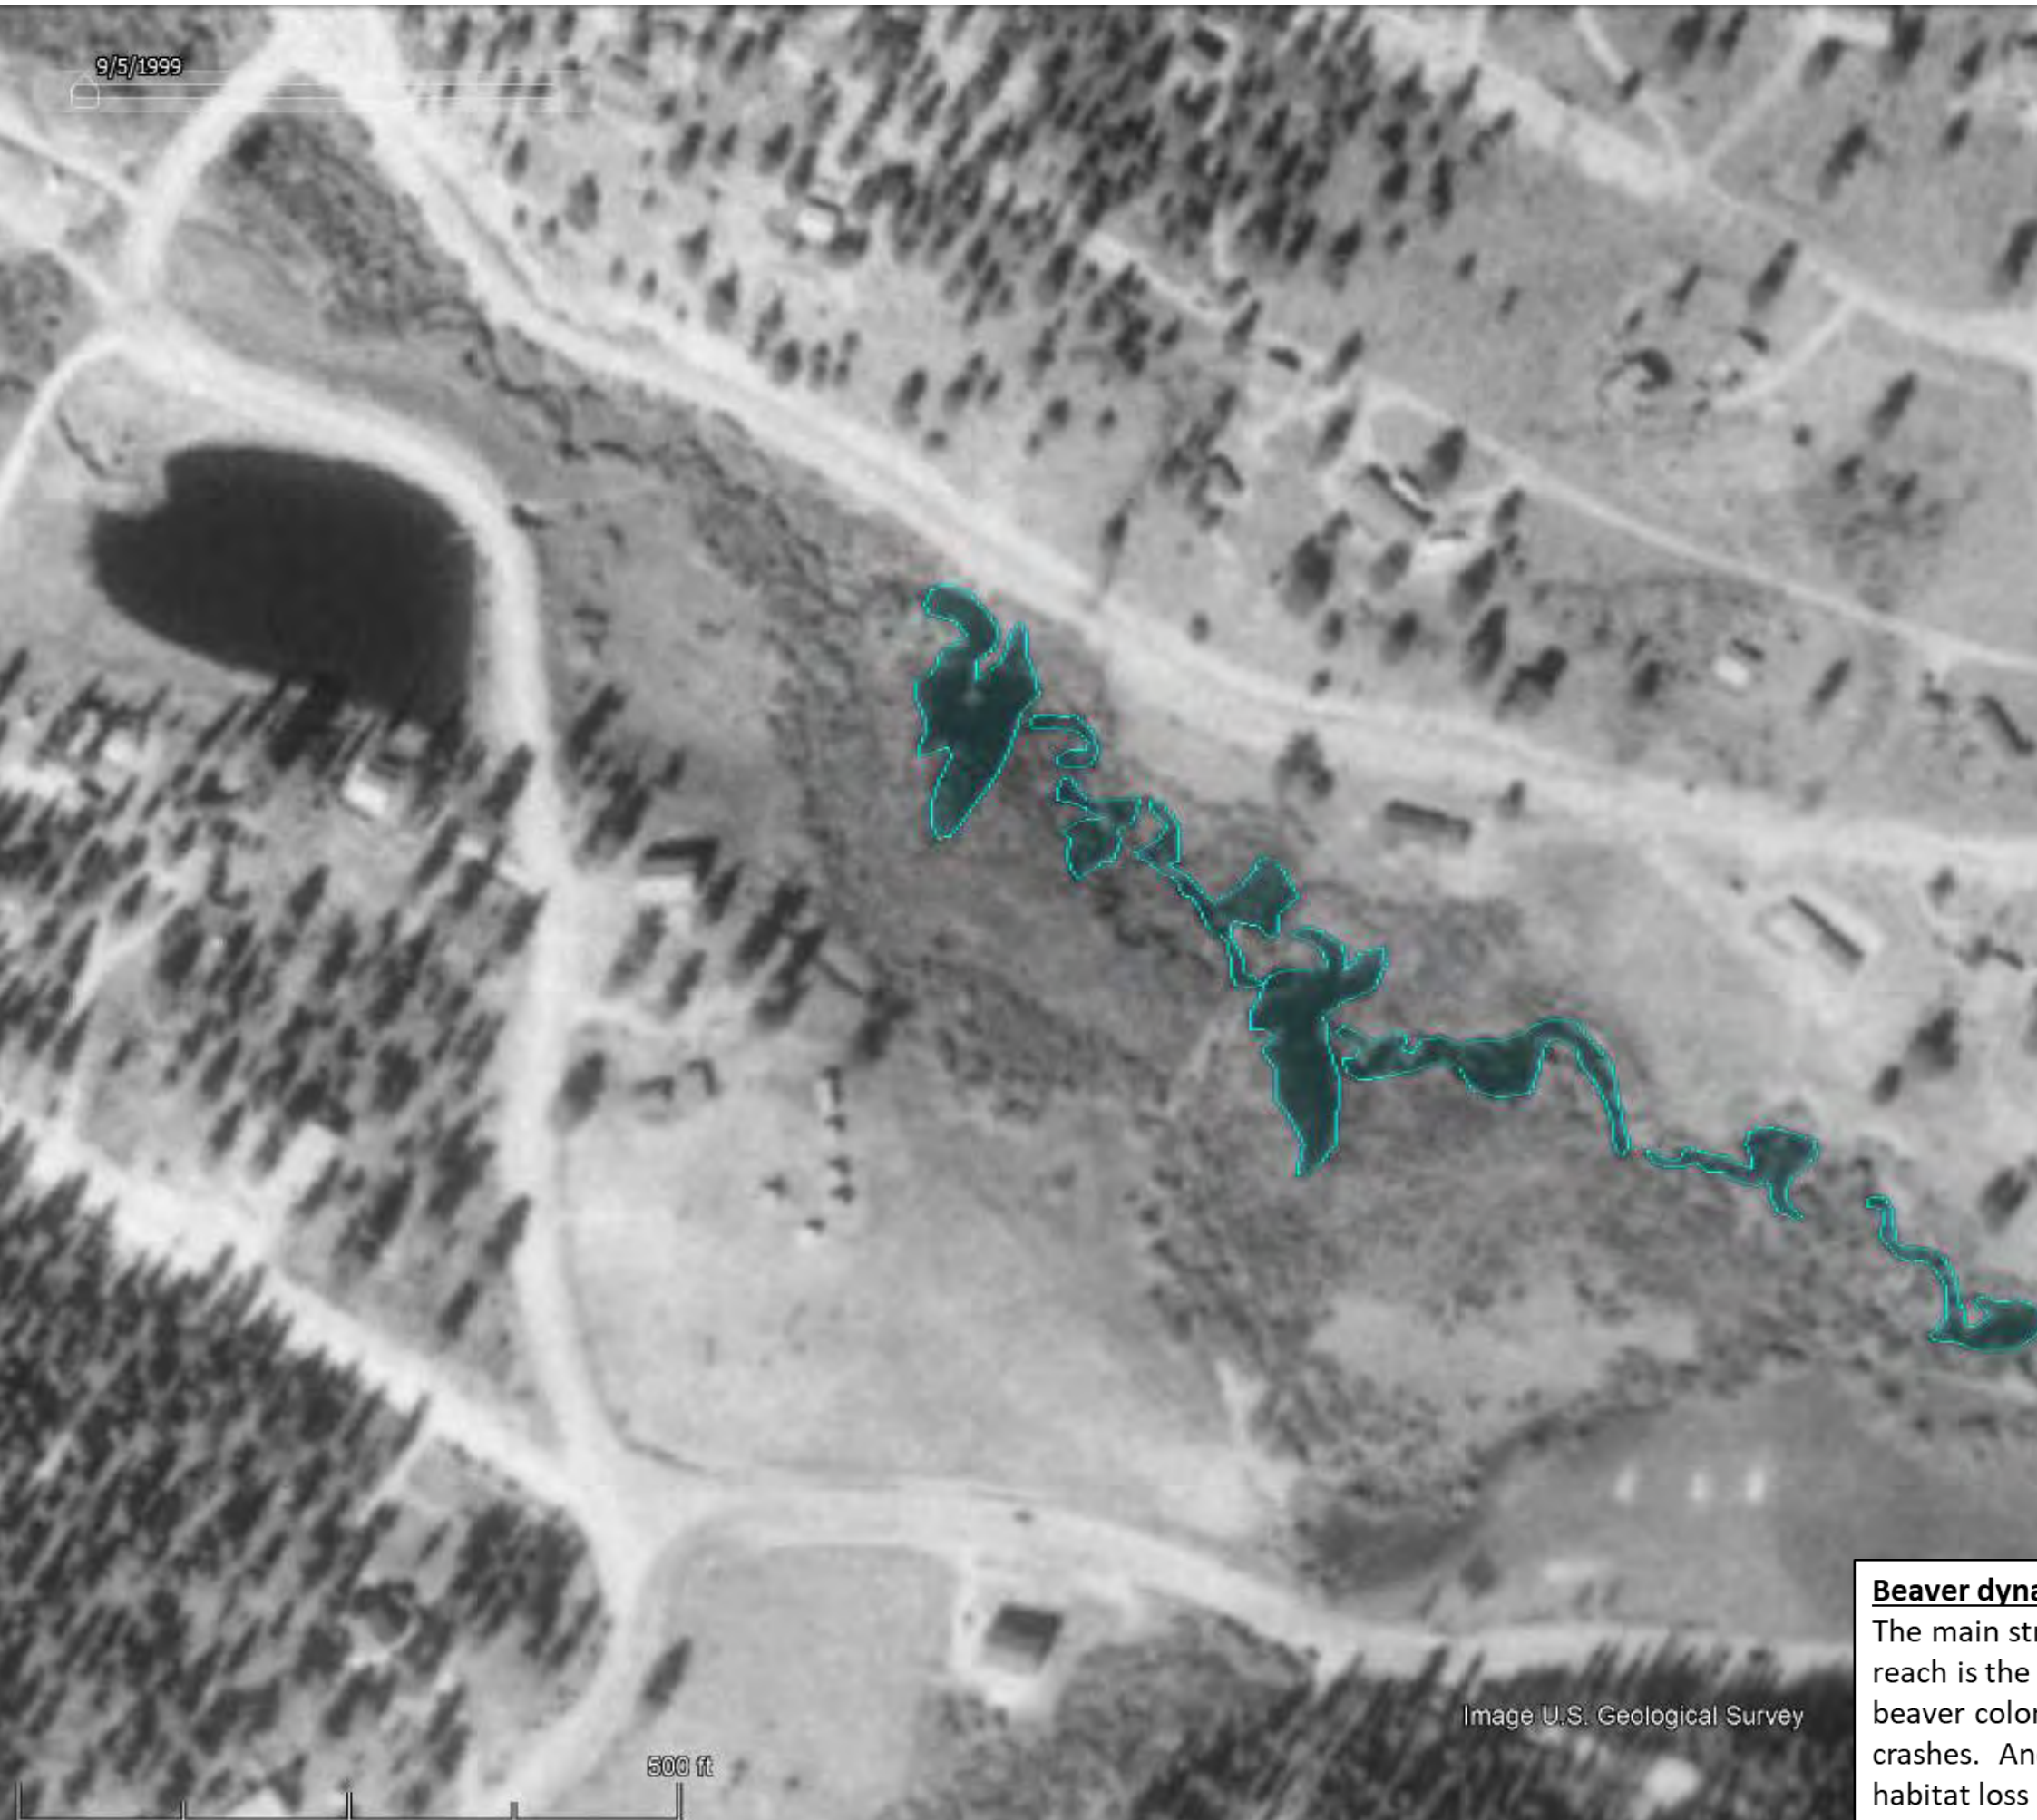
Beaver activity — 1999

The main stressor affecting stream and riparian health on the ECHPOA reach is the prolonged absence of beaver activity. Our hypothesis is that beaver colonies have become unnaturally susceptible to population crashes. And when populations do crash, they are slow to recover due to habitat loss and fragmentation at the landscape scale.
