December 29, 2011

Re: 2011 Monitoring Report for the Phase 2A and 2B Edwards Eagle River Restoration Project in Eagle County, Colorado, Corps File No. SPK-2008-00608

EAGLE RIVER PHASE 2B 2011 MONITORING REPORT VEGETATION TREATMENTS

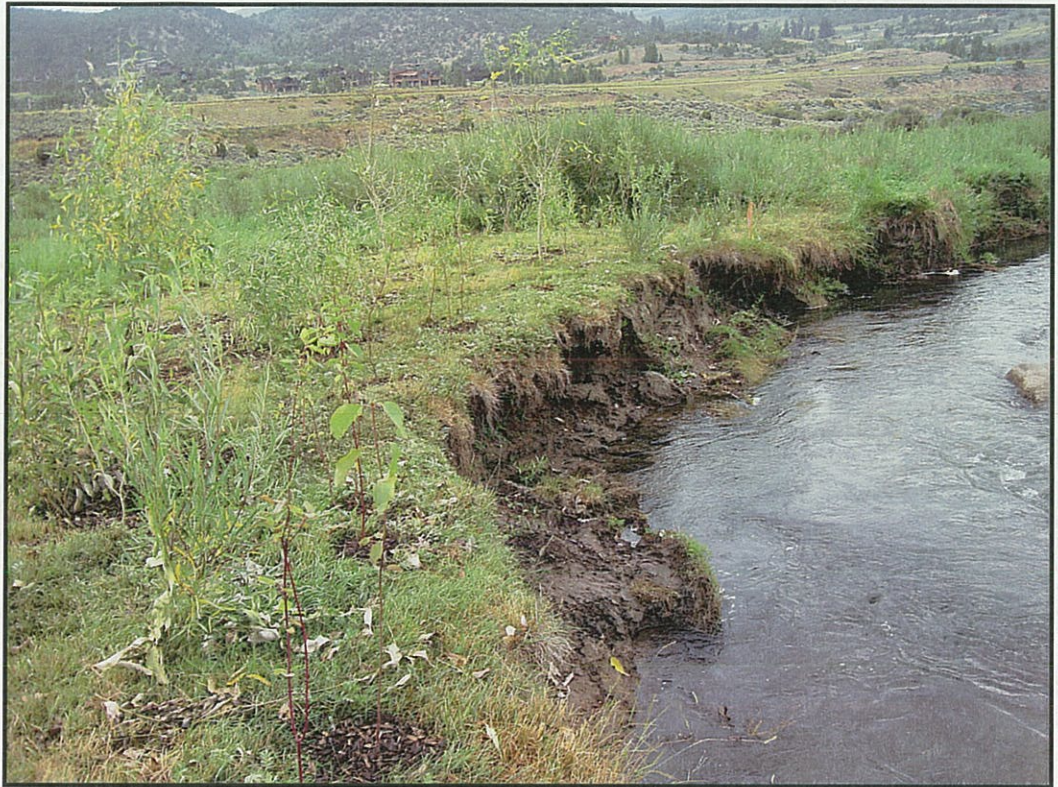
Point 2BV8L: Treatment area 2B-1 at Lake Creek looking downstream, before grading.

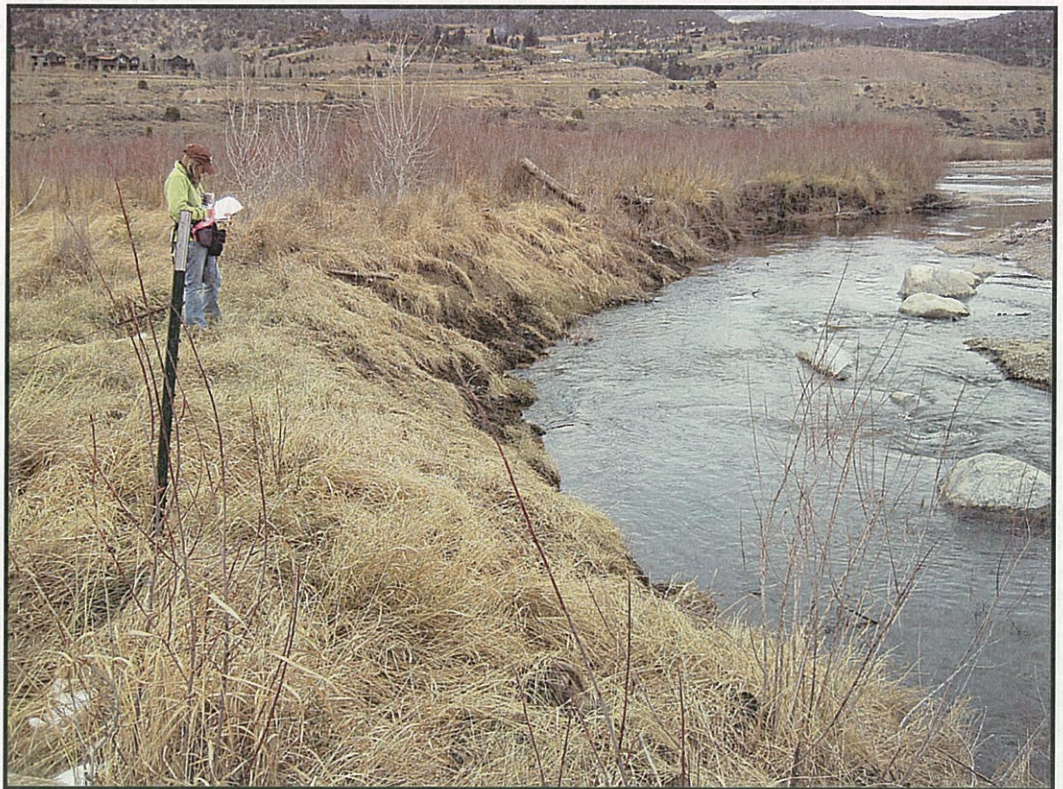
Point 2BV8L: 11-11-11 Treatment area 2B-1 looking upstream, after smashbank treatment.

The bank damaged by high flows was repaired using the smashbank technique, in which river banks are pushed back with a large excavator bucket to a more gradual slope, but no soil is removed. Willow wattles and coir erosion control blanket were replaced, and an extra width of coir erosion control blanket was installed at the top of the bank slope.

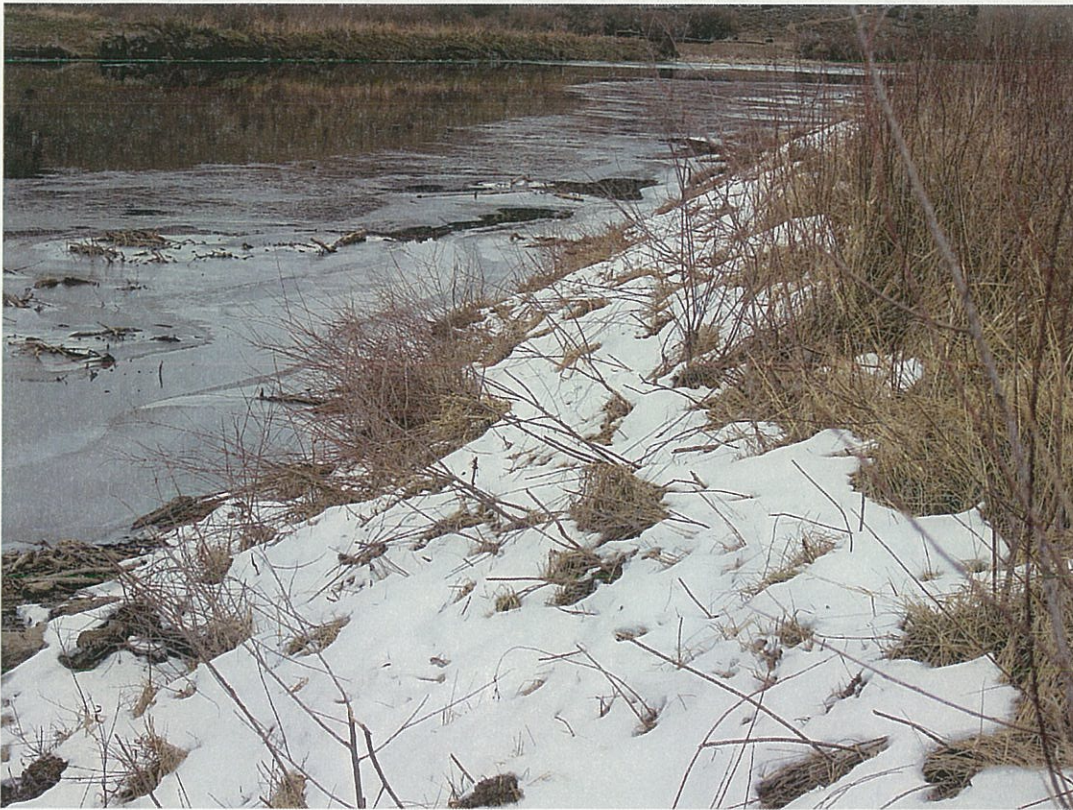
Point 2BV5L: 11-11-11 Treatment area 2B-2Ca looking upstream, as-built.

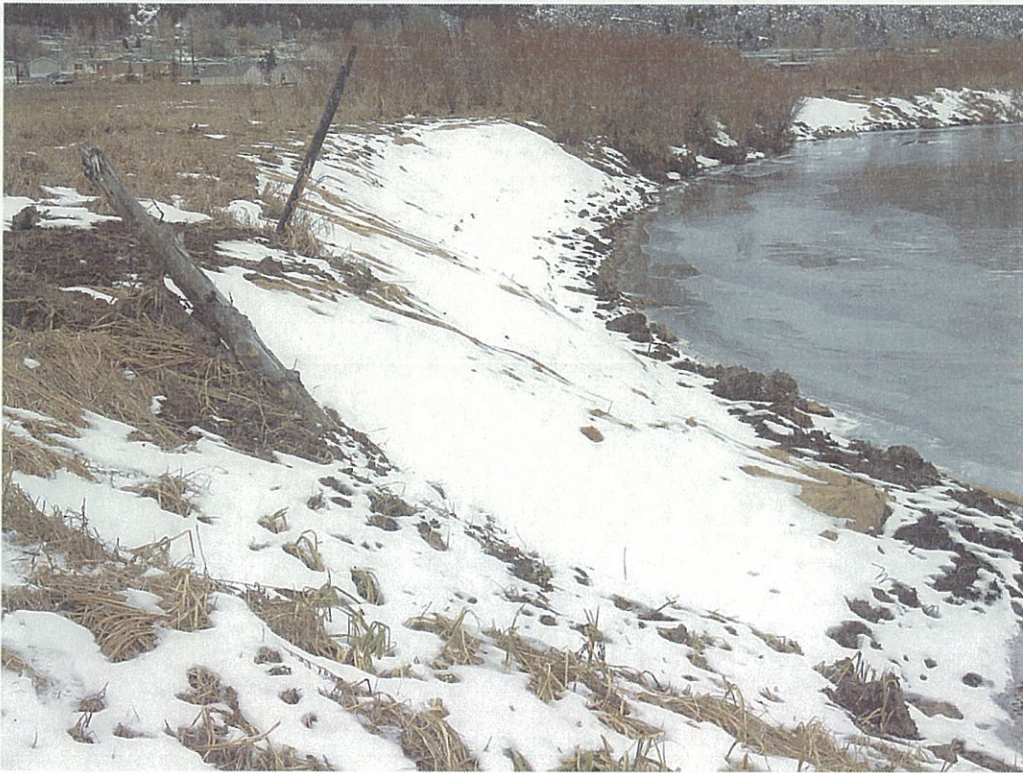
Point 2BV4L: 11-11-11 Treatment area 2B-2Da and 2B2Db looking downstream, as-built.

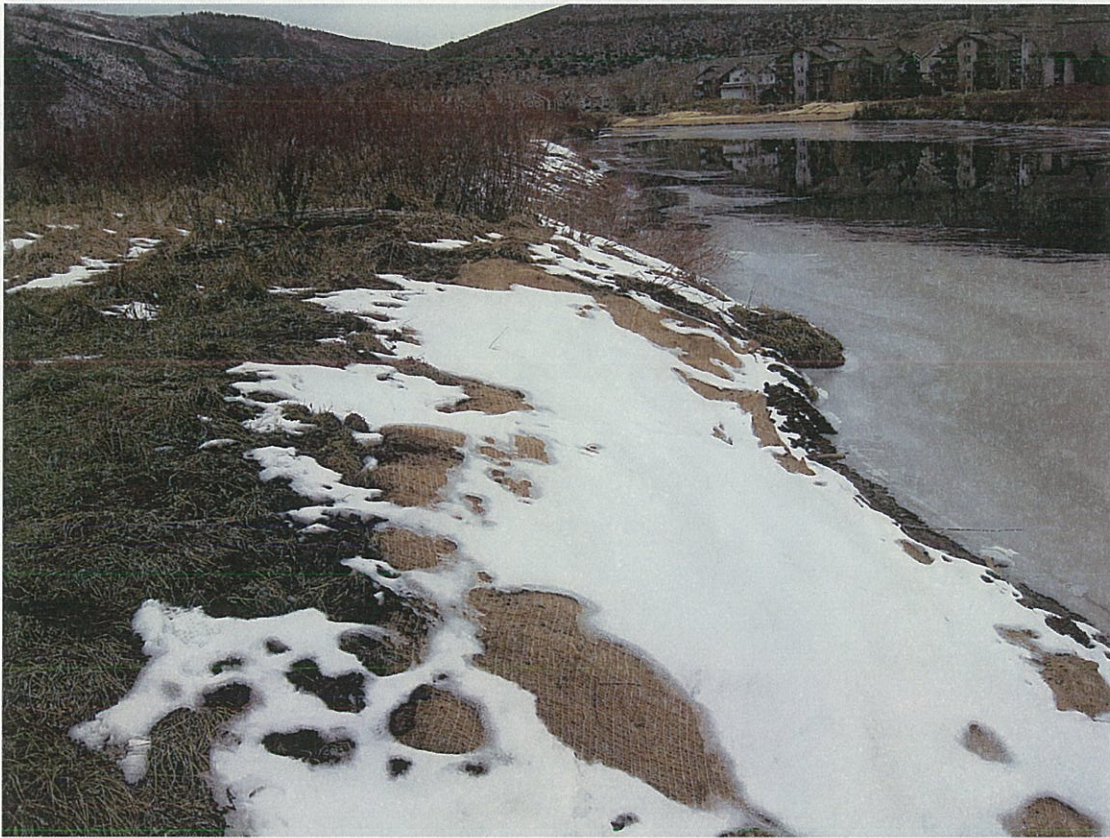
Point 2BV3L: 11-1-11 Treatment area 2B-2E looking downstream, as-built.

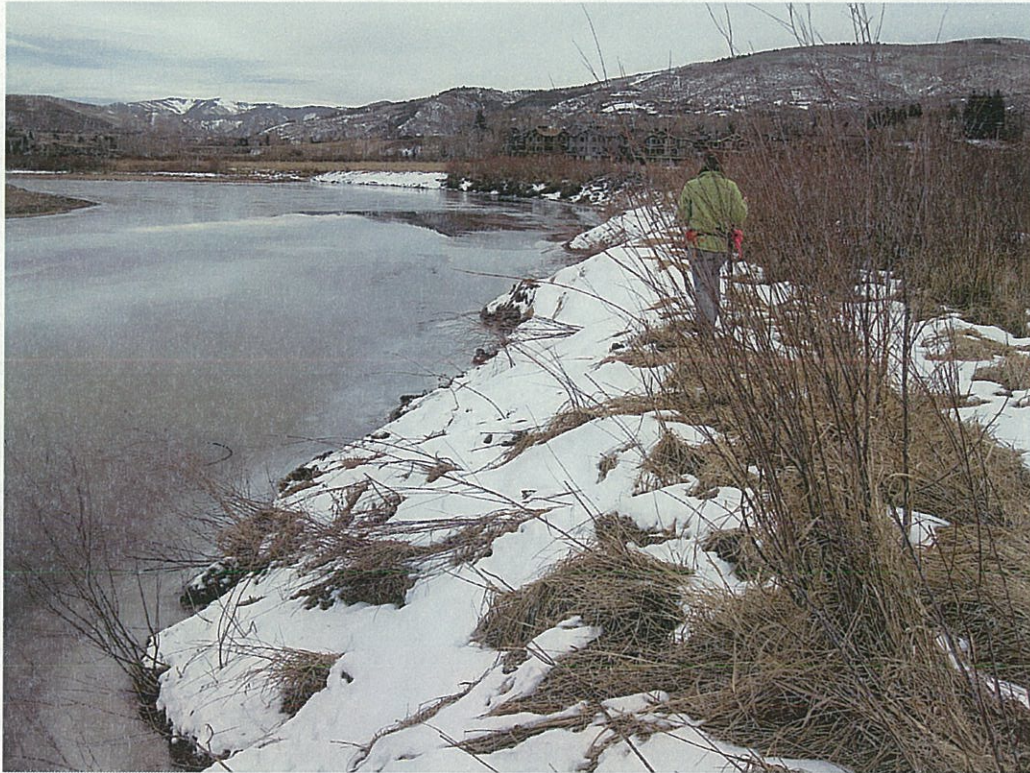
Point 2BV2L: 11-11-11 Treatment area 2B-2Fb looking upstream, as-built.

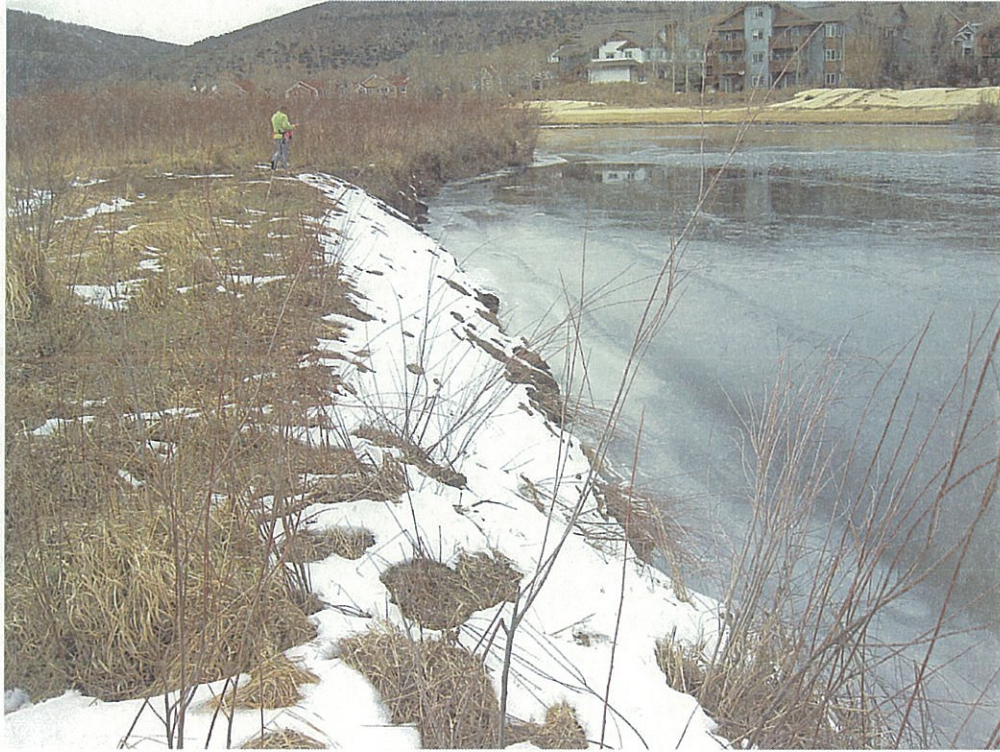
Point 2BV1L: 11-11-11 Treatment area 2B-2Ba looking downstream, as-built.

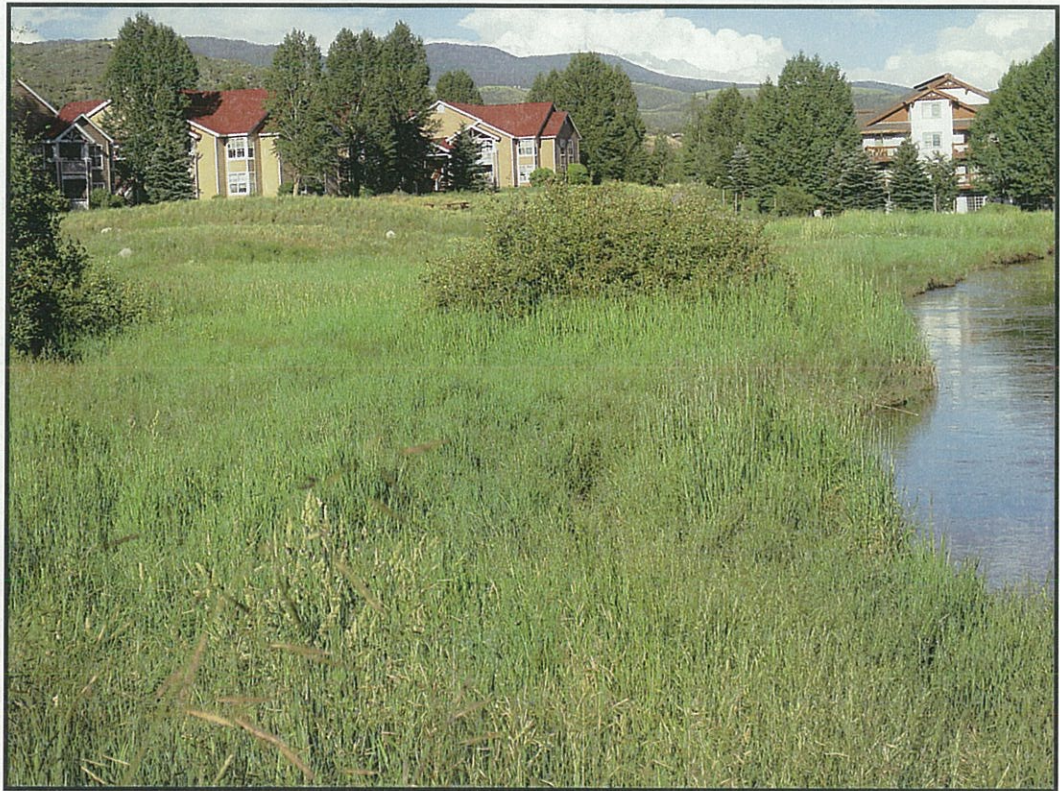
Point 2BV1R: 7-13-11 Treatment area 2b-3F looking upstream prior to grading.

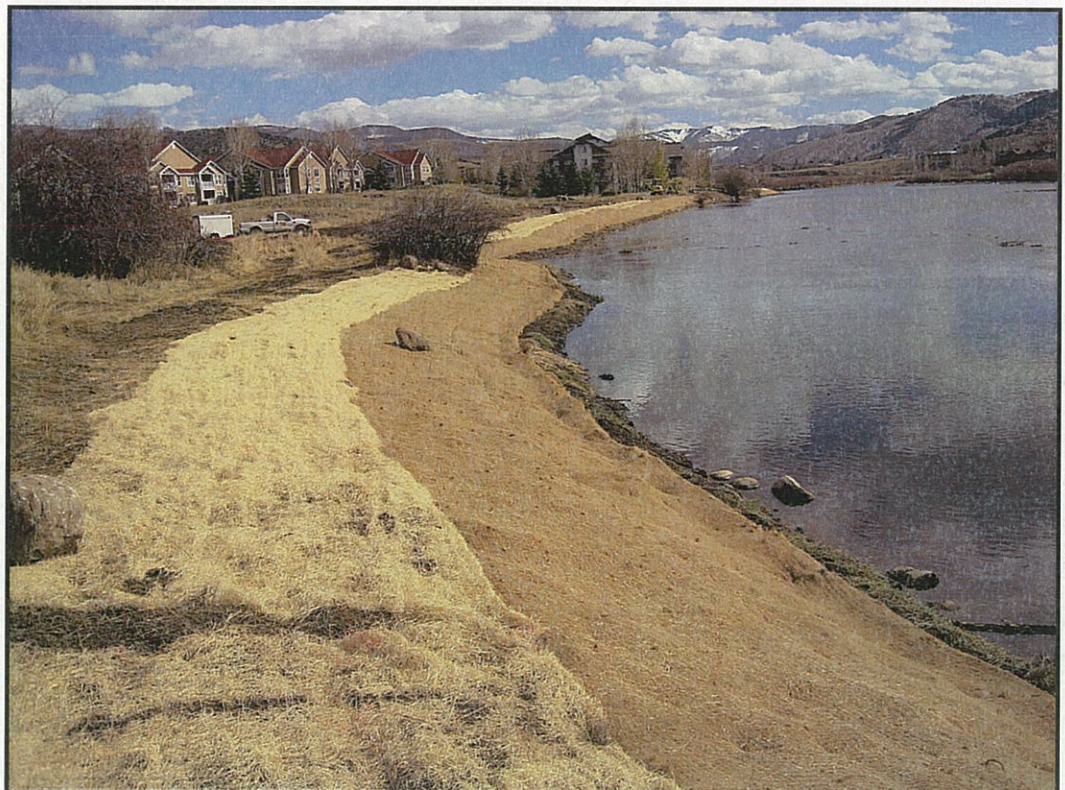
Point 2BV1R: 11-18-11 Treatment area 2B-3F as-built.

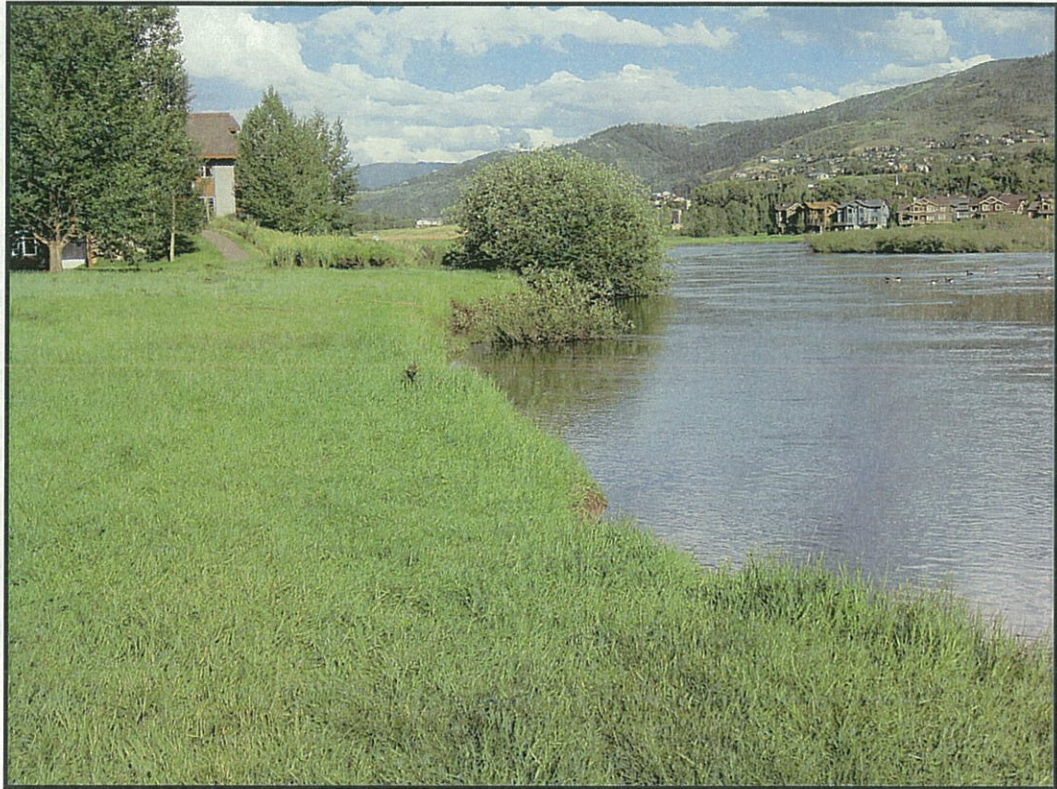
Point 2BV2R: 7-13-11 Treatment area 2B-3D looking upstream prior to grading.

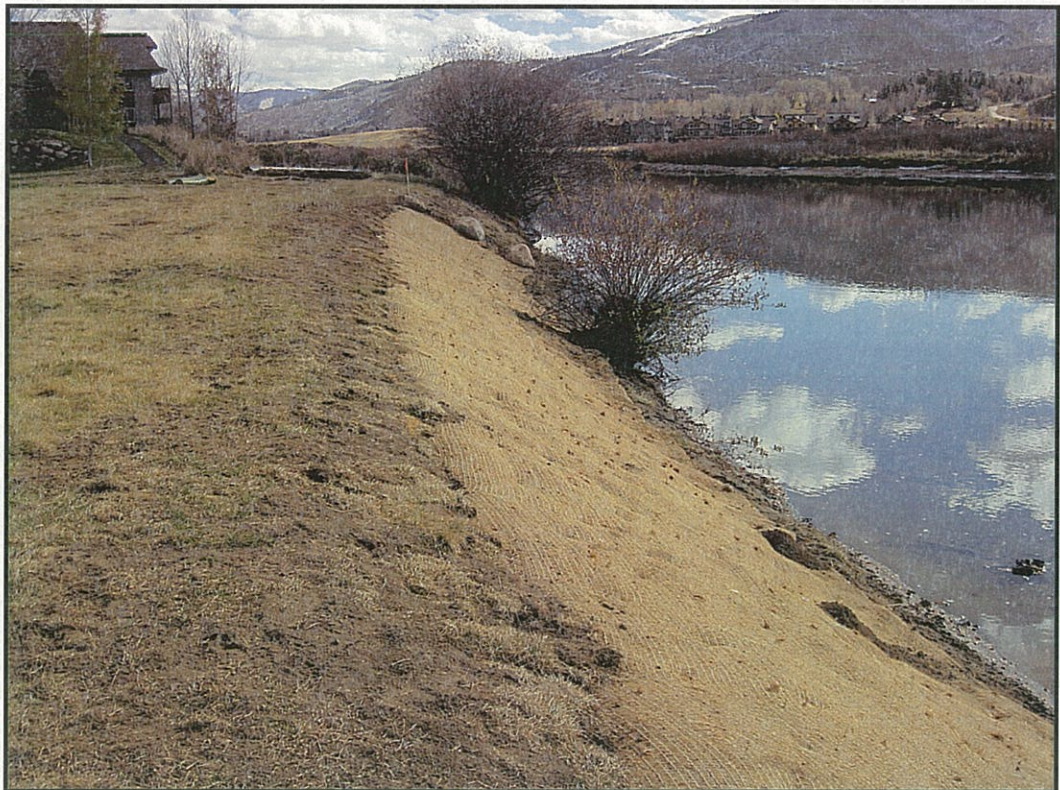
Point 2BV2R: 11-18-11 Treatment area 2B-3D as-built.

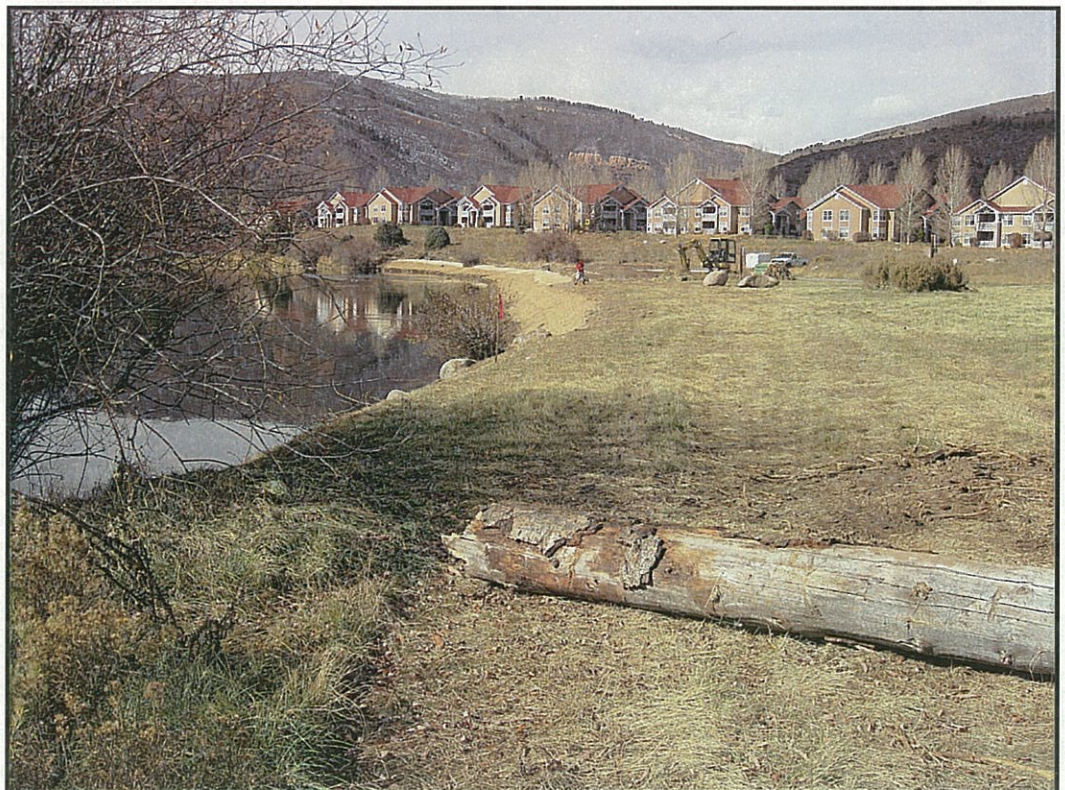
Point 2B3VR: 11-18-11 Treatment area 2B-3C as-built.

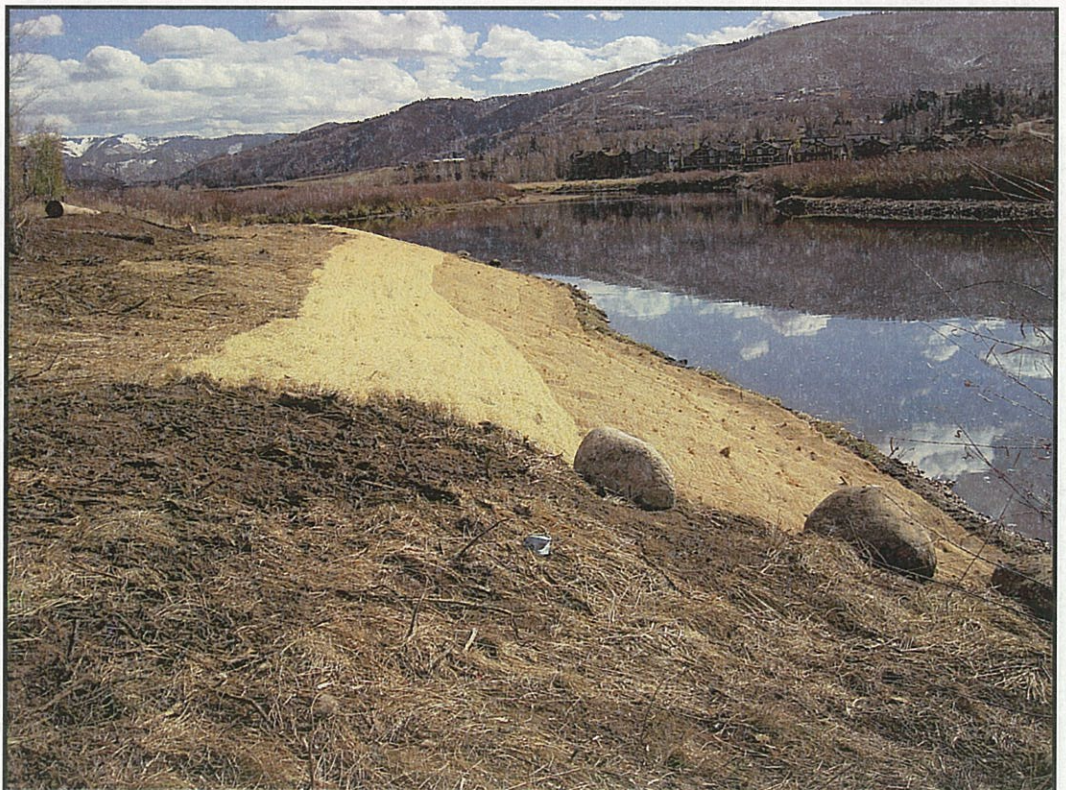
Point 2BV4R: 7-13-11 Treatment area 2B-3B as-built.

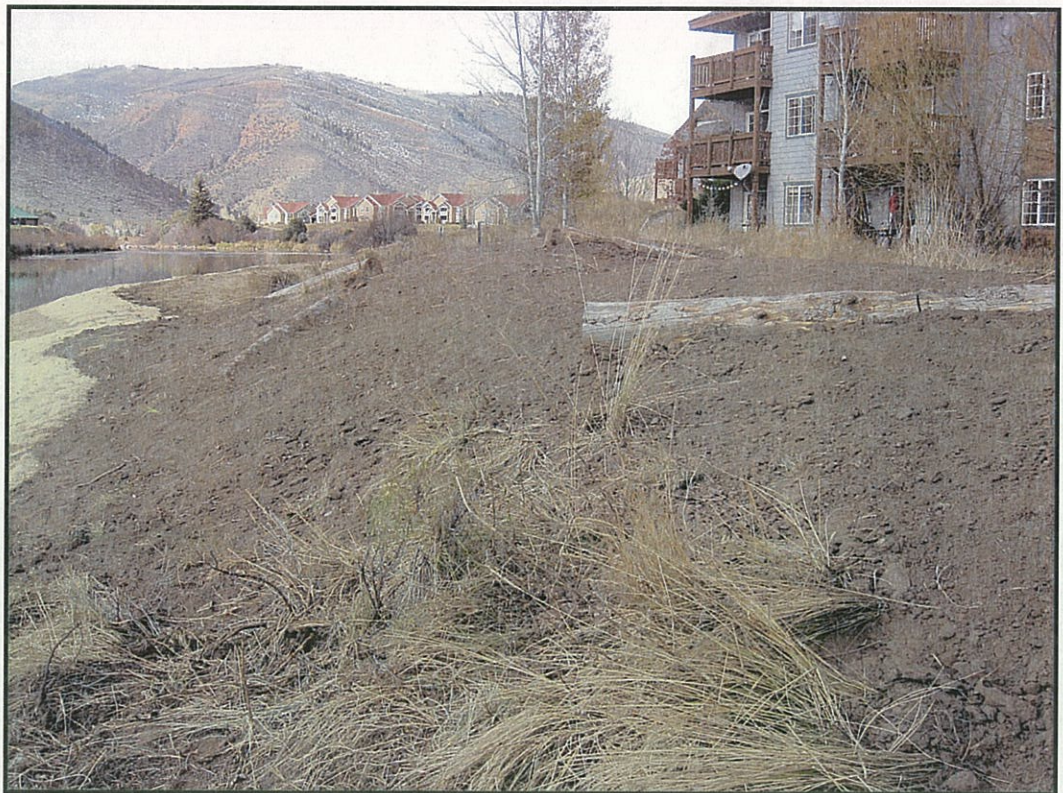
Point 2BV5R: 11-18-11 Treatment area 2B-3A, as-built.

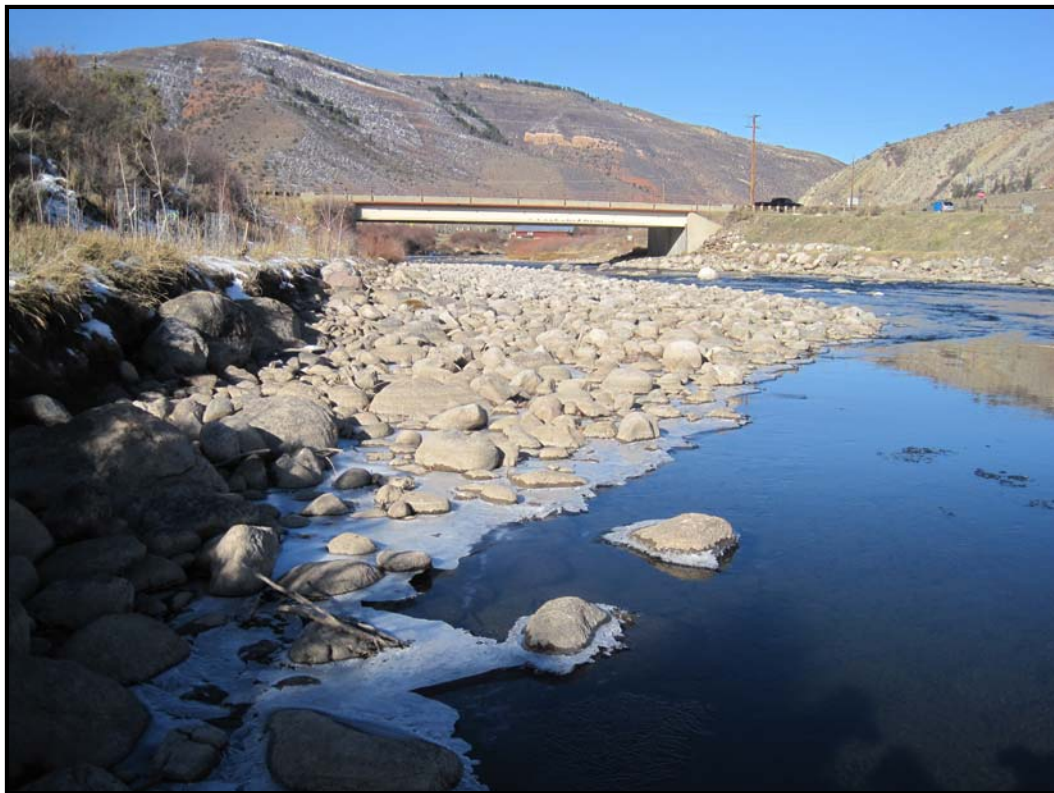
Point 1S2L: 11-11-11 Reach 2, left bank, looking downstream to Bar 1-17.

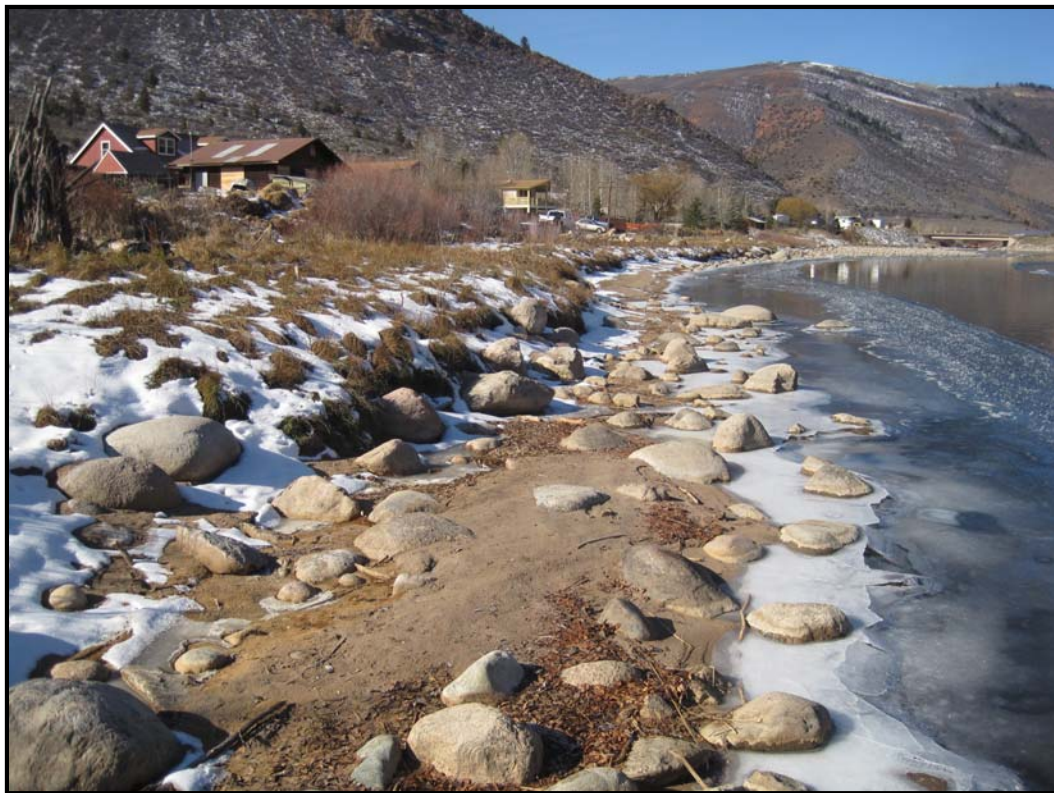
Point 1S3L: 11-11-11 Reach 2, looking downstream along Boulder/cobble Toe Treatment 1-16.

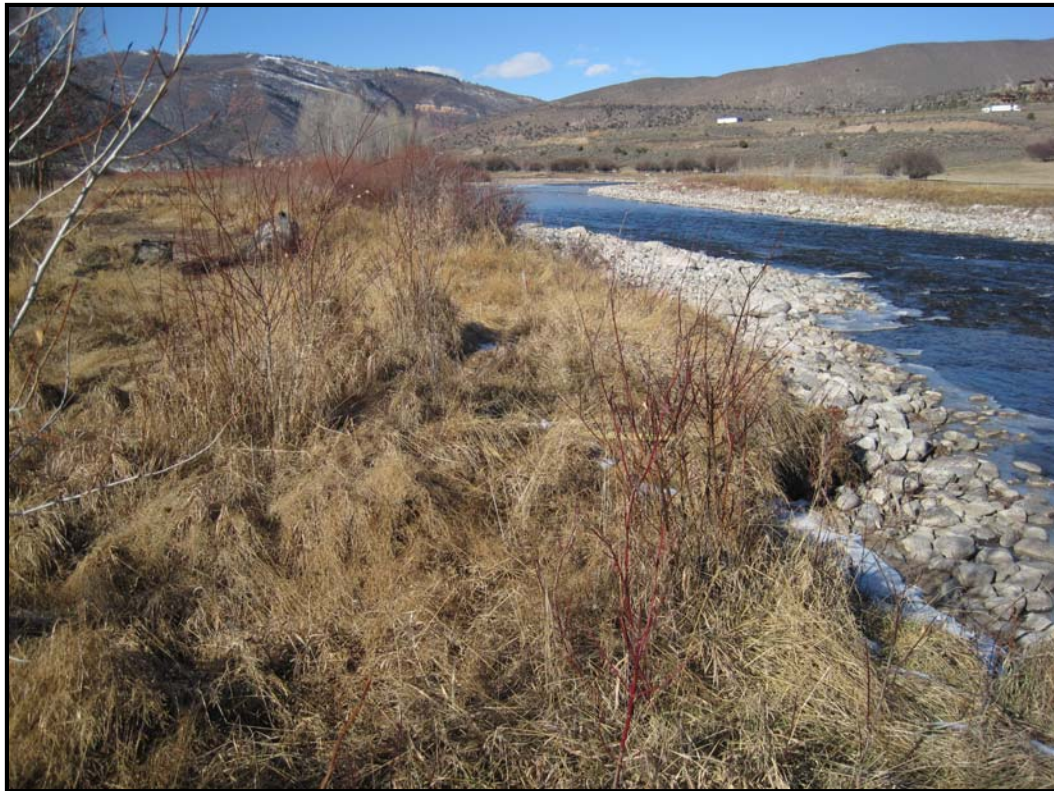
Point 1S4L: 11-11-11 Reach 5, left bank, looking downstream to Bar 1-9.

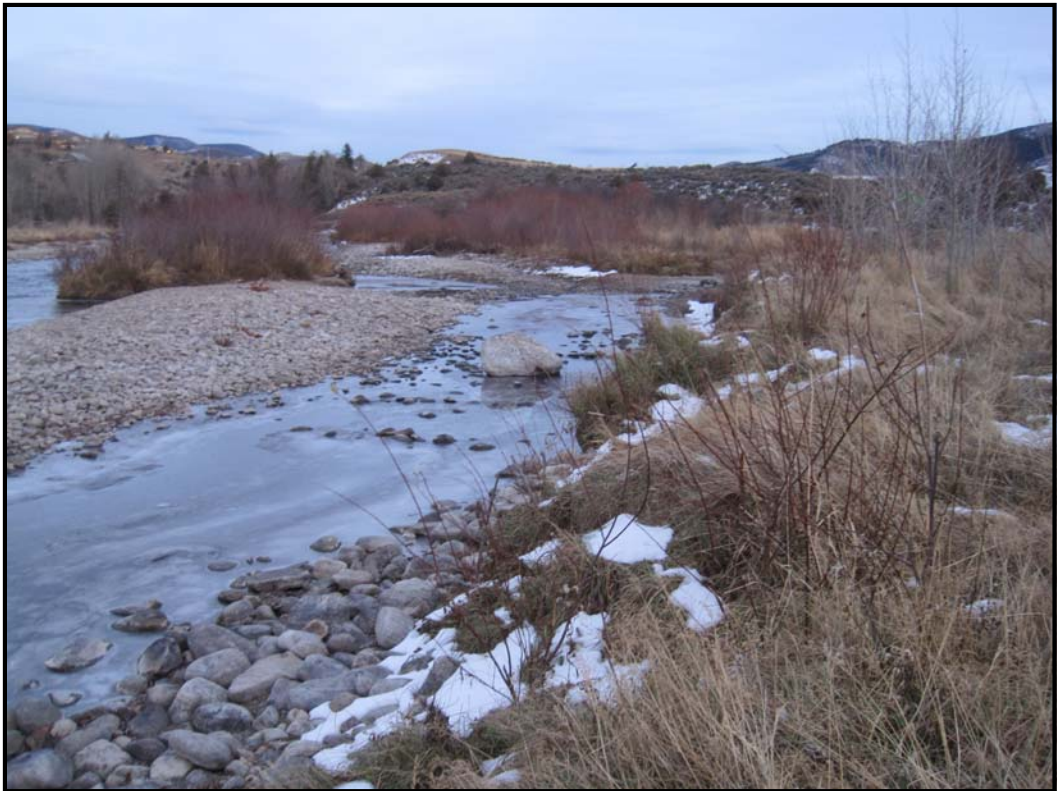
Point 1S5L: 11-11-11 Reach 5, left bank, looking upstream to Plug 1-6.

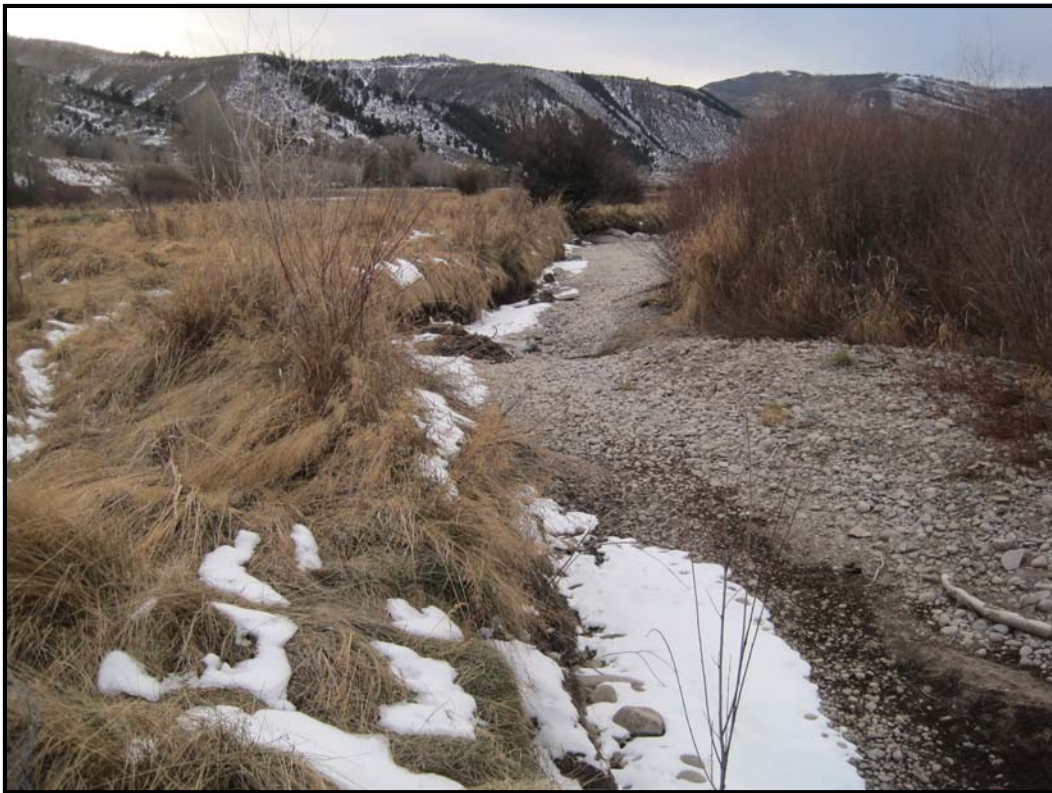
Point 1S7L: 11-11-11 Reach 5, side channel along left bank, looking downstream at side channel.

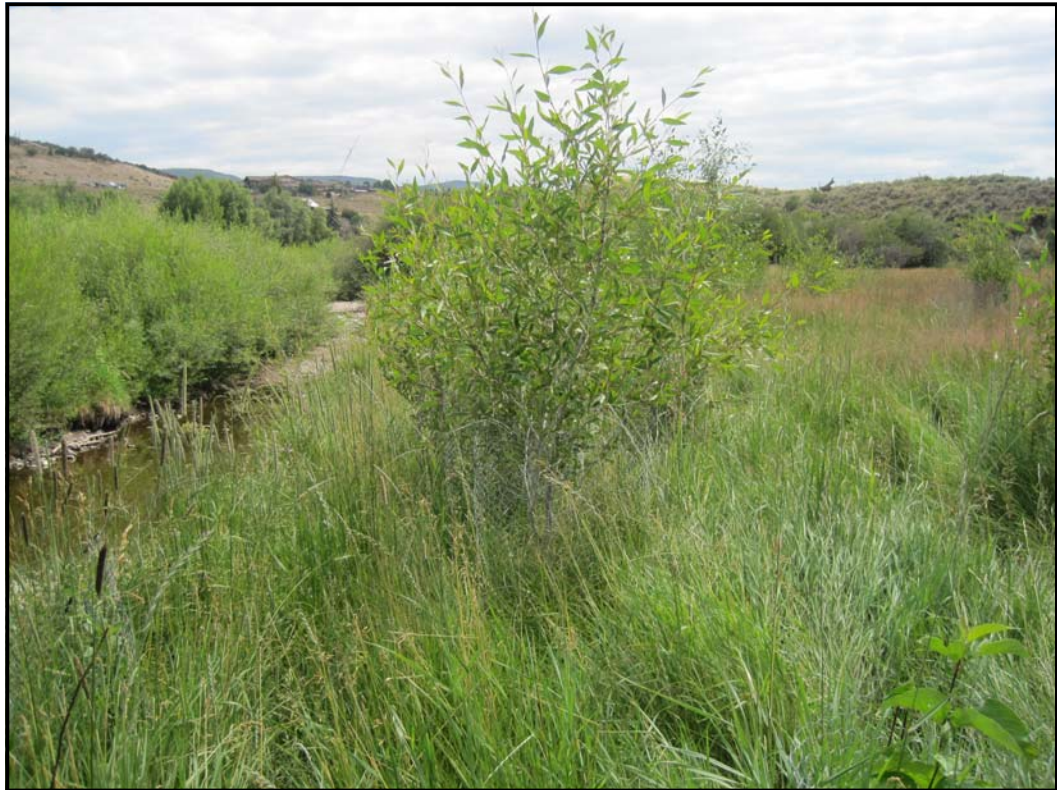
Point 1S8L: 819-11Reach 5, side channel along left bank, looking upstream at side channel.

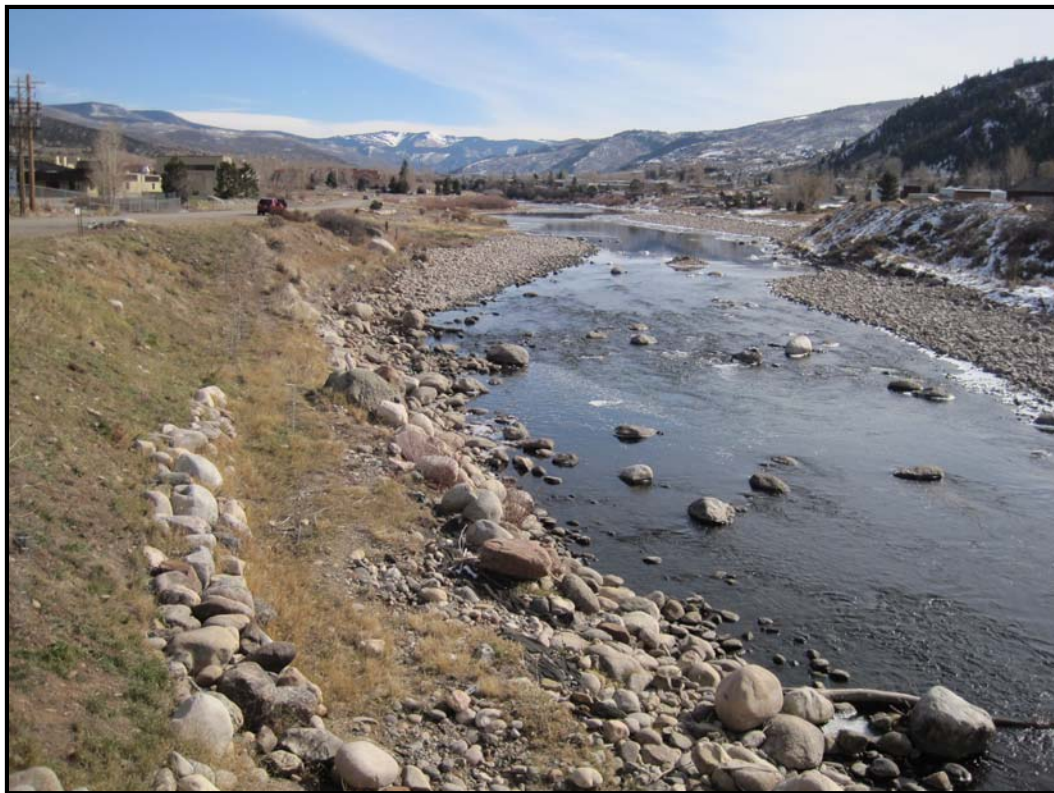
Point 1S1R: 1-1-11 Reach 1, right bank, looking upstream from Hillcrest Drive bridge, showing Bars 1-20 and 1-22.

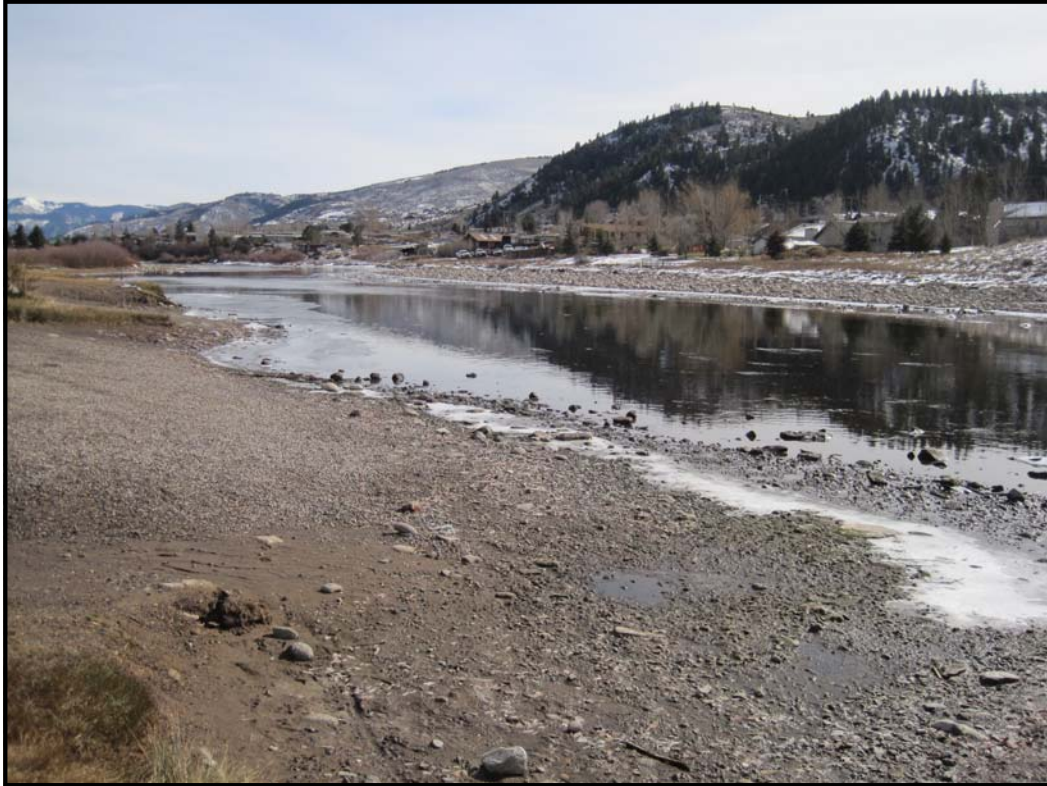
Point 1S3R: 11-11-11 From the boat launch, looking across/up river toward Bar 1-17 (in background).

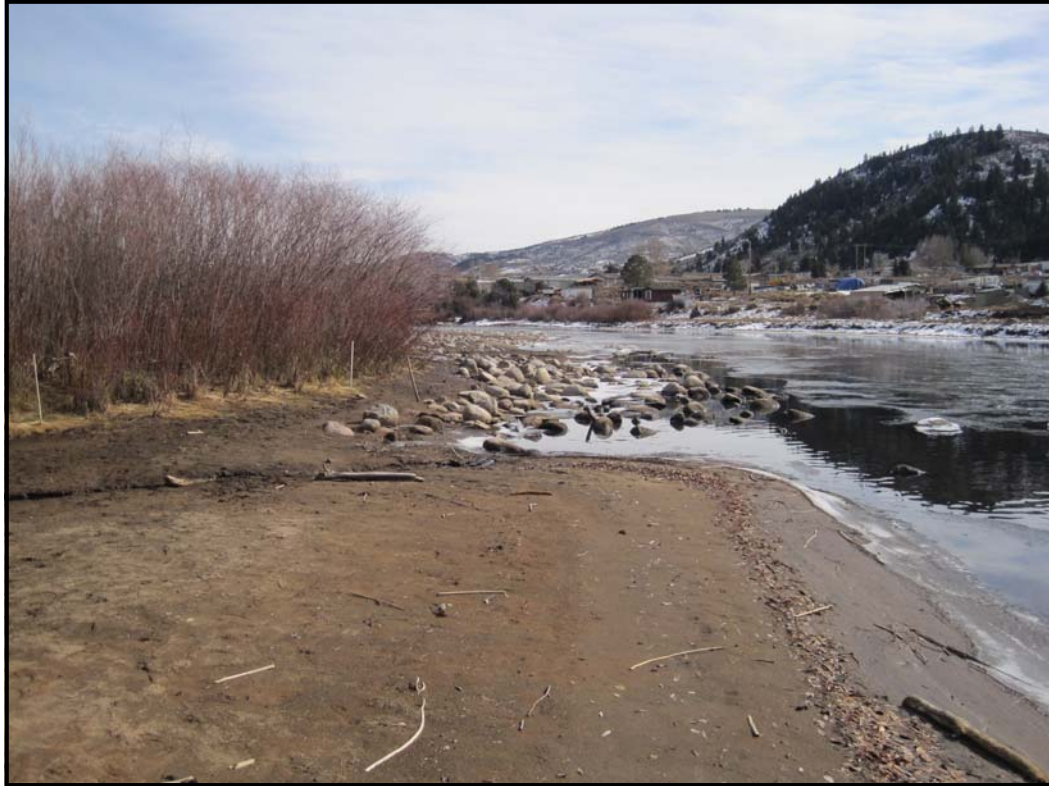
Point 1S4R: 11-11-11 Reach 2, right bank, looking upstream at Bar 1-15a, with Bar 1-15 in the background.

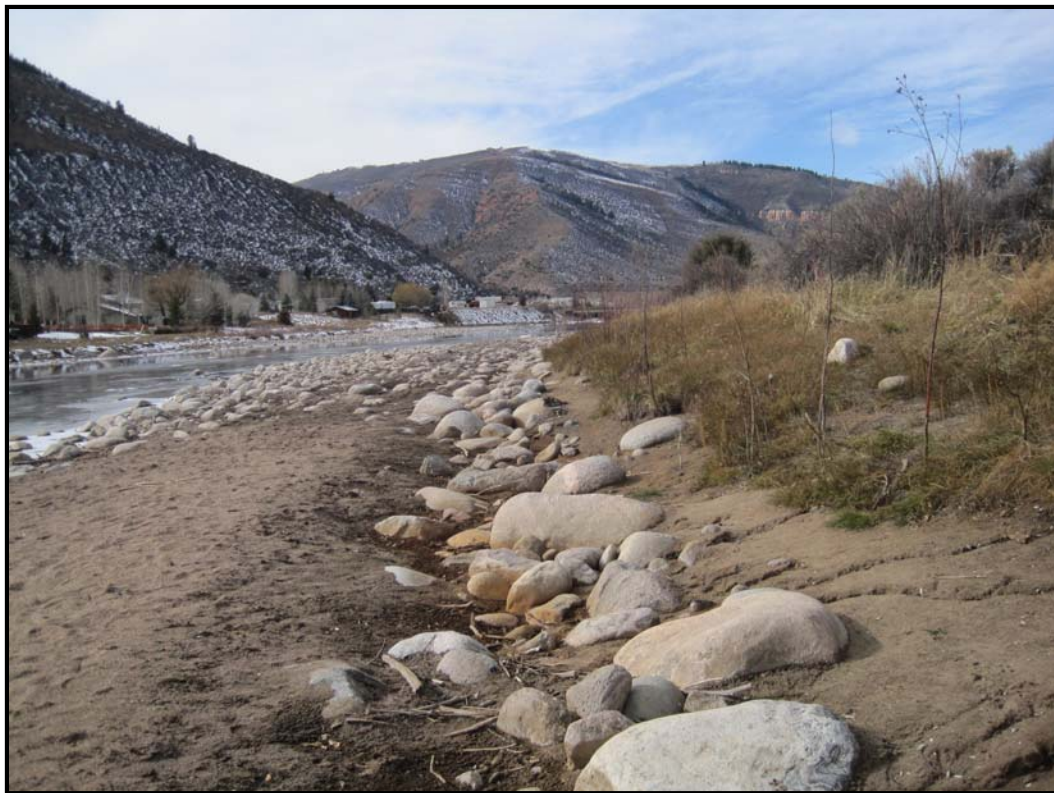
Point 1S5R: 11-11-11 Reach 2, right bank, looking downstream to Bar 1-15b.

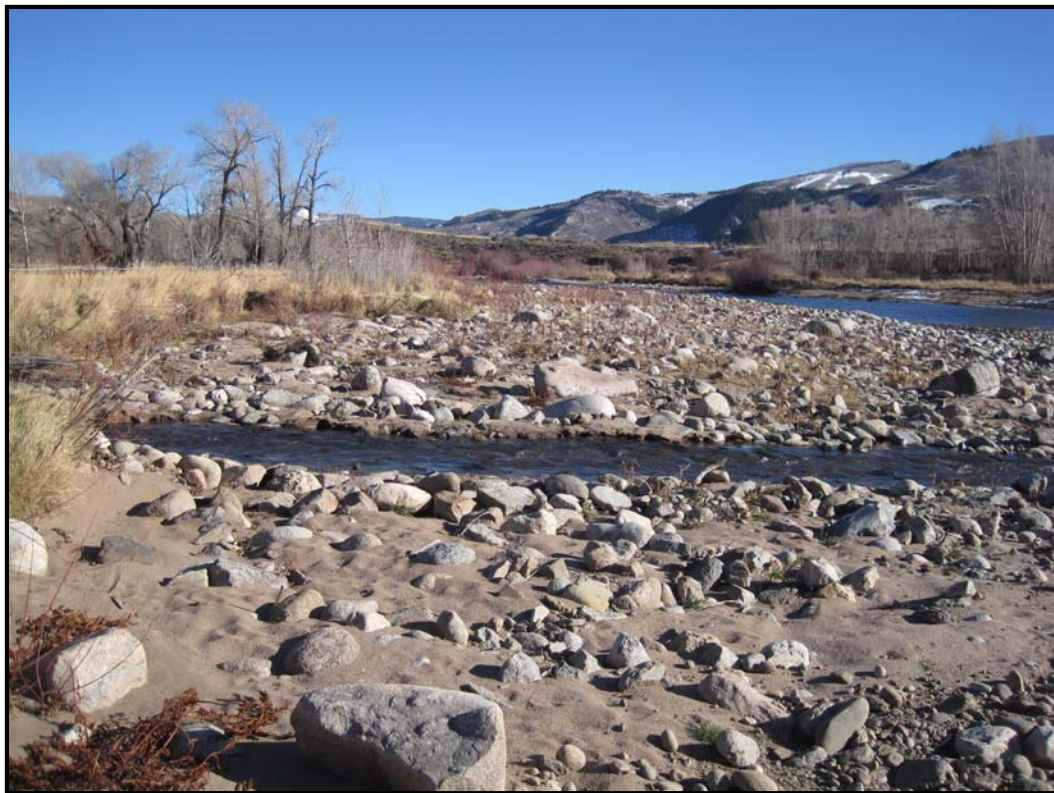
Point 1S6R: 11-18-11 Reach 5, right bank, looking upstream at Bar 1-8. Outlet of realined ditch is in foreground.

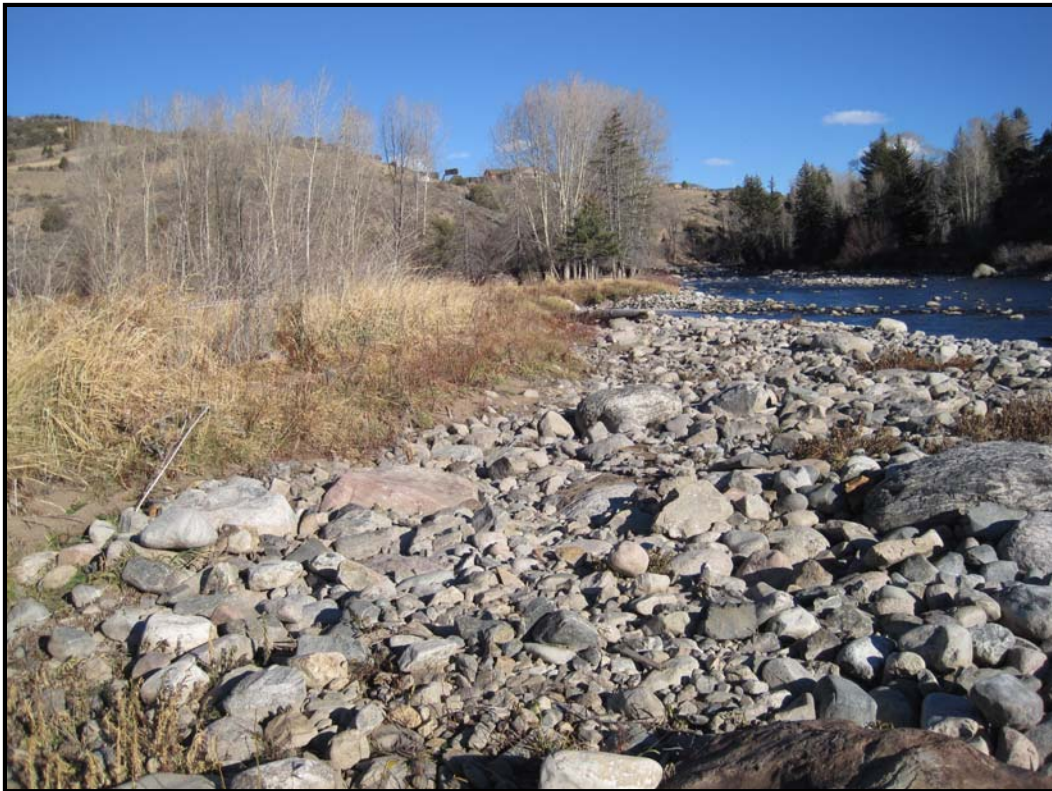
Point 1S7R: 11-18-11 Reach 5, right bank, looking upstream at Bar 1-1.

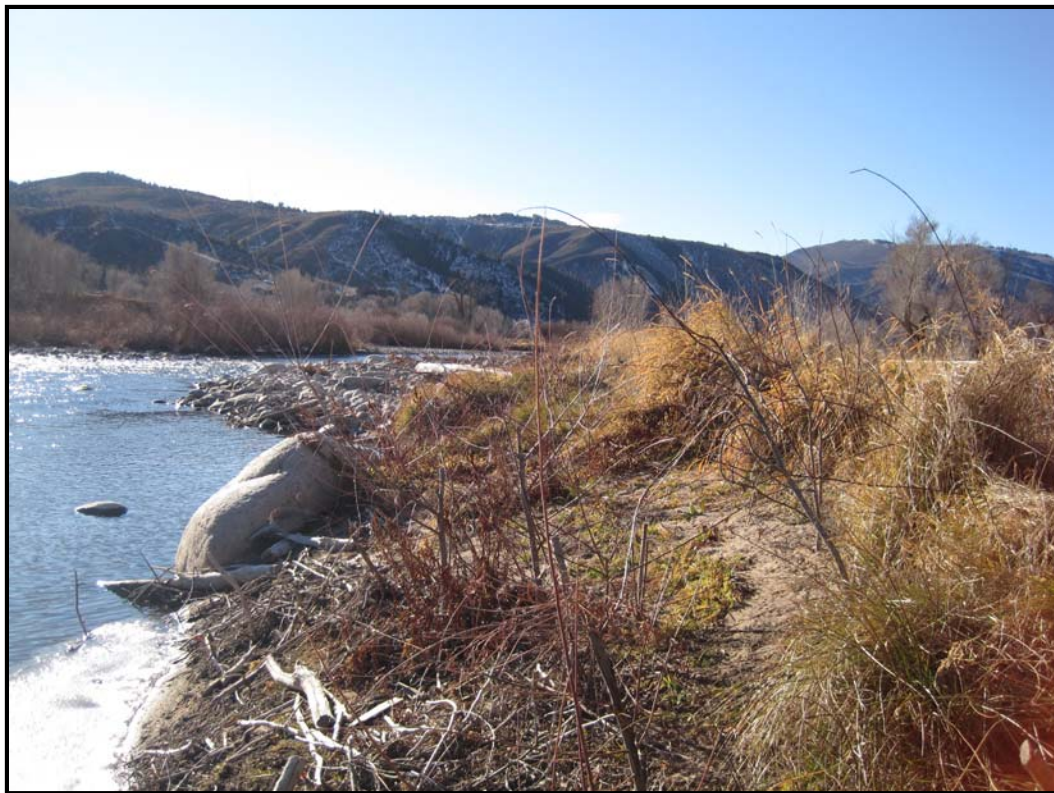
Point 1S8R: 11-18-11 Reach 5, right bank, looking downstream) to Bar 1-4.
