December 29, 2011

Re: 2011 Monitoring Report for the Phase 2A and 2B Edwards Eagle River Restoration Project in Eagle County, Colorado, Corps File No. SPK-2008-00608

EAGLE RIVER PHASE 2B 2011 MONITORING REPORT VEGETATION TREATMENTS

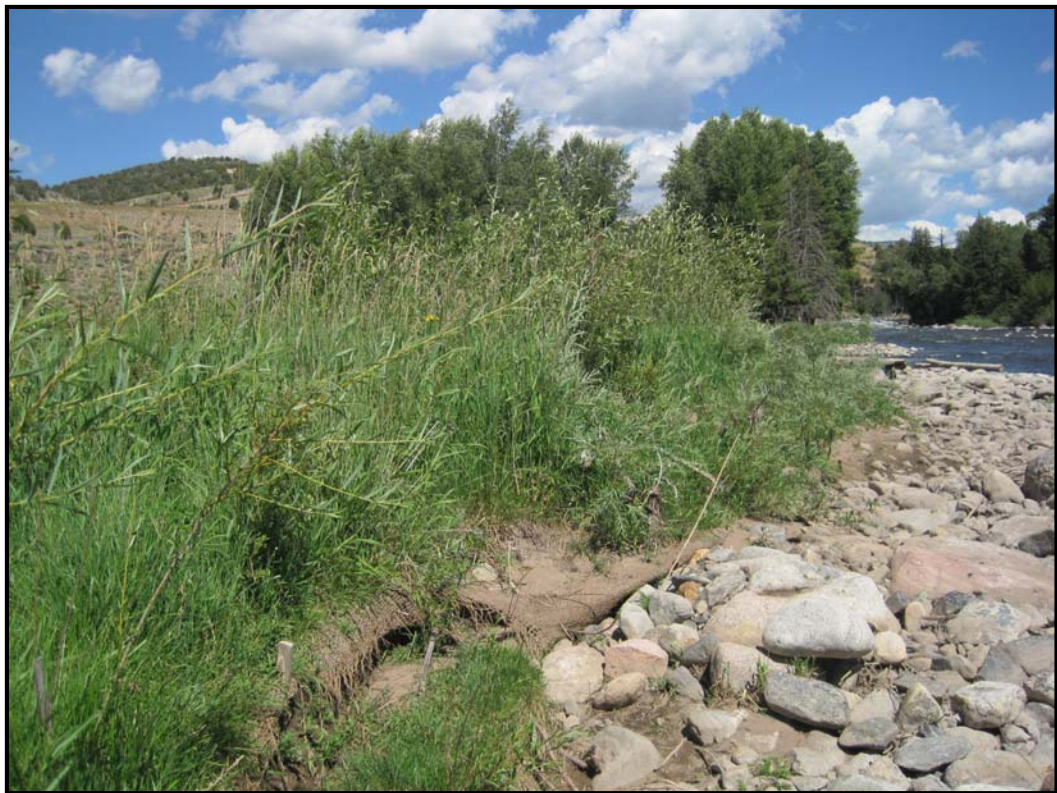
Point 1S9R: 8-15-11 Reach 5, right bank, looking upstream to oxbow confluence and Bar 1-1.

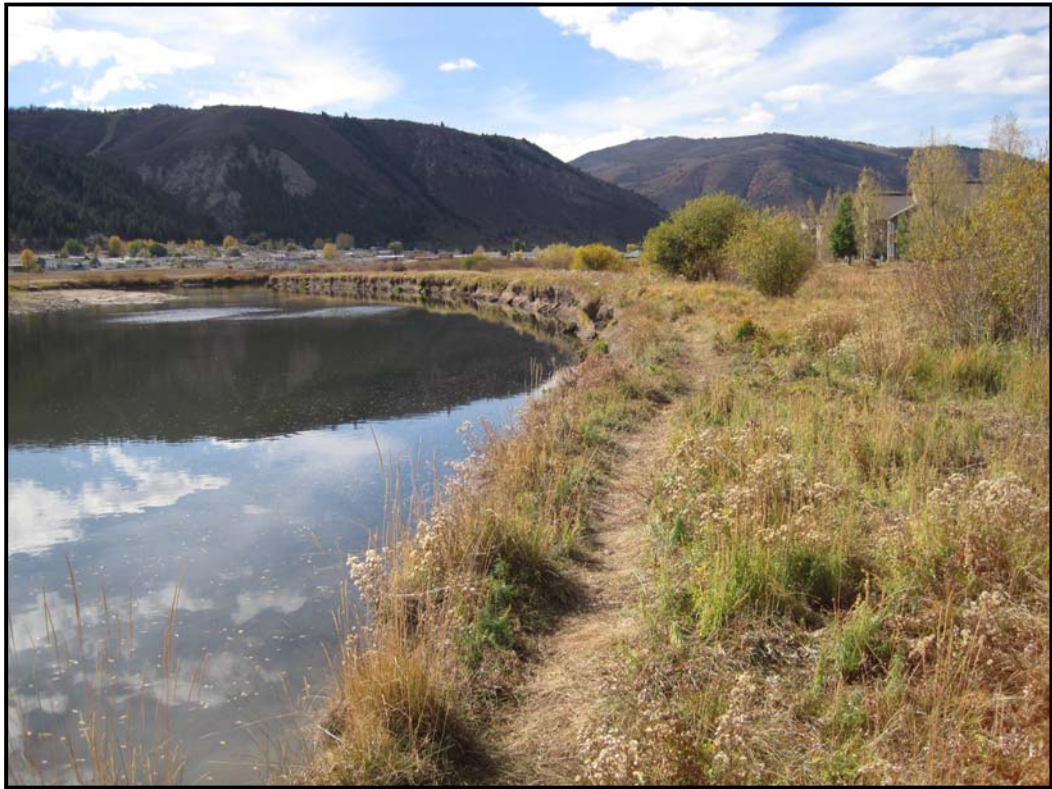
Point 2V1R: 10-5-10 Treatment area 2-13 looking downstream, before grading.

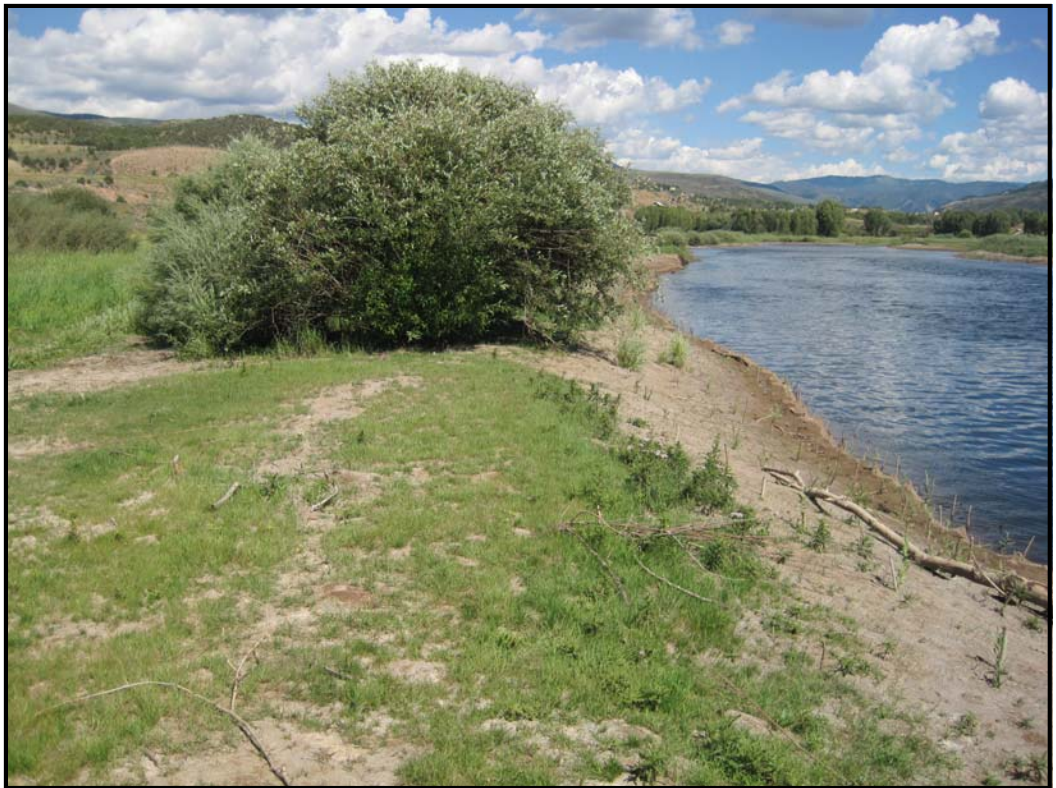
Point 2V2R: 8-15-11 Treatment area 2-13 looking upstream.

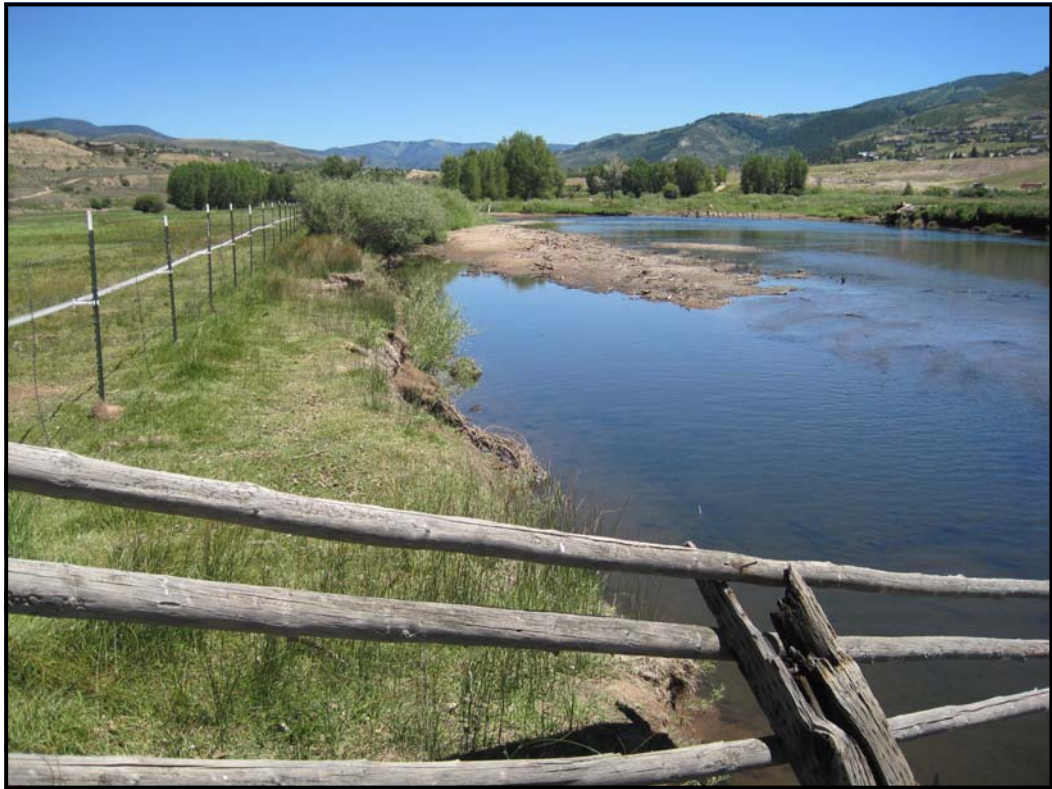
Point 2S1R: 9-2-10 Treatment area 2-11 looking upstream, before work.

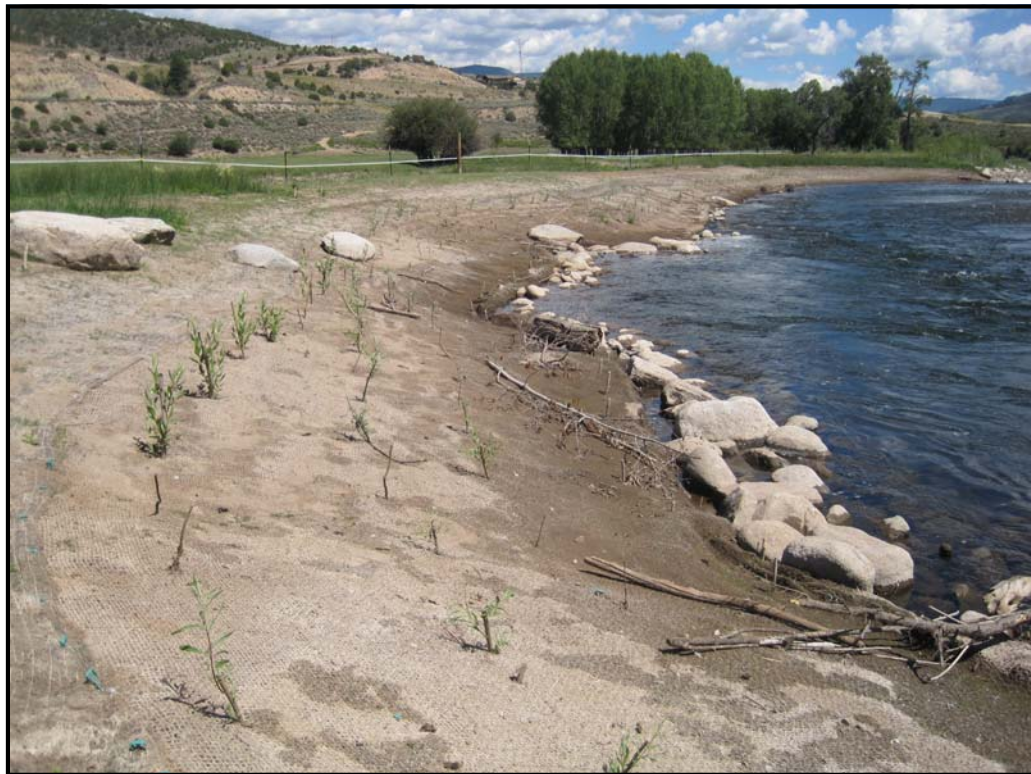
There was some damage to graded banks as a result of the sustained high flows. Coir erosion control blanket was pulled off of approximately 200 linear feet of graded bank in the lower section of treatment 2-6. Treatment area 2-10 received 6-12 inches of sand deposition in some areas and erosion in the downstream-most 100 linear feet. A length of about 400 linear feet at the downstream end of treatment area 2-13 incurred the most damage. Erosion control blanket and willow wattles were completely removed. This area was repaired in November of 2011. Brief descriptions of the bank and vegetation condition at each treatment area follow:

Point 2V3R: 8-15-11 Treatment area 2-6 after bank layback, ditch abandonment, willow wattle installation, and cobble toe reinforcement.

The bank damaged by high flows was repaired using the smashbank technique, in which river banks are pushed back with a large excavator bucket to a more gradual slope, but no soil is removed. Willow wattles and coir erosion control blanket were replaced, and an extra width of coir erosion control blanket was installed at the top of the bank slope.

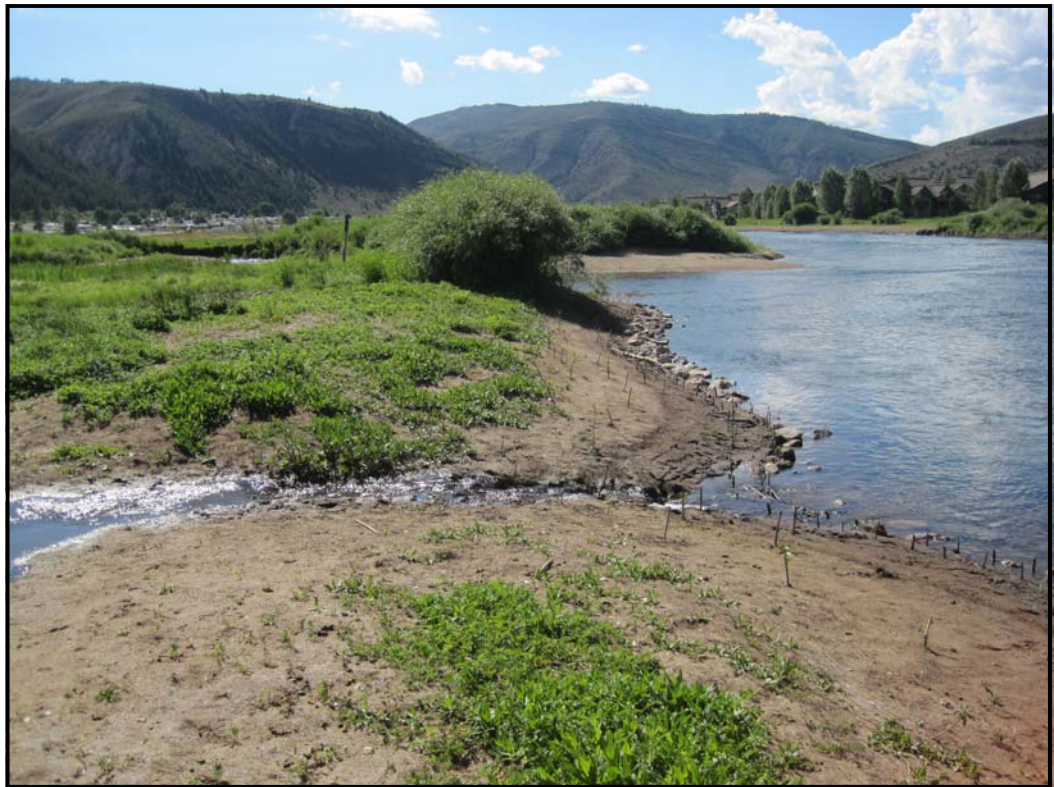
Willow stake survival on the row closer to the river averages about 10% and survival on the landward row is approximately 90%. Willow wattles were not installed on this bank. About 100 linear feet at the downstream end were damaged by high flows. This area was repaired in November of 2011 with the smashbank treatment, and clumps of existing Baltic rush were integrated. Erosion control blanket is intact on all other areas of the bank and native grass cover averages about 40%. In October of 2011, this area was the subject of a demonstration planting of long-pole containerized plants. Approximately 55 native trees and shrubs (grown by the Natural Resources Conservation Service Plant Materials Center in Los Lunas, NM) were planted.

Point 2V1L: 8-15-11 Treatment area 2-10 after fence removal, bank layback, willow wattle installation, and cobble toe reinforcement.

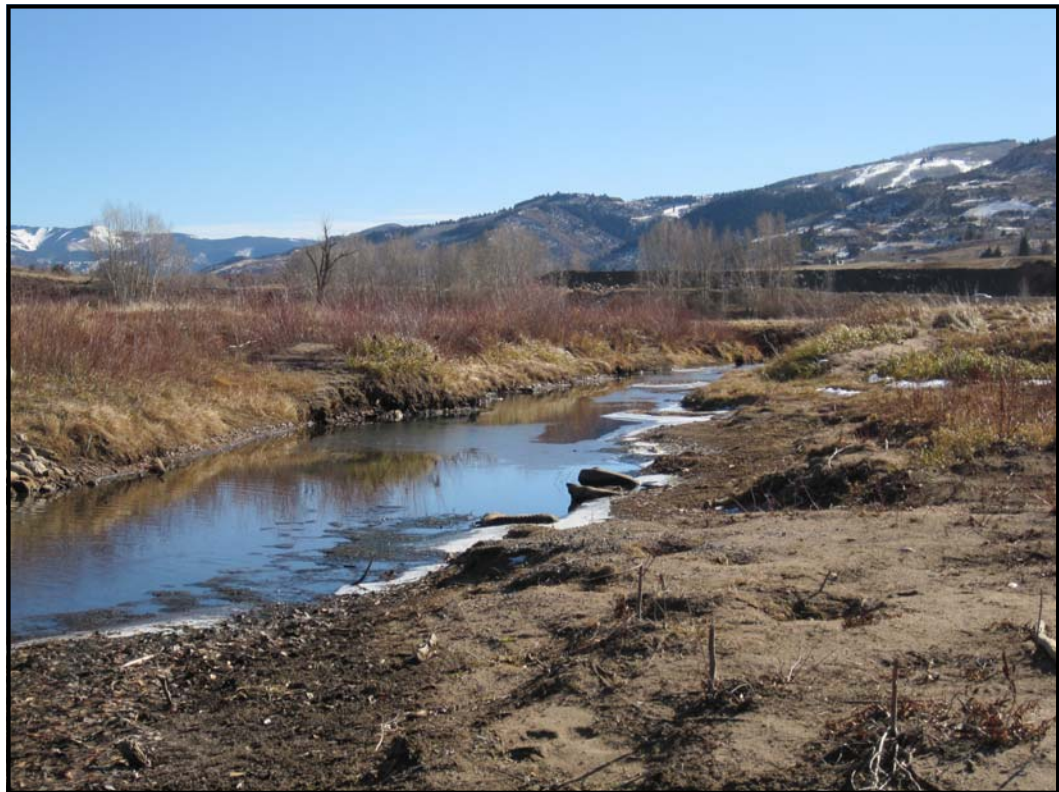
Point 2S1L: 11-18-11 Treatment area 2-8 looking south into side channel, after enhancements.

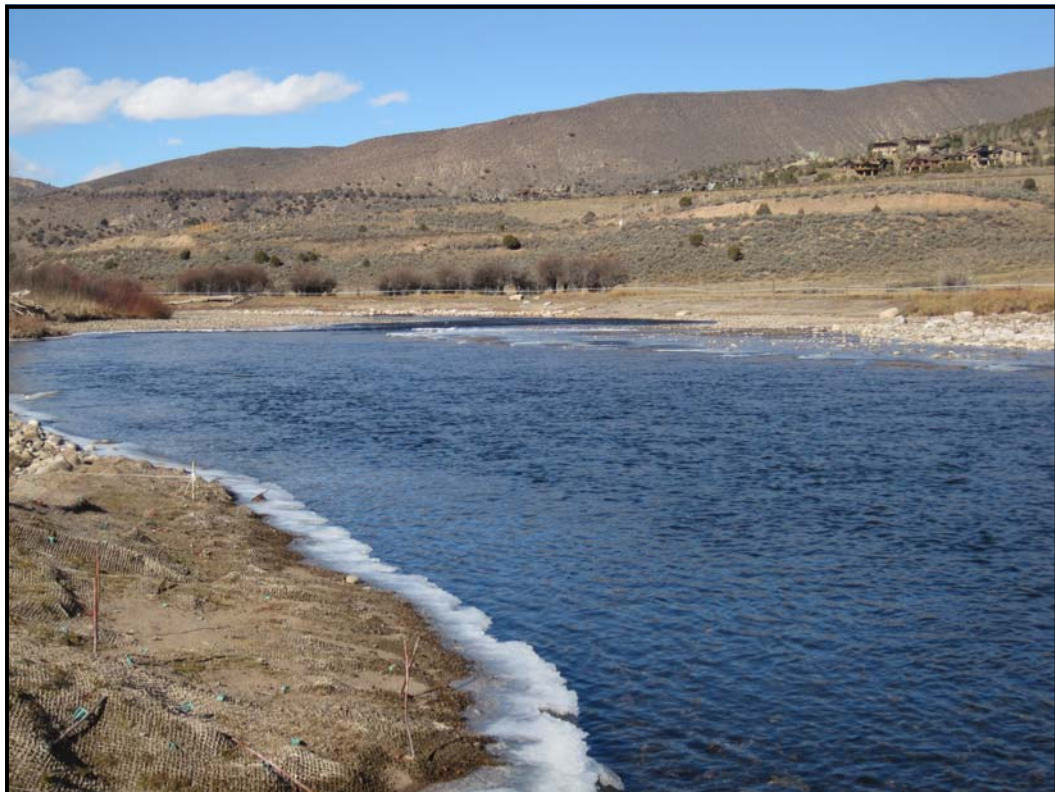
Point 2S2L: 11-18-11 Treatment area 2-7 looking downstream.

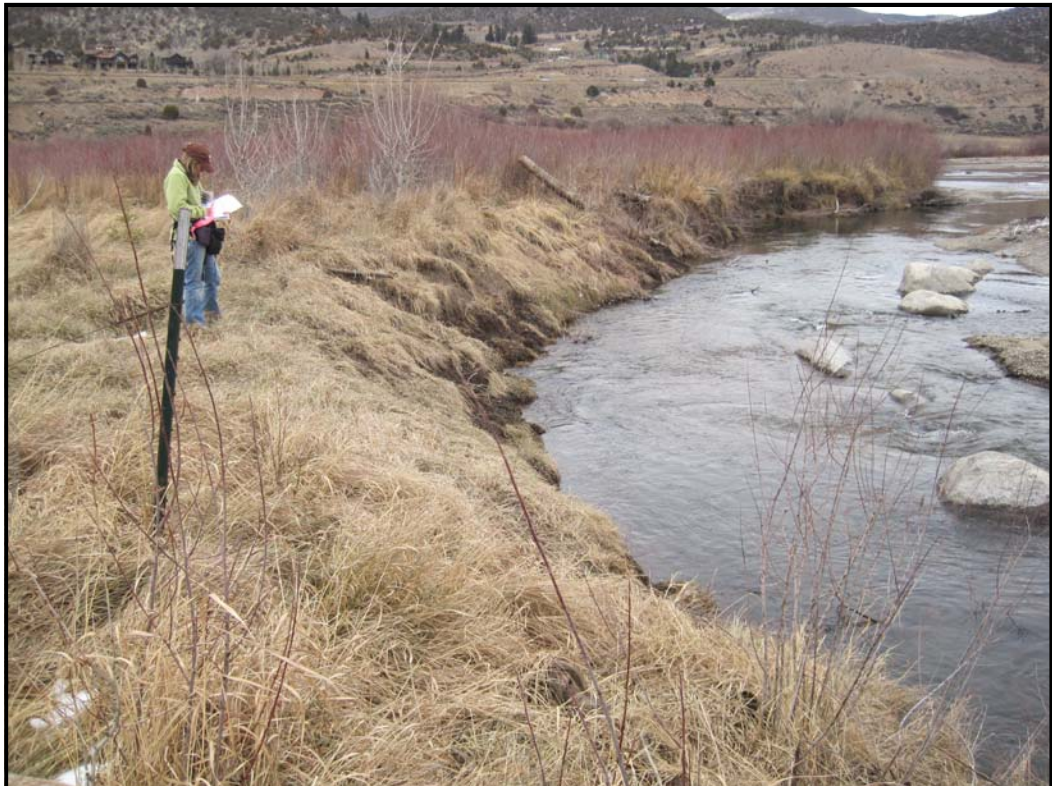
Point 2BV8L: 11-11-11 Treatment area 2B-1 looking upstream, after smashbank treatment.

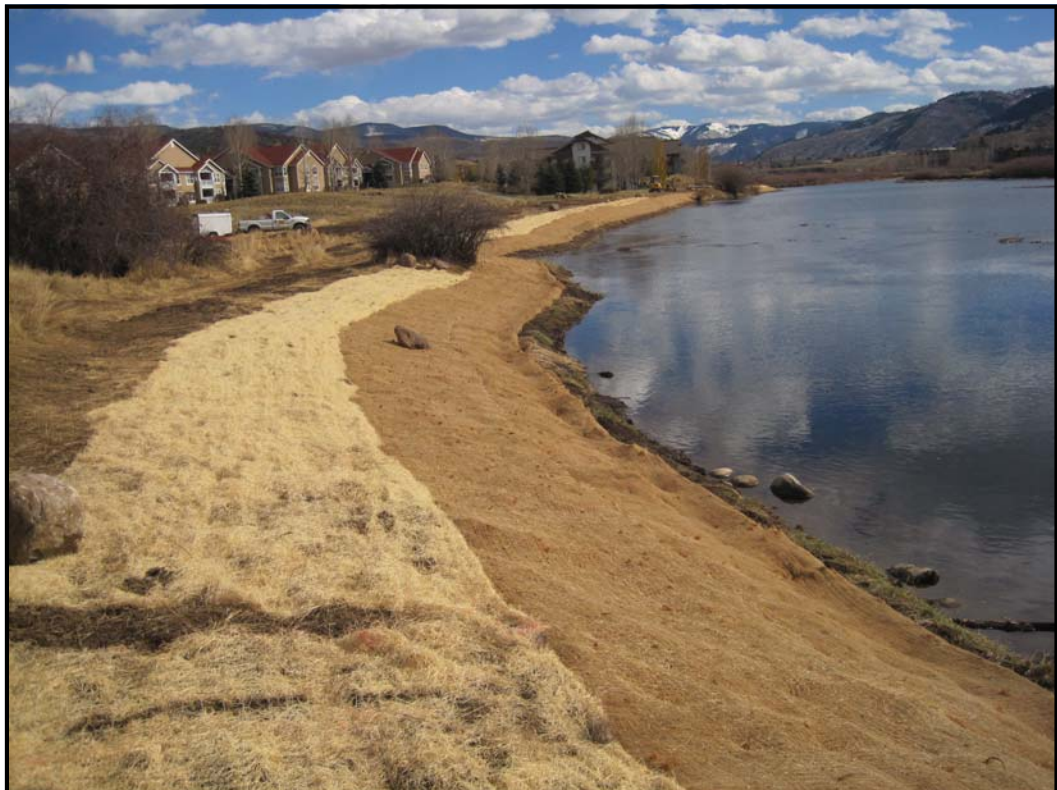
Point 2BV1R: 11-18-11 Treatment area 2B-3F as-built.

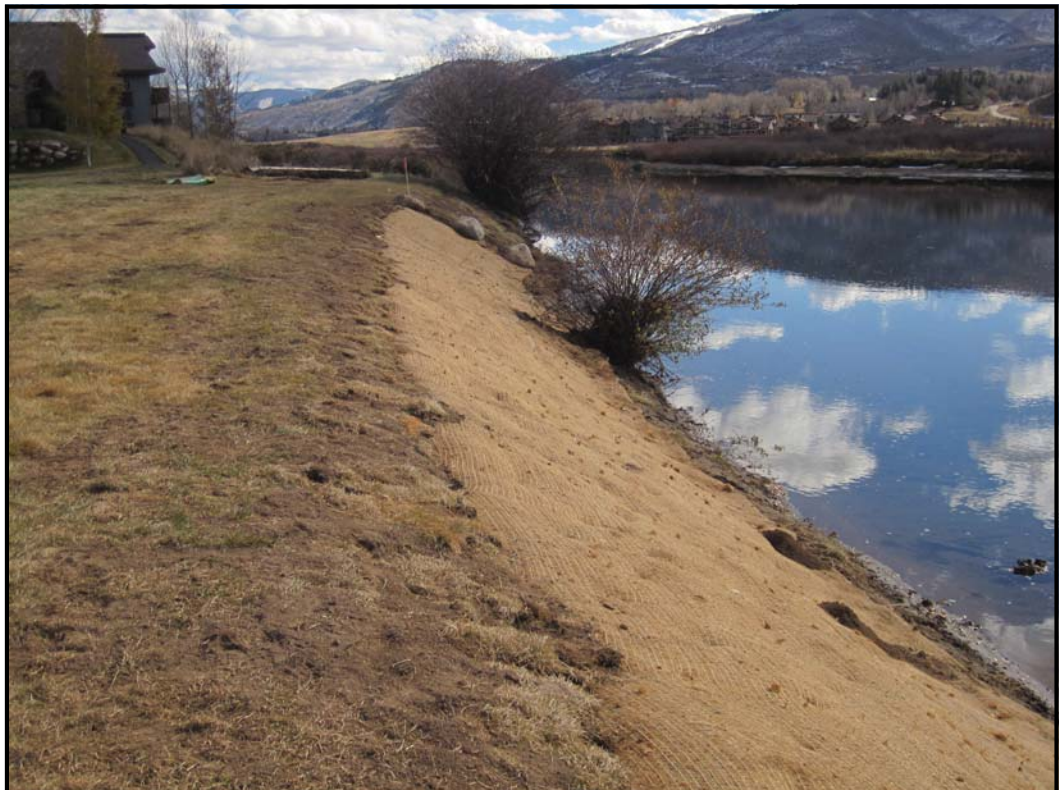
Point 2BV2R: 7-13-11 Treatment area 2B-3D looking upstream prior to grading.

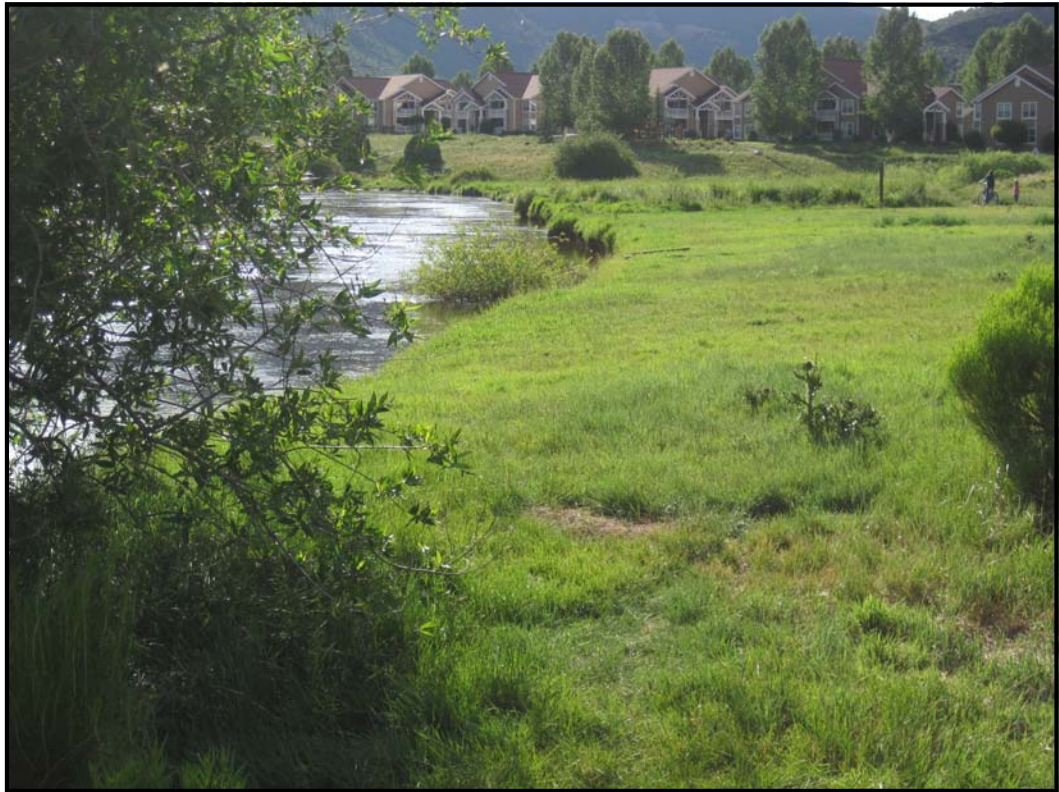
Point 2BV2R: 11-18-11 Treatment area 2B-3D as-built.

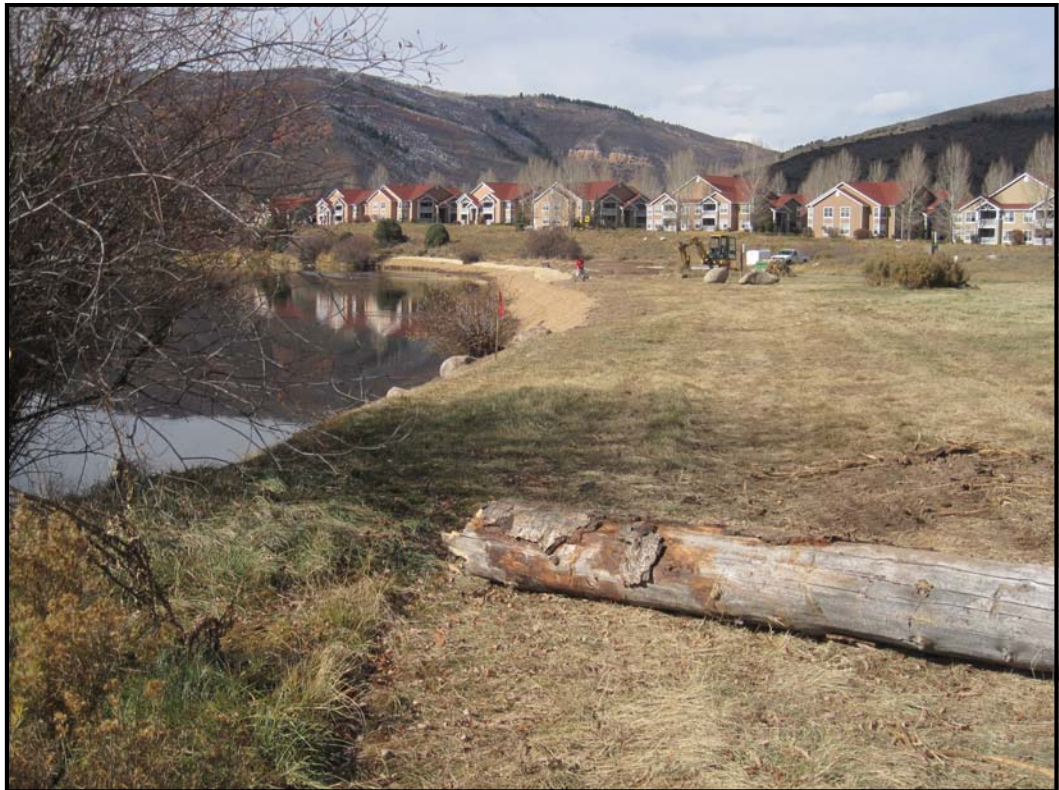
Point 2B3VR: 7-13-11 Treatment area 2B-3C looking upstream prior to grading.

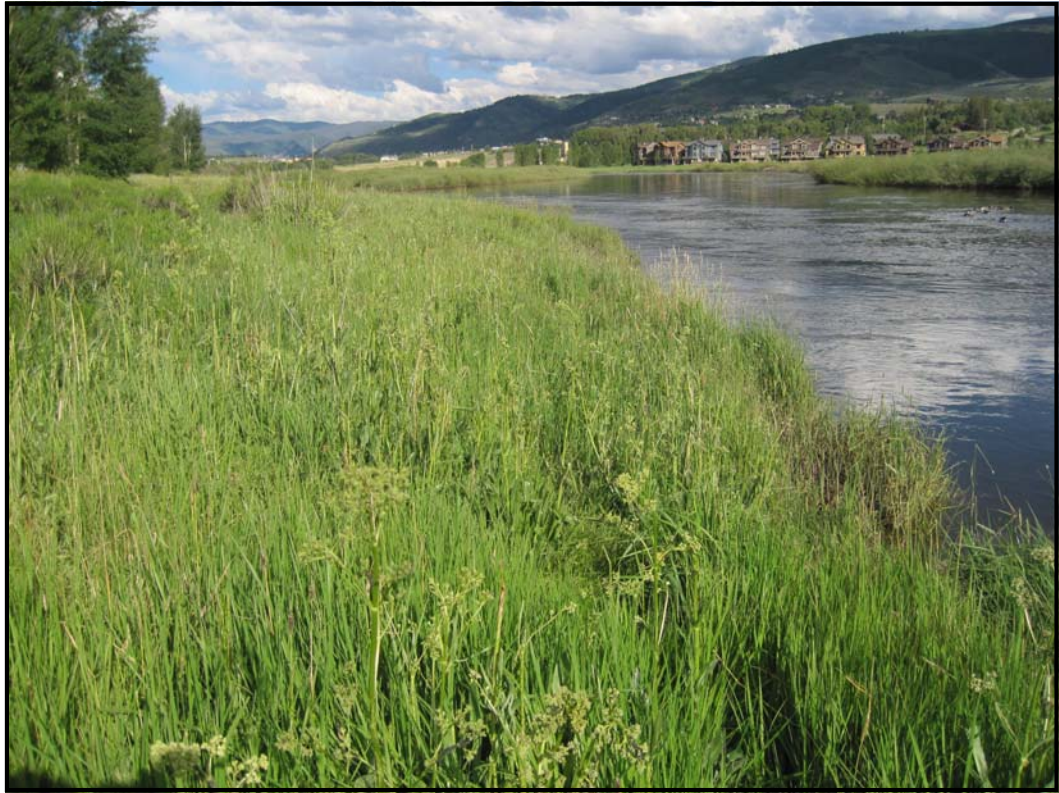
Point 2B3VR: 11-18-11 Treatment area 2B-3C as-built.

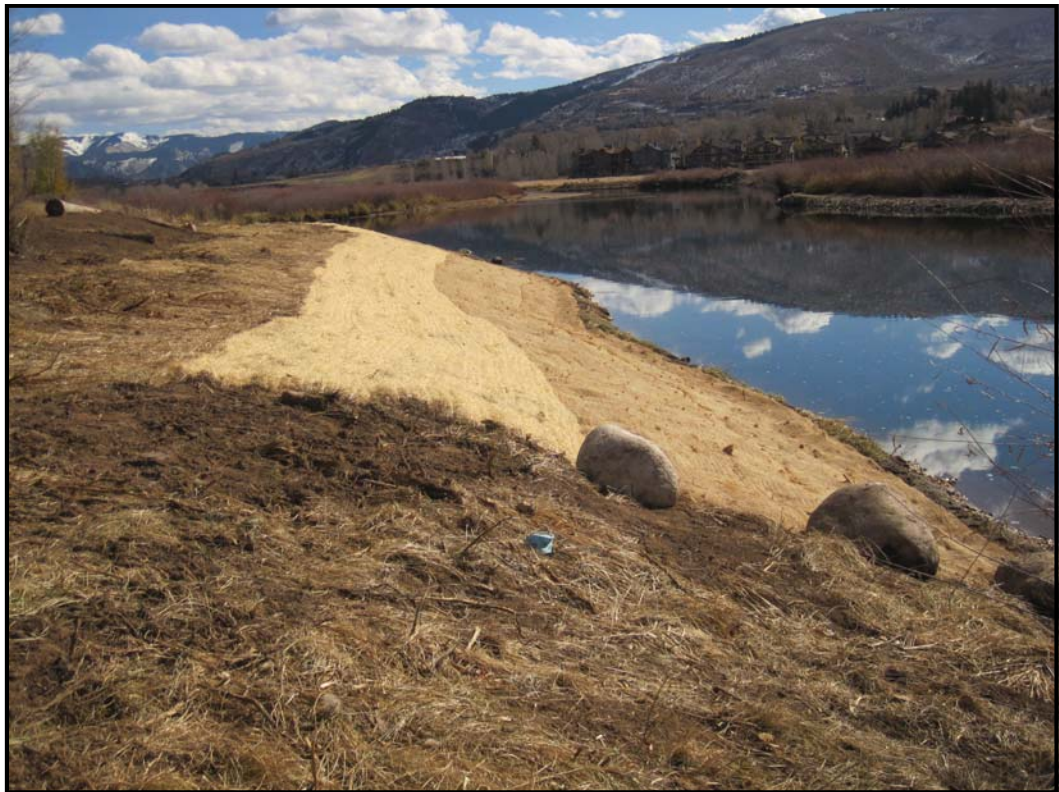
Point 2BV4R: 7-13-11 Treatment area 2B-3B looking upstream prior to grading.

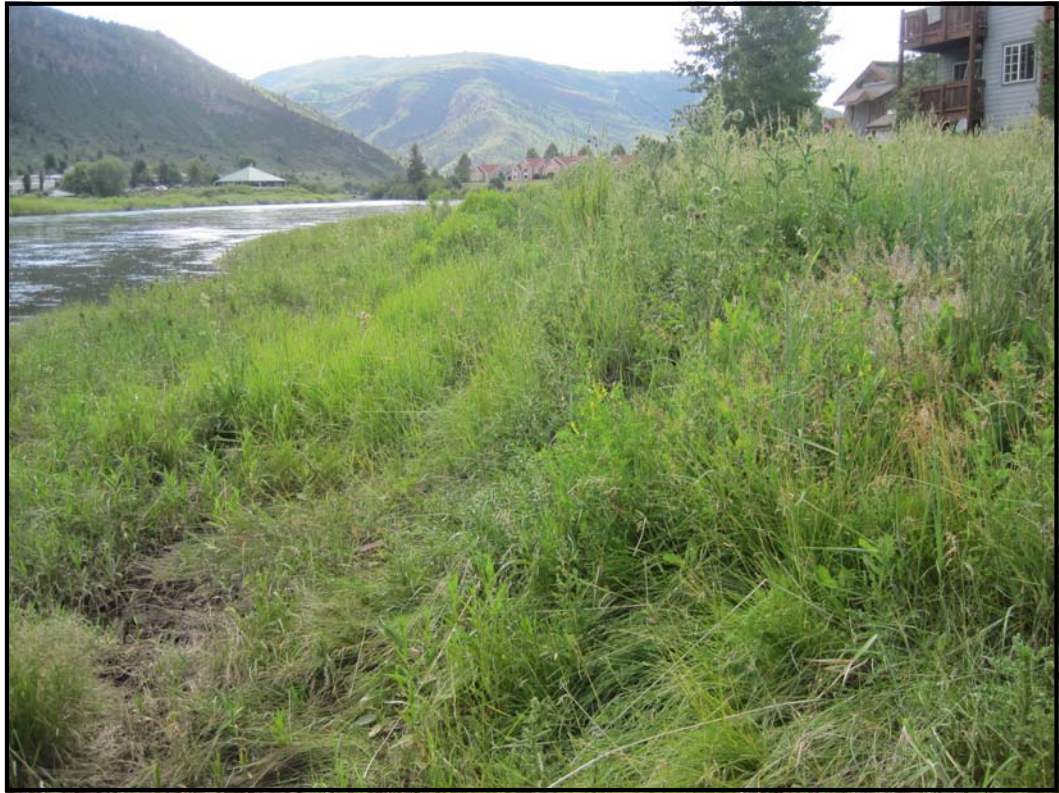
Point 2BV4R: 7-13-11 Treatment area 2B-3B as-built.

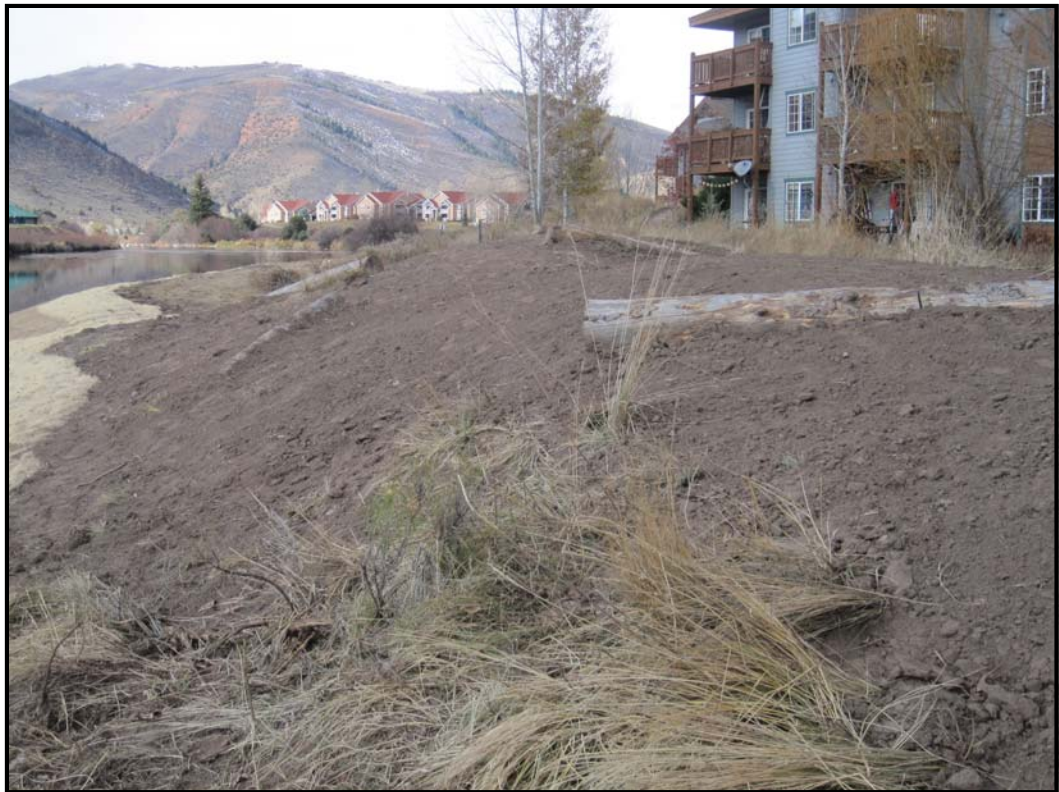
Point 2BV5R: 7-13-11 Treatment area 2B-3A looking downstream, before grading.

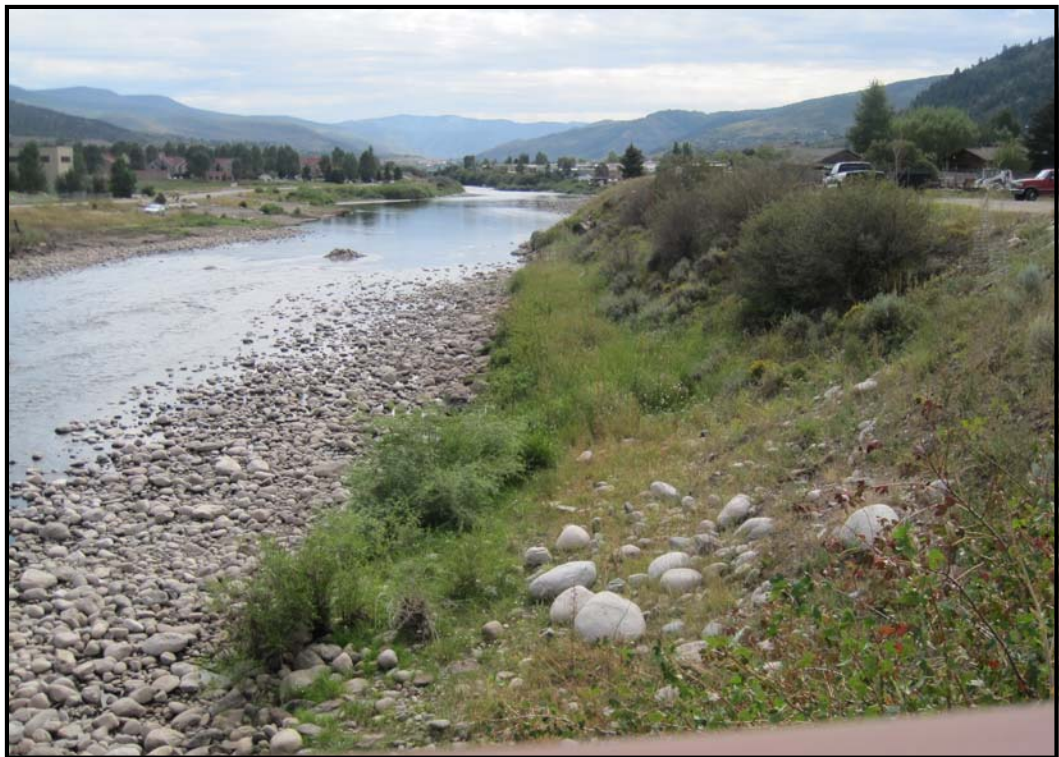
Point 1V1L: 8-19-11 15 additional cottonwood trees were planted this year.

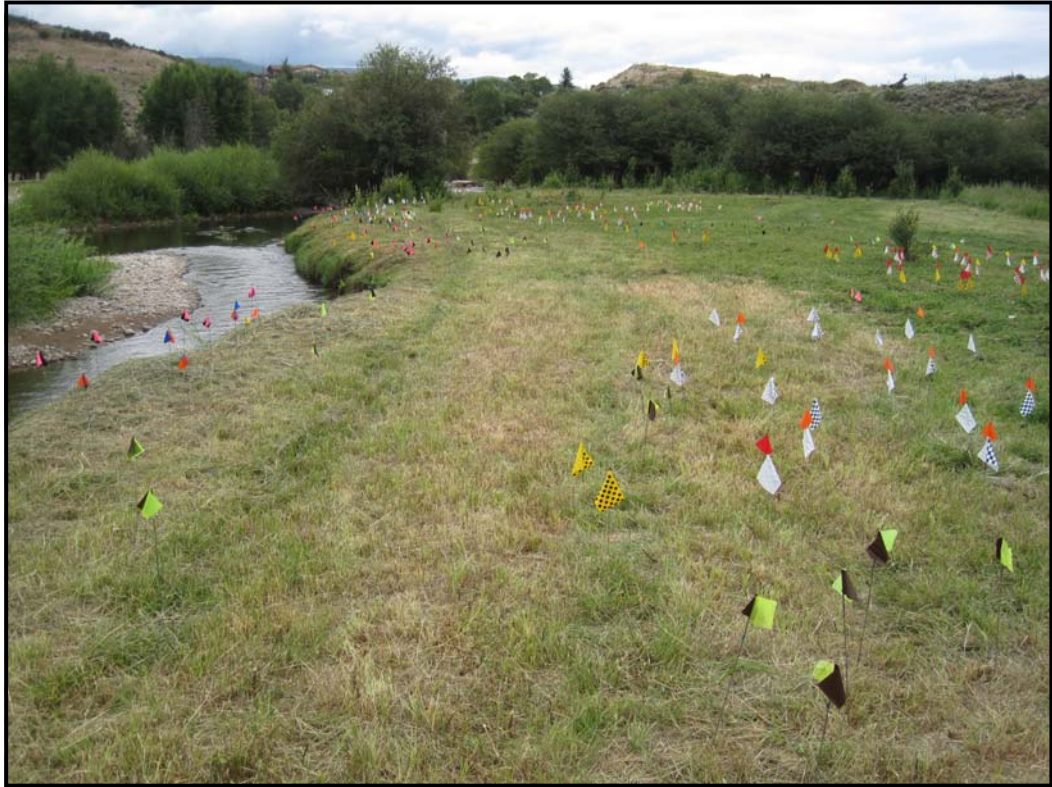
Point 1V10L: 8-19-11 Willows on bank; cottonwoods and mixed shrubs behind.

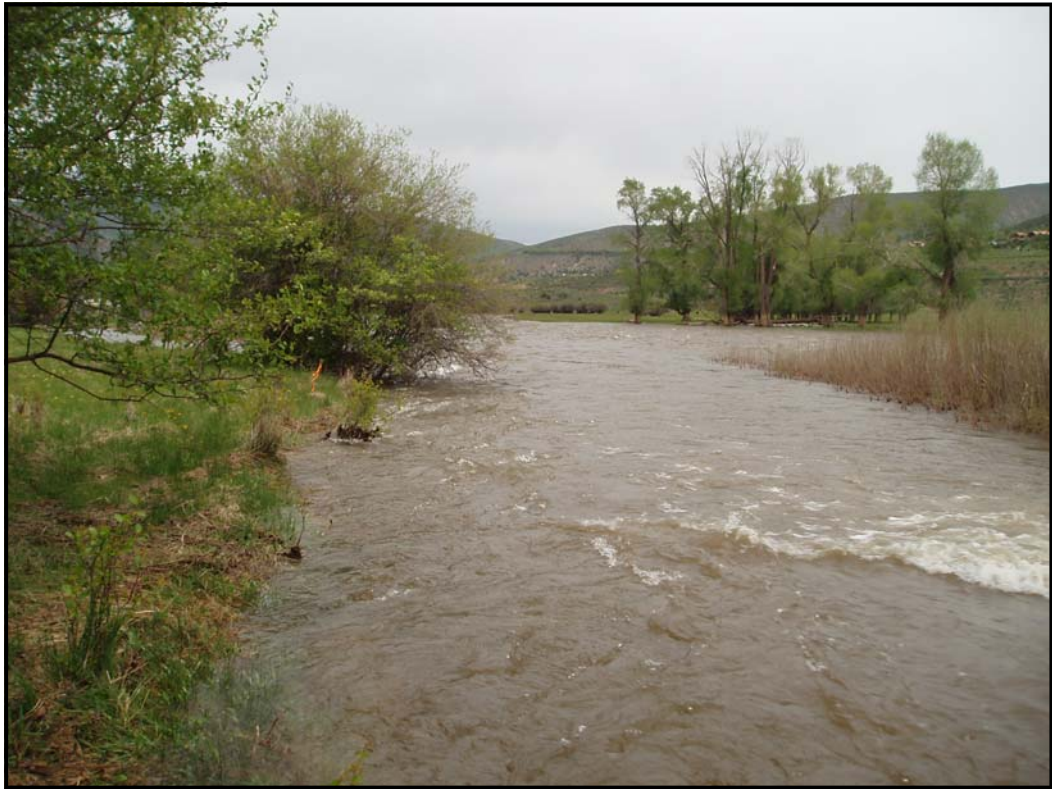
Point 1V11L: 8-19-11 Willows, dogwood, and currant on bank; cottonwoods, hawthorns, and mixed shrubs behind.

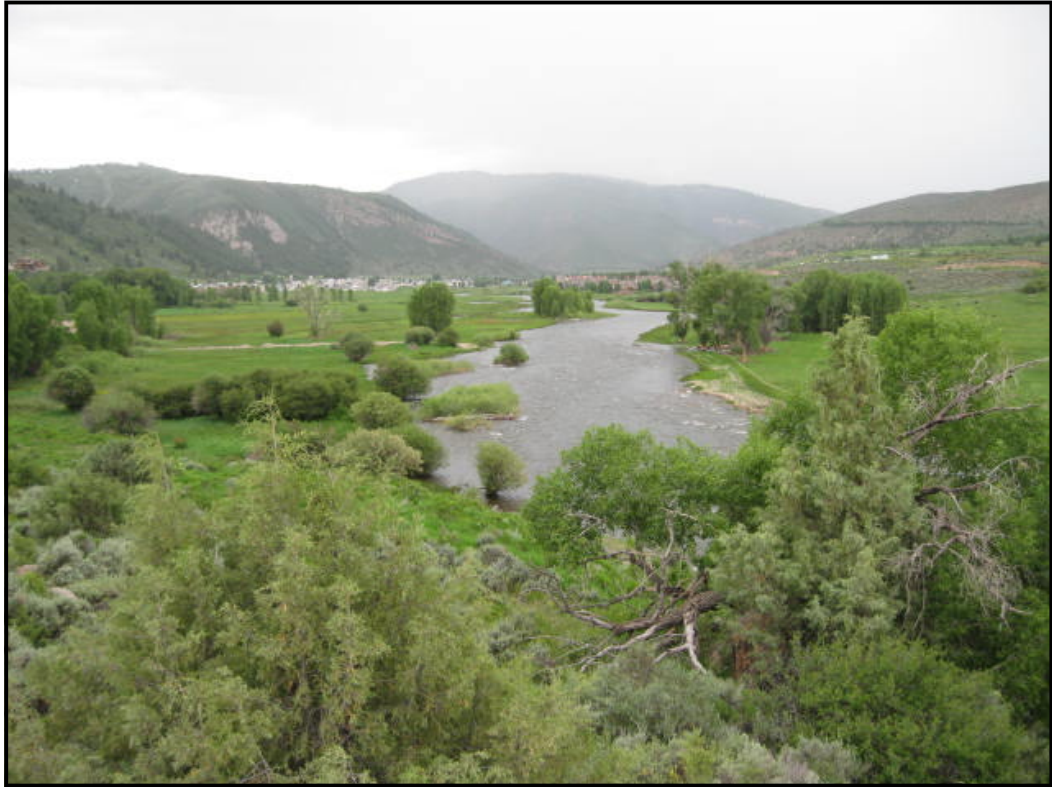
Point 1V13L: 11-11-011 Willows, dogwood, honeysuckle, and currant on bank; hawthorns, and mixed shrubs behind.

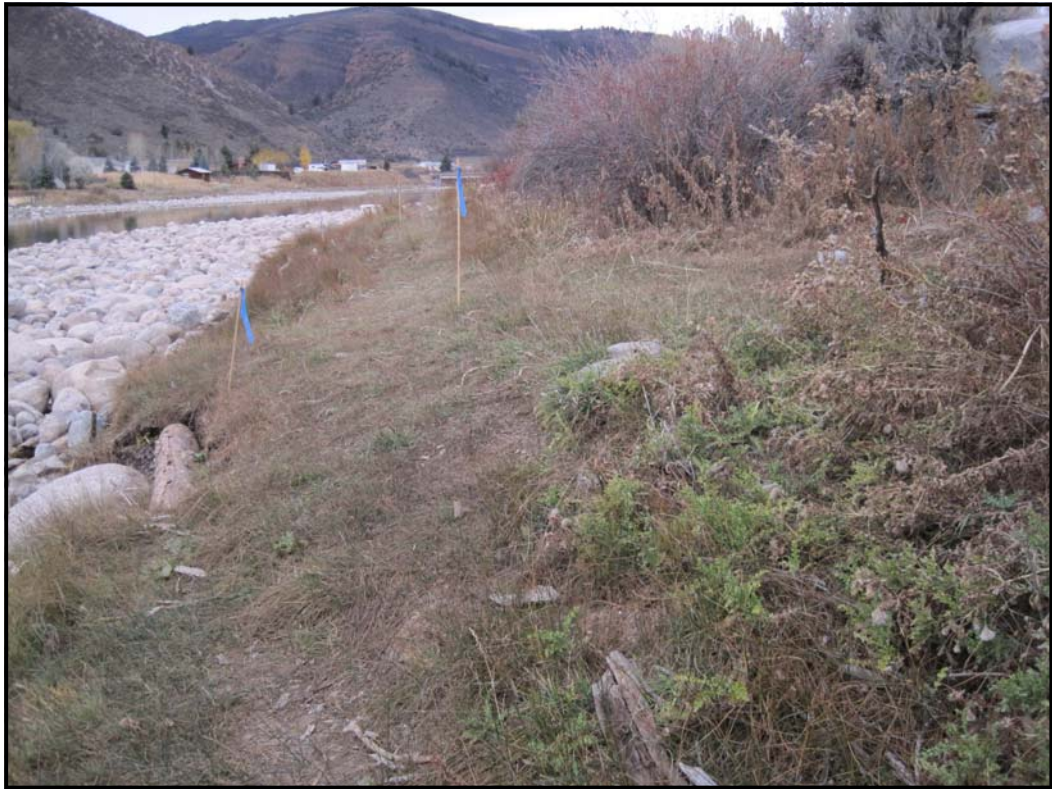
Point 1V5R: 8-15-11 Looking upstream from Cobble Bar 1-15; willow and birch plantings in foreground.

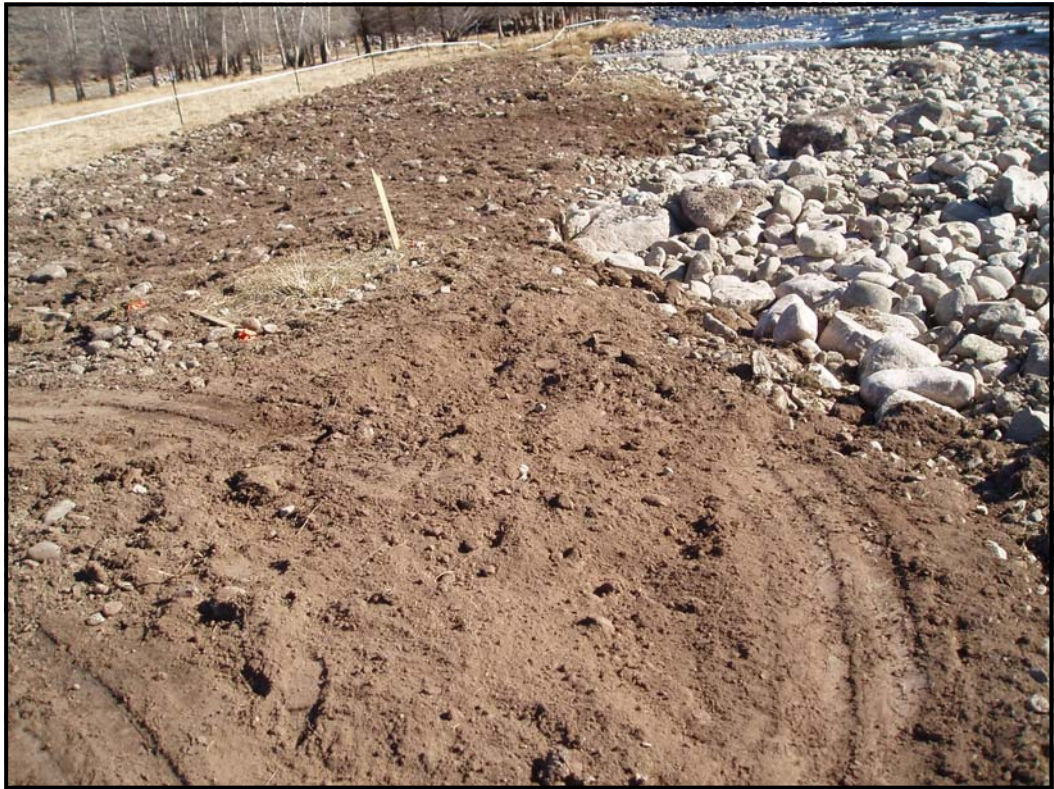
Point 1V6R: 8-15-11 Willows, birch, alder, dogwood, honeysuckle, and currant near bank, with cottonwoods and mixed shrubs behind. Silver buffaloberry, three-leaf sumac, wax currant, and big sage interplanted with existing shrubs on upper bank.

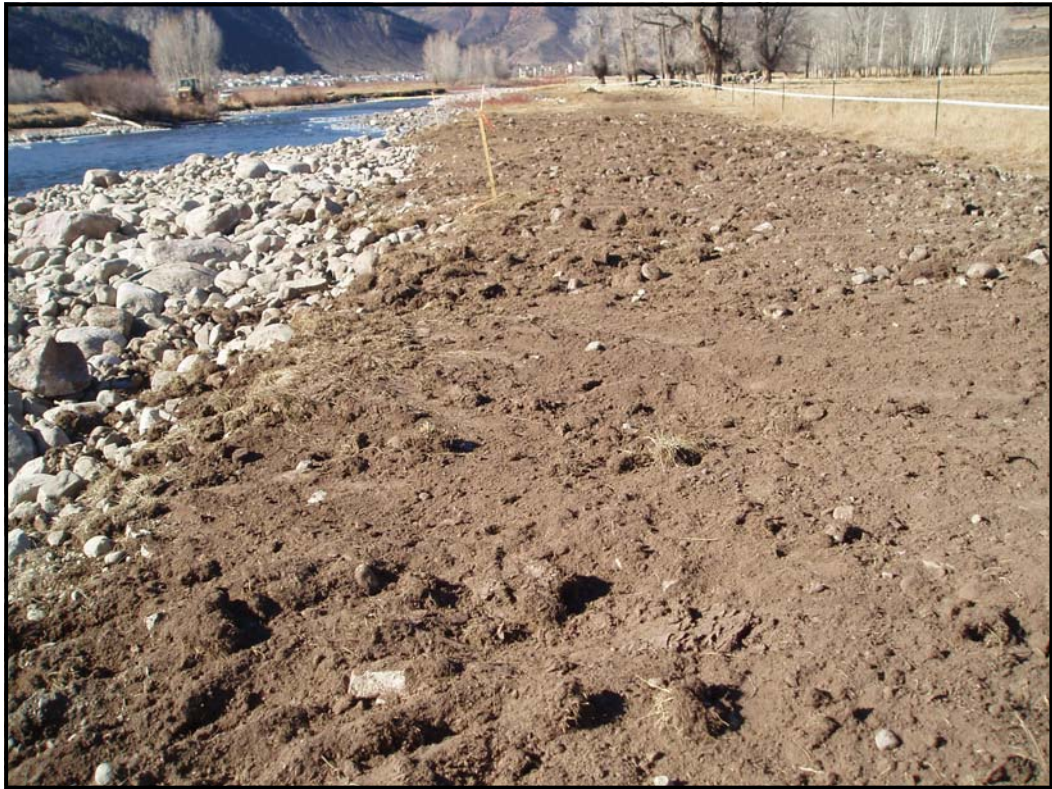
Point 1V8R: 11-18-11 Willows, dogwood, honeysuckle, and currant near bank, with cottonwoods, blue spruce, and mixed shrubs behind.

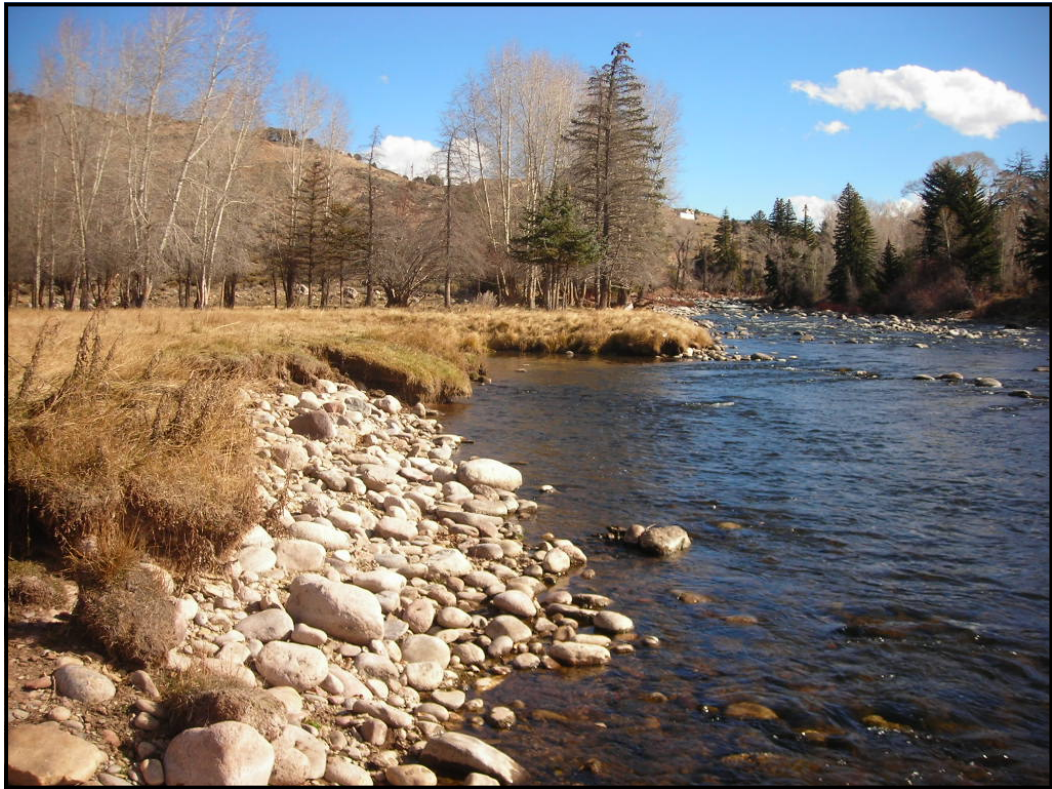
Point 1V10R: 11-18-11 Willows, dogwood, honeysuckle, and currant near bank, with cottonwoods, blue spruce, and mixed shrubs behind.
